Detection of Stripping in HMA

2005 Southeastern States Pavement Management and
Design Conference
June 2005

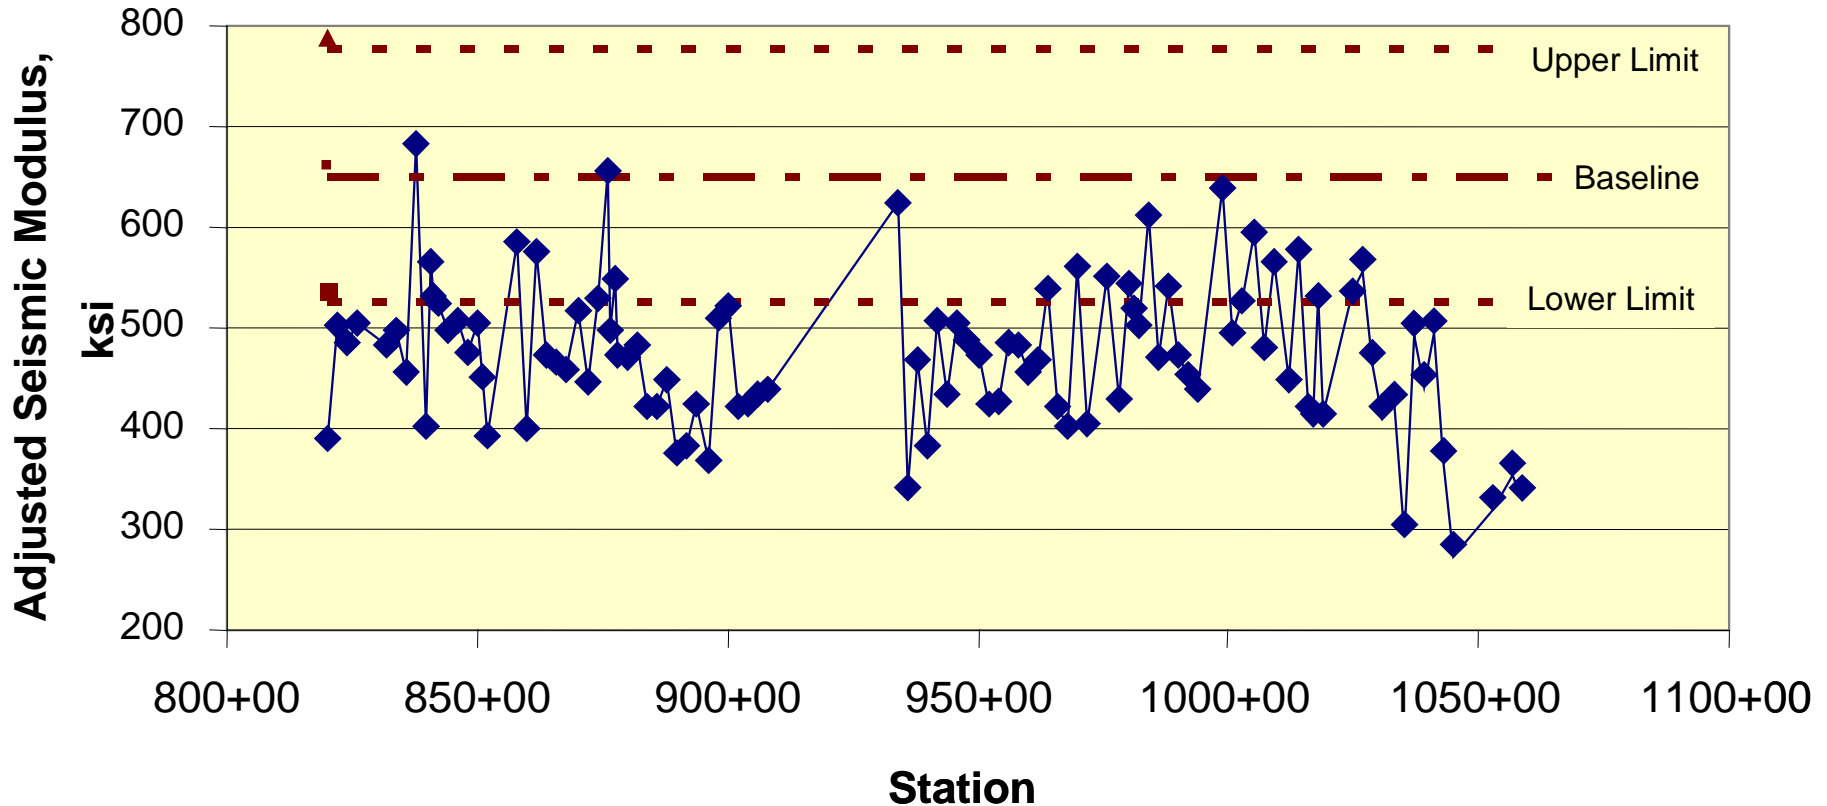
Phase I Seismic Chart

- Thermal anomalies were not good indicators of deterioration from stripping in full-depth asphalt pavements.
- Forward-calculated HMA moduli from FWD basins were not sensitive to moisture damage.
- Seismic tests indicate that the uppermost layer (3 to 4 inches) is in good condition with lower quality material between 4 and 6 inches below the surface.

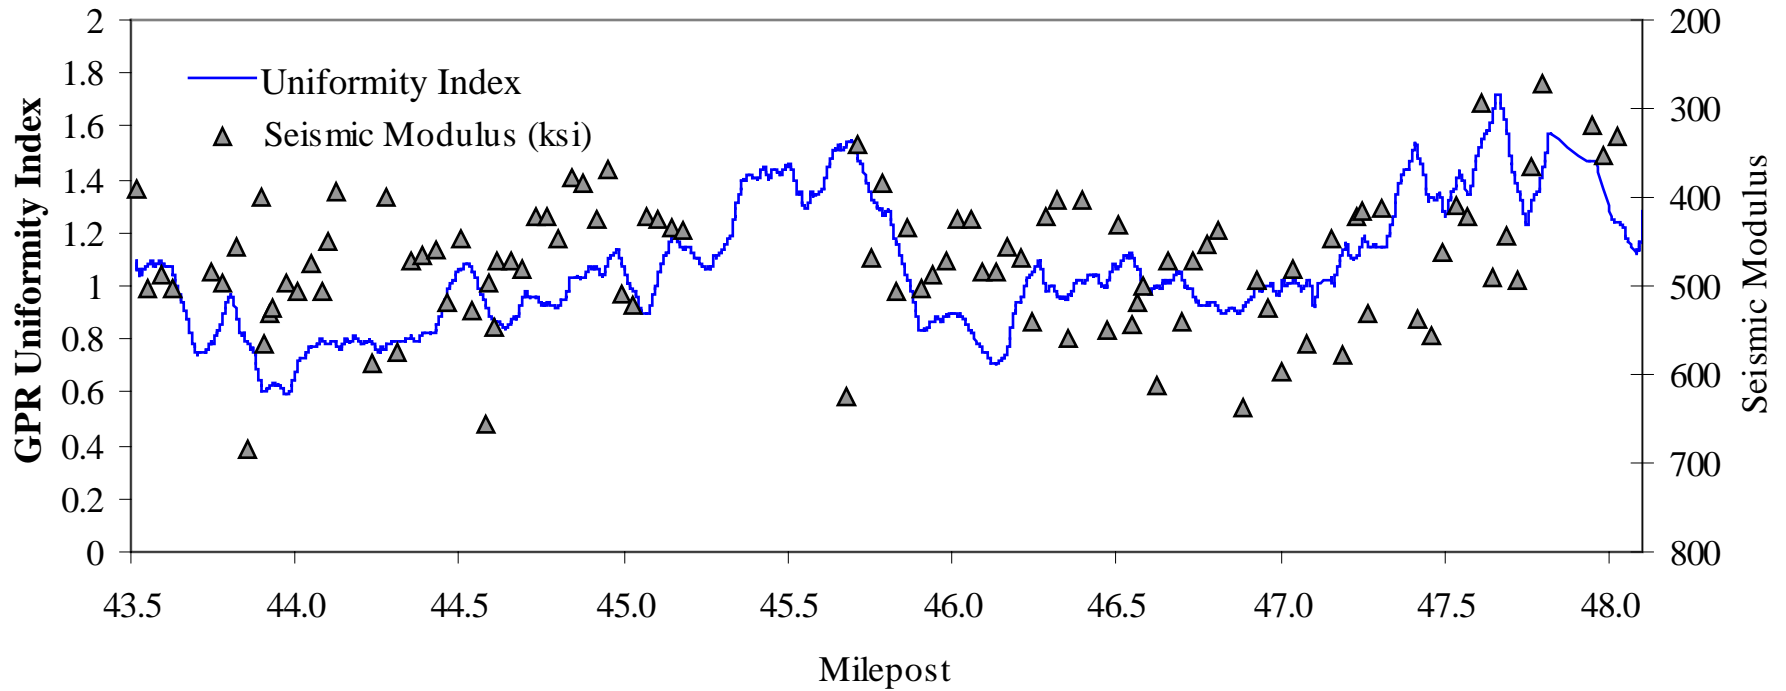
Phase I Uniformity Index

- GPR is an effective screening tool to identify areas with changes in electromagnetic properties possibly caused by moisture damage.
- The GPR Uniformity Index provides a method to pinpoint localized non-uniformity within the pavement section.
- The upper 8 inches of HMA should be removed during rehabilitation to preclude significant distortions from construction traffic.

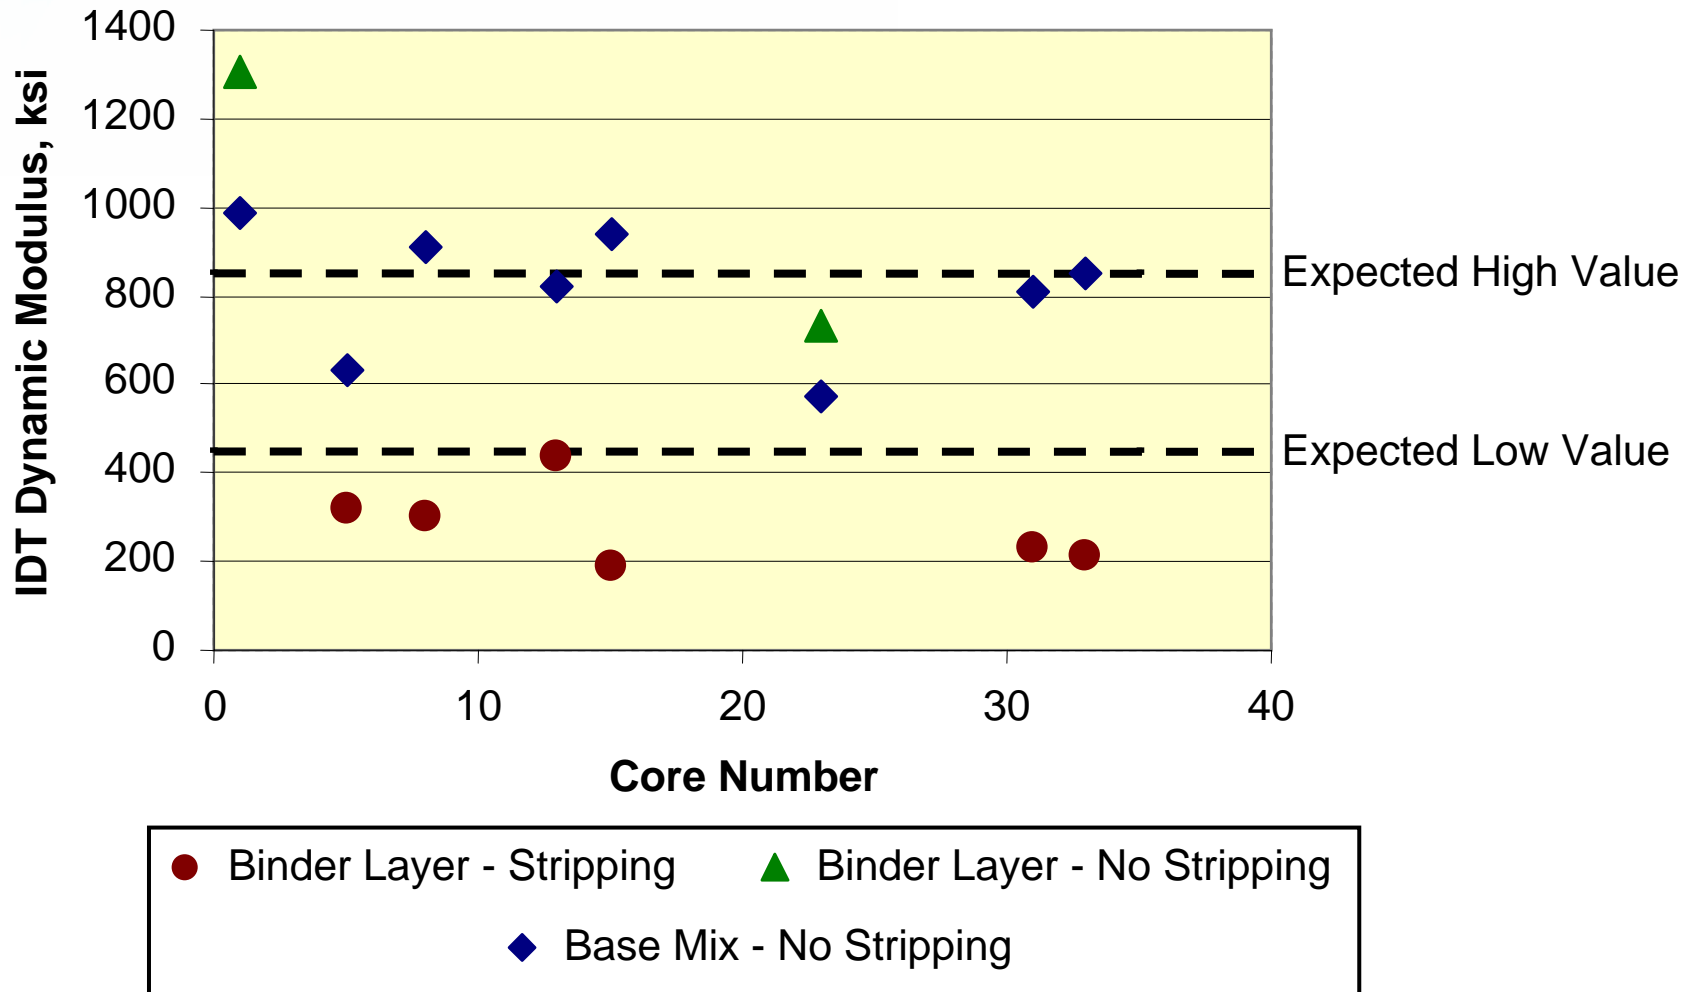
Phase I IDT Results

- Widespread moisture damage exists within the intermediate (binder) layer at a depth of 4 to 8 inches.
- While little of this damage has progressed to full-blown stripping, the integrity of the material has been compromised to the extent that rehabilitation design strategies will be impacted.
- Remove top 8 inches as a part of the rehabilitation strategy.

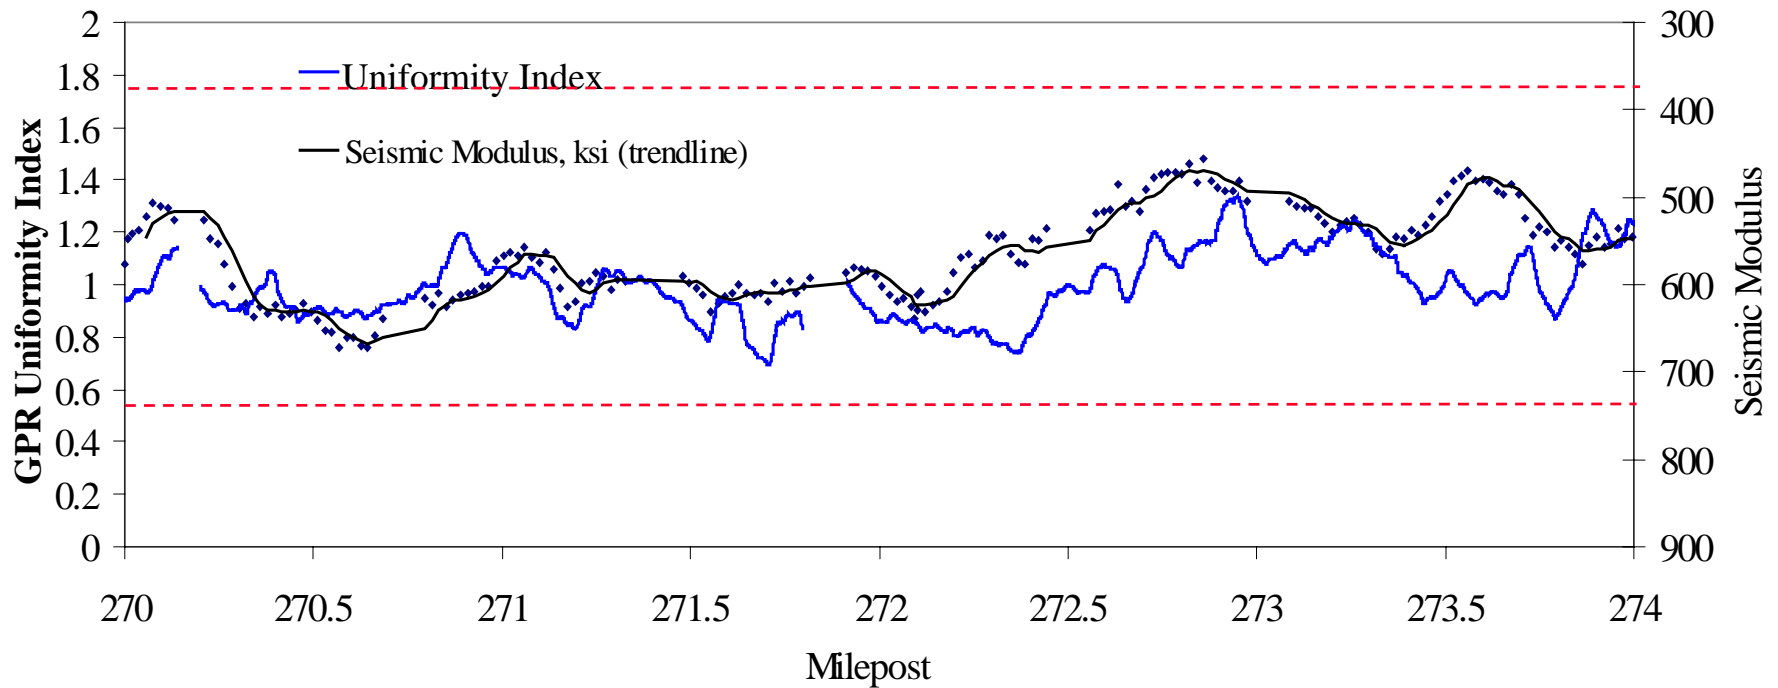
Phase II GPR UI and Seismic Modulus

- Moisture damage is isolated to localized areas.
- The GPR survey suggests that moisture is present along the entire length of the pilot project.
- GPR and seismic comparison shows that
 - Moisture is primarily confined to the interfaces between layers.
 - Moisture has reduced bond between layers, but has not affected the integrity of the HMA
- Most mix disintegration has occurred near the lower portion of the base layer.
- With the exception of a couple of isolated locations, any damaged material is far enough below the surface so that it should not influence the rehabilitation strategy.
