**2005 Southeastern States
Pavement Management and Design Conference**

Pavement Forensics
Route 3, Lancaster County, Virginia

Mohamed Elfino, PhD, PE
Assistant State Materials Engineer

- **Project Number:0003-051-114, C501**
- **Location:WB Route 3, MP 16.10 – 19.10**
- **Lancaster County, Fredericksburg District**
- **White Stone - Kilmarnock**

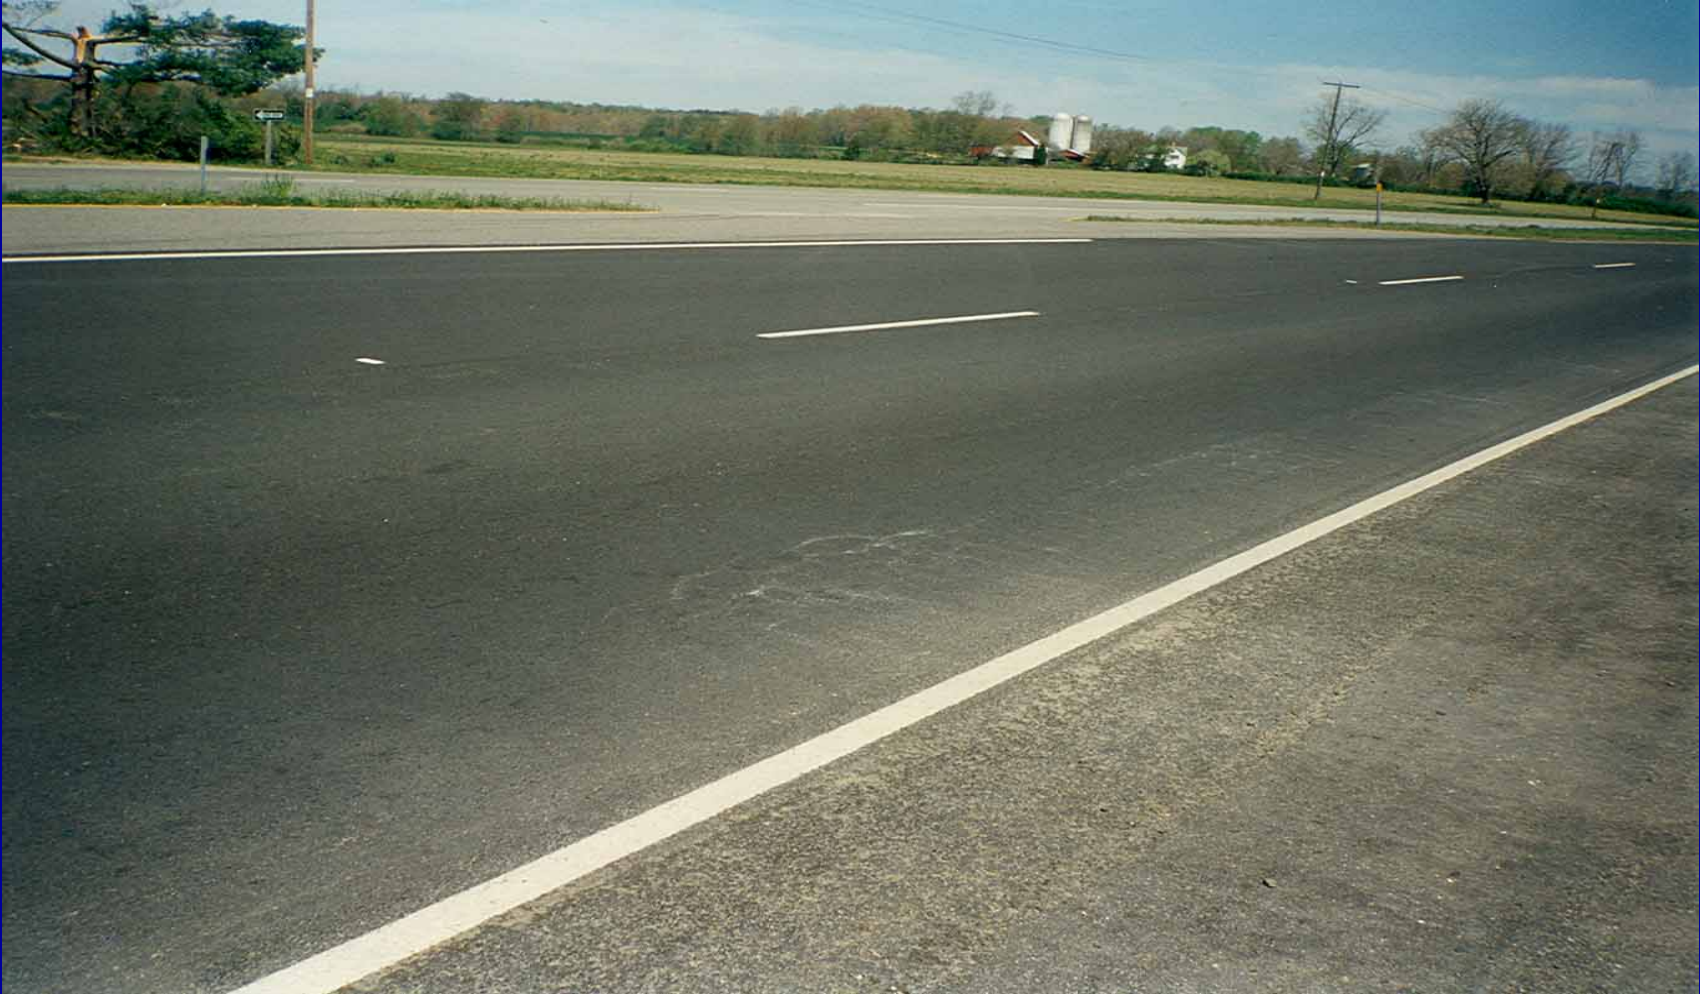
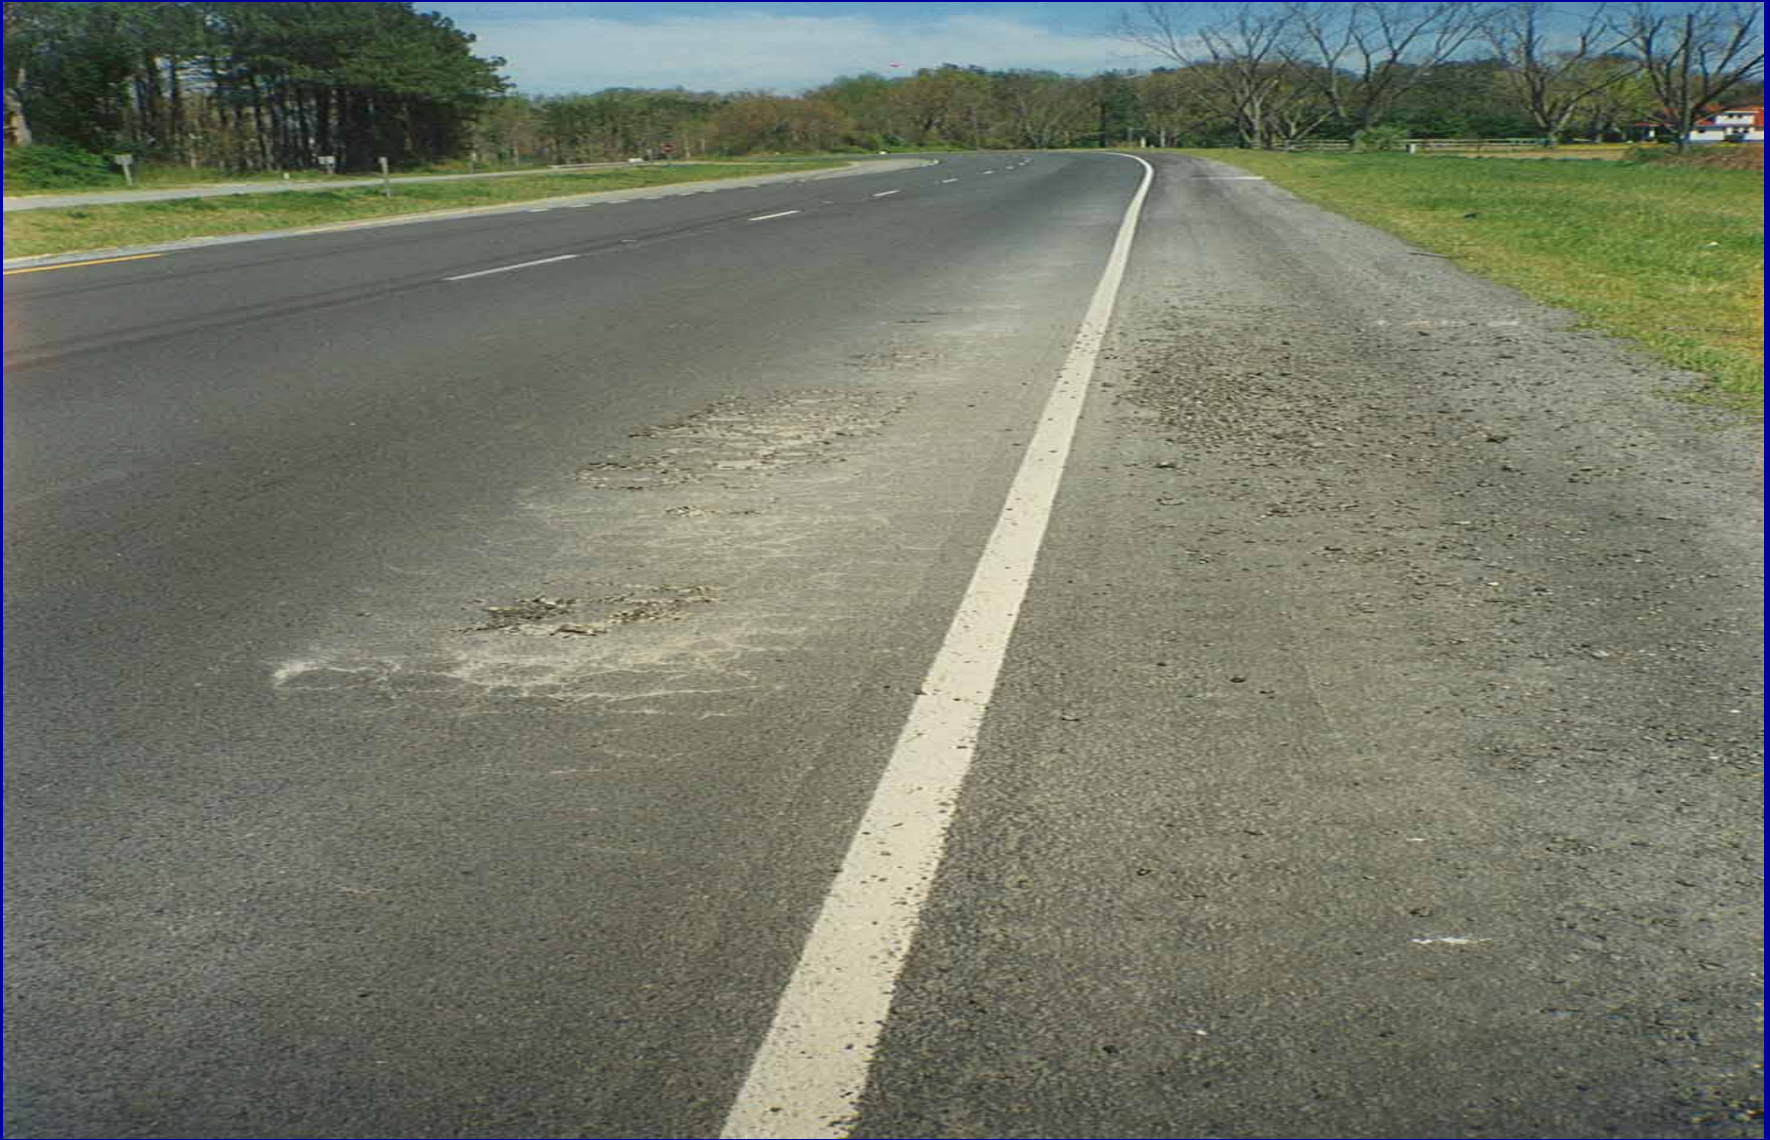
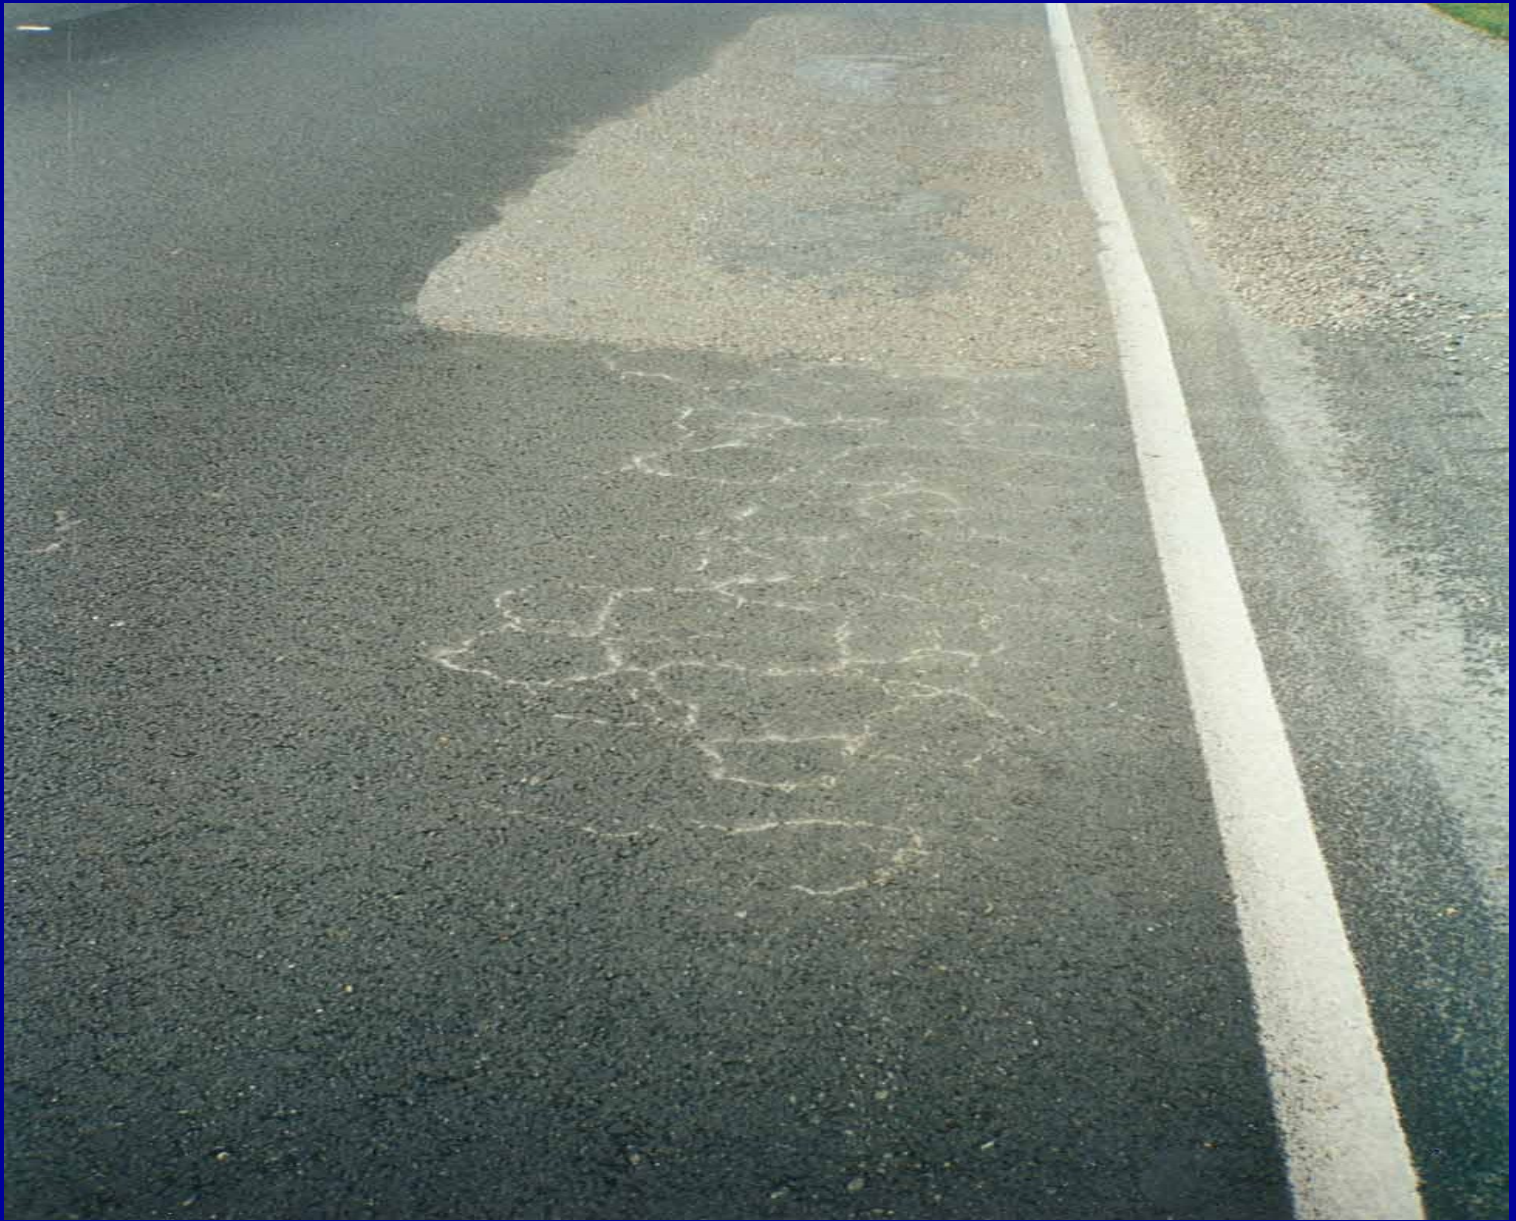
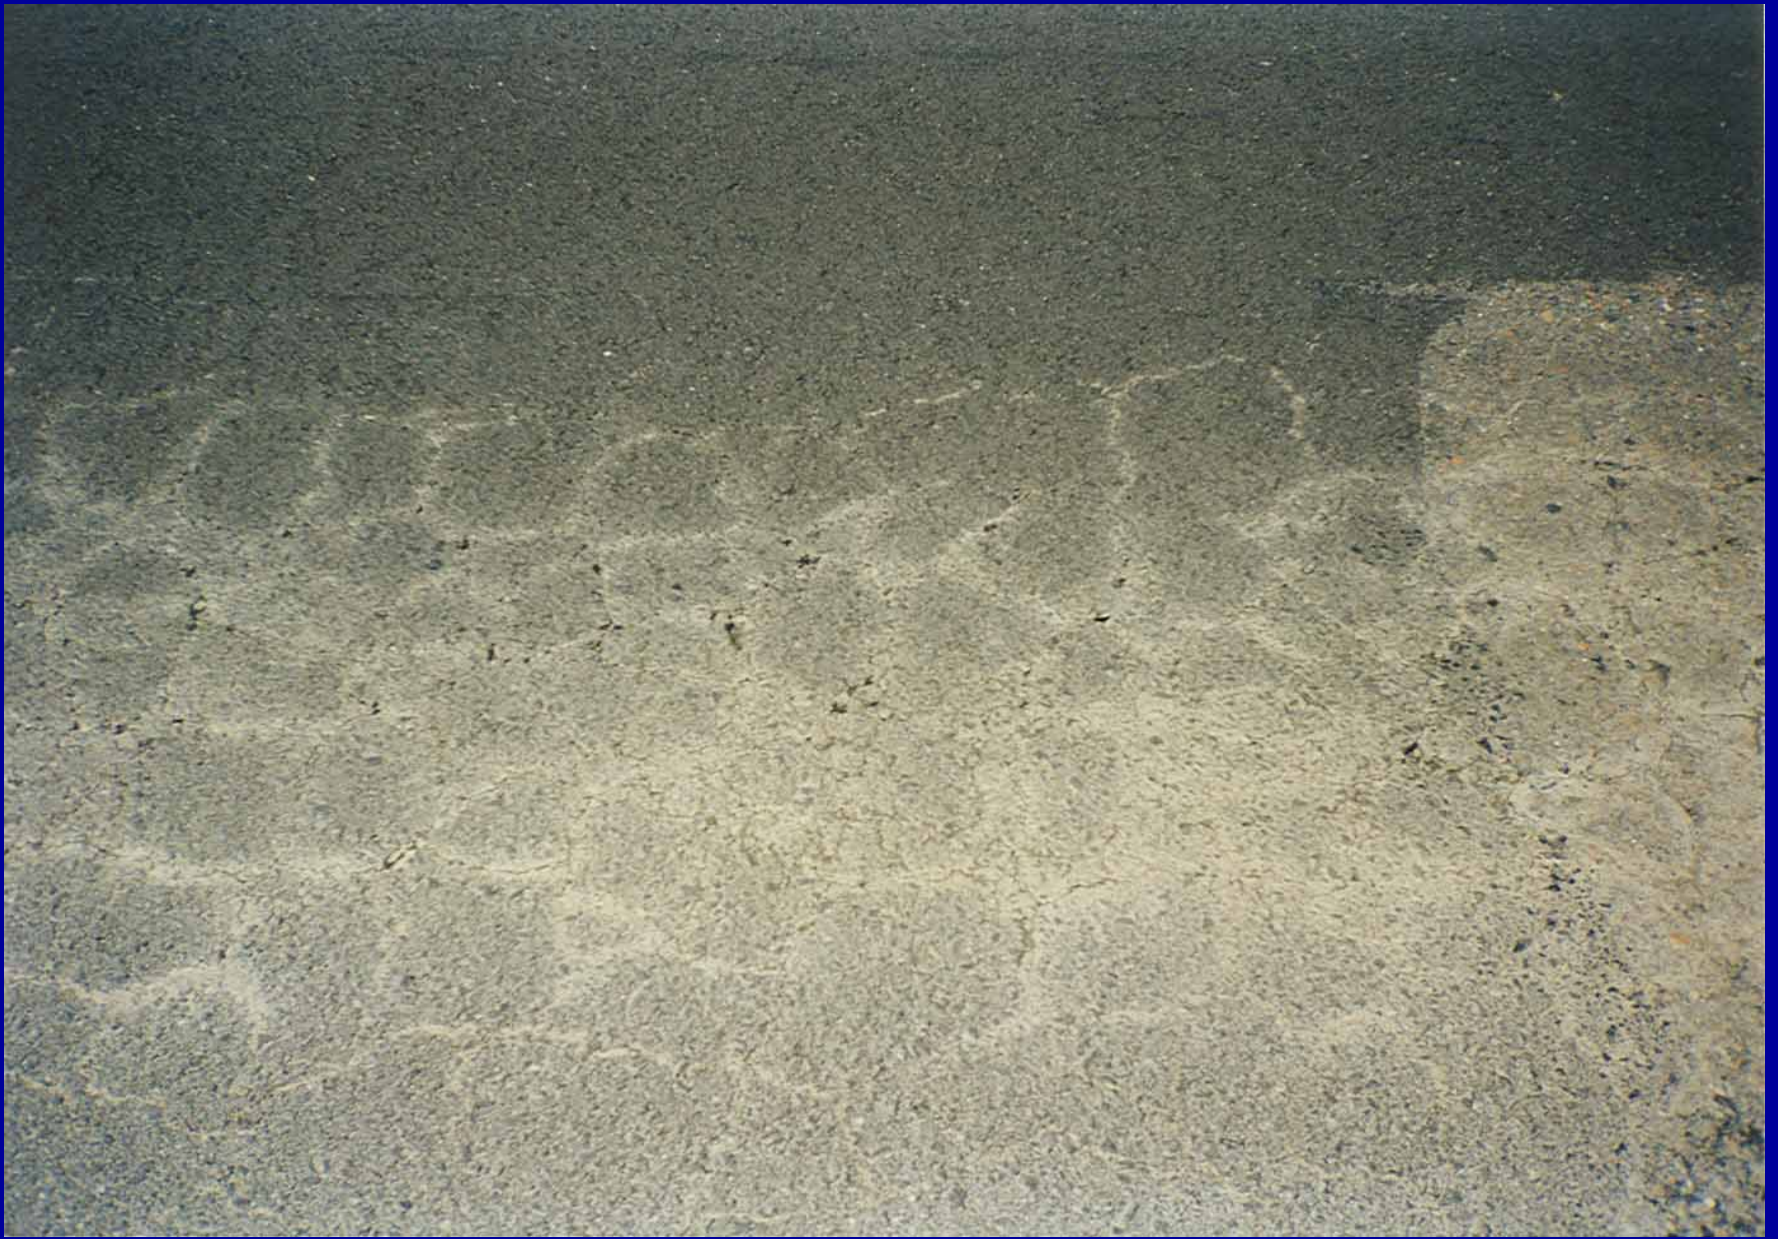
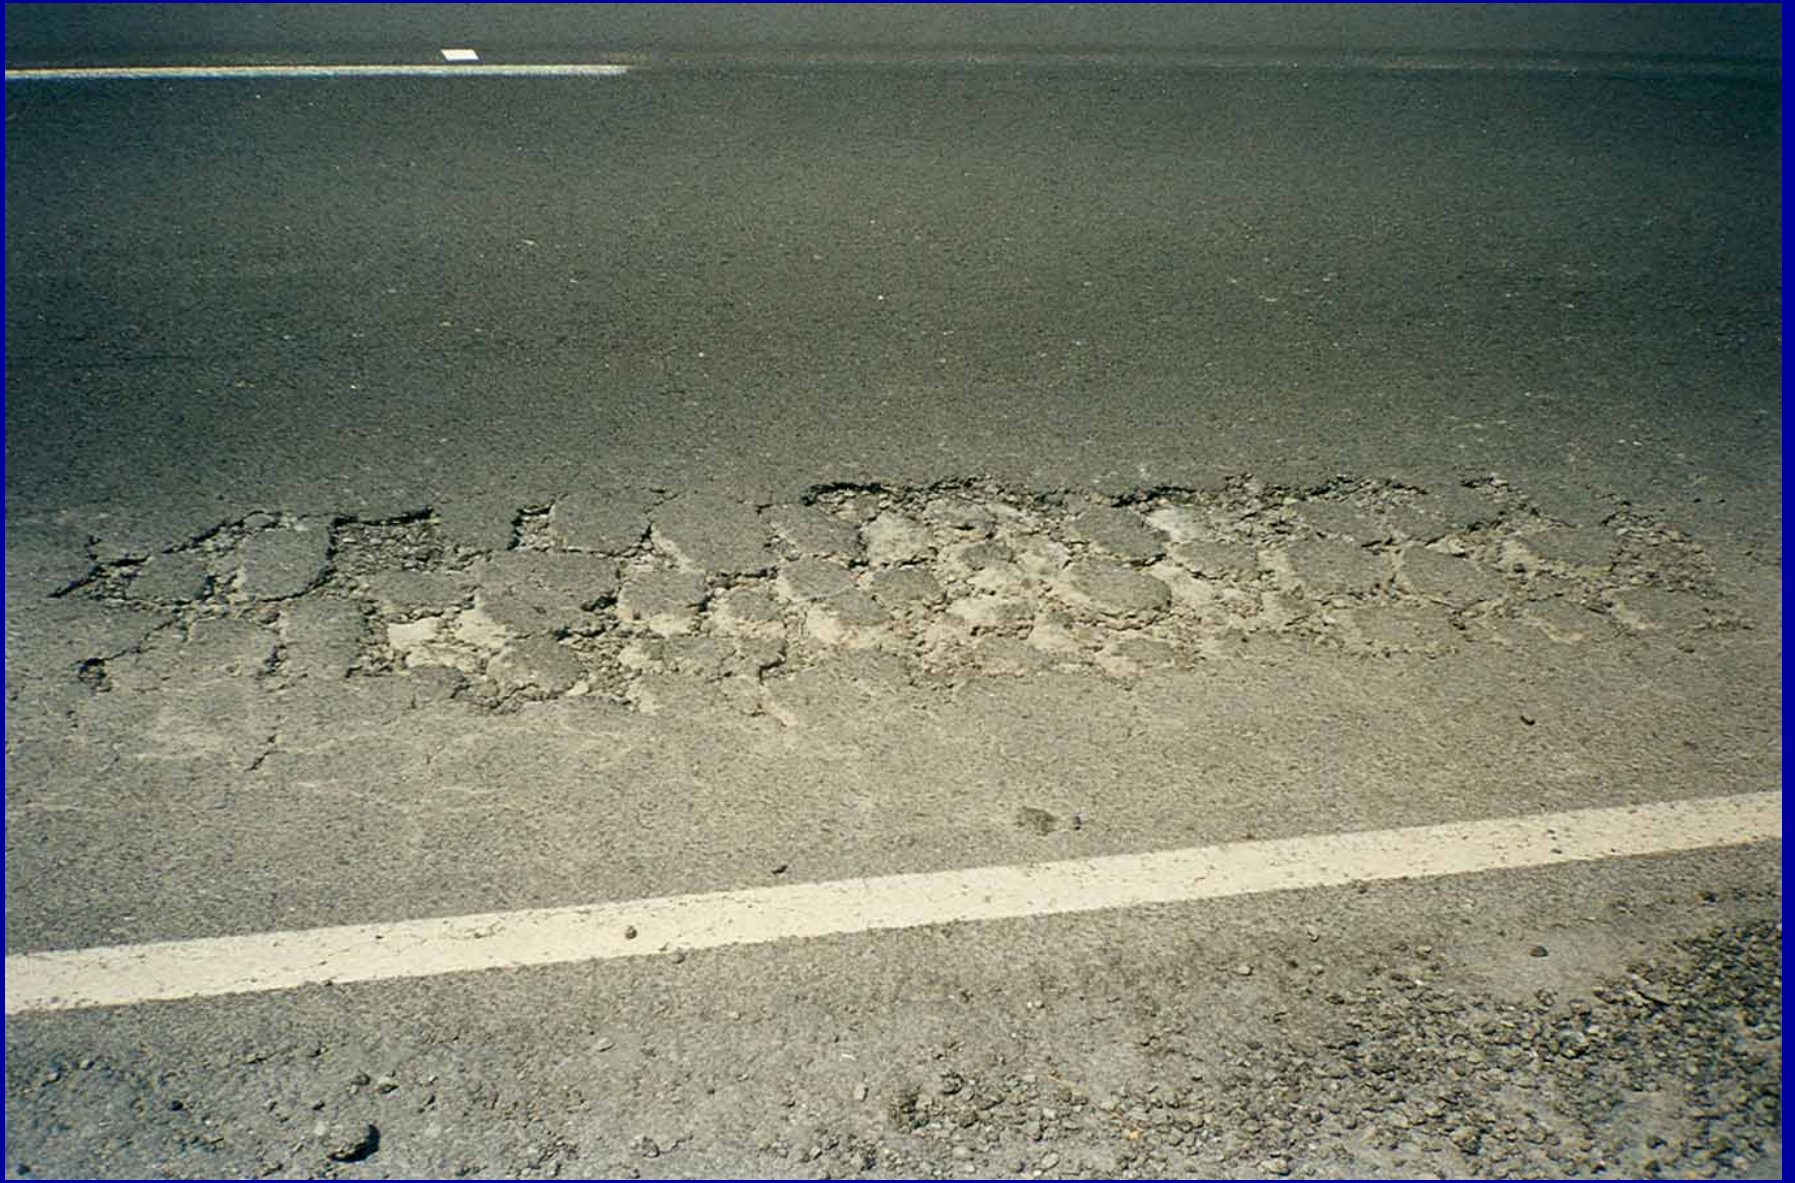
- **1994-** white stains were evident in the surface layer in isolated spots, no distress was observed
- **1998-** several areas of the travel lane were failing in fatigue and alligator cracking. The asphalt (4.5 inches) was milled and replaced in both lanes
- **1999-** travel lane developed severe alligator cracking in two areas totaling 0.27 miles, the failures were worse than those of 1998

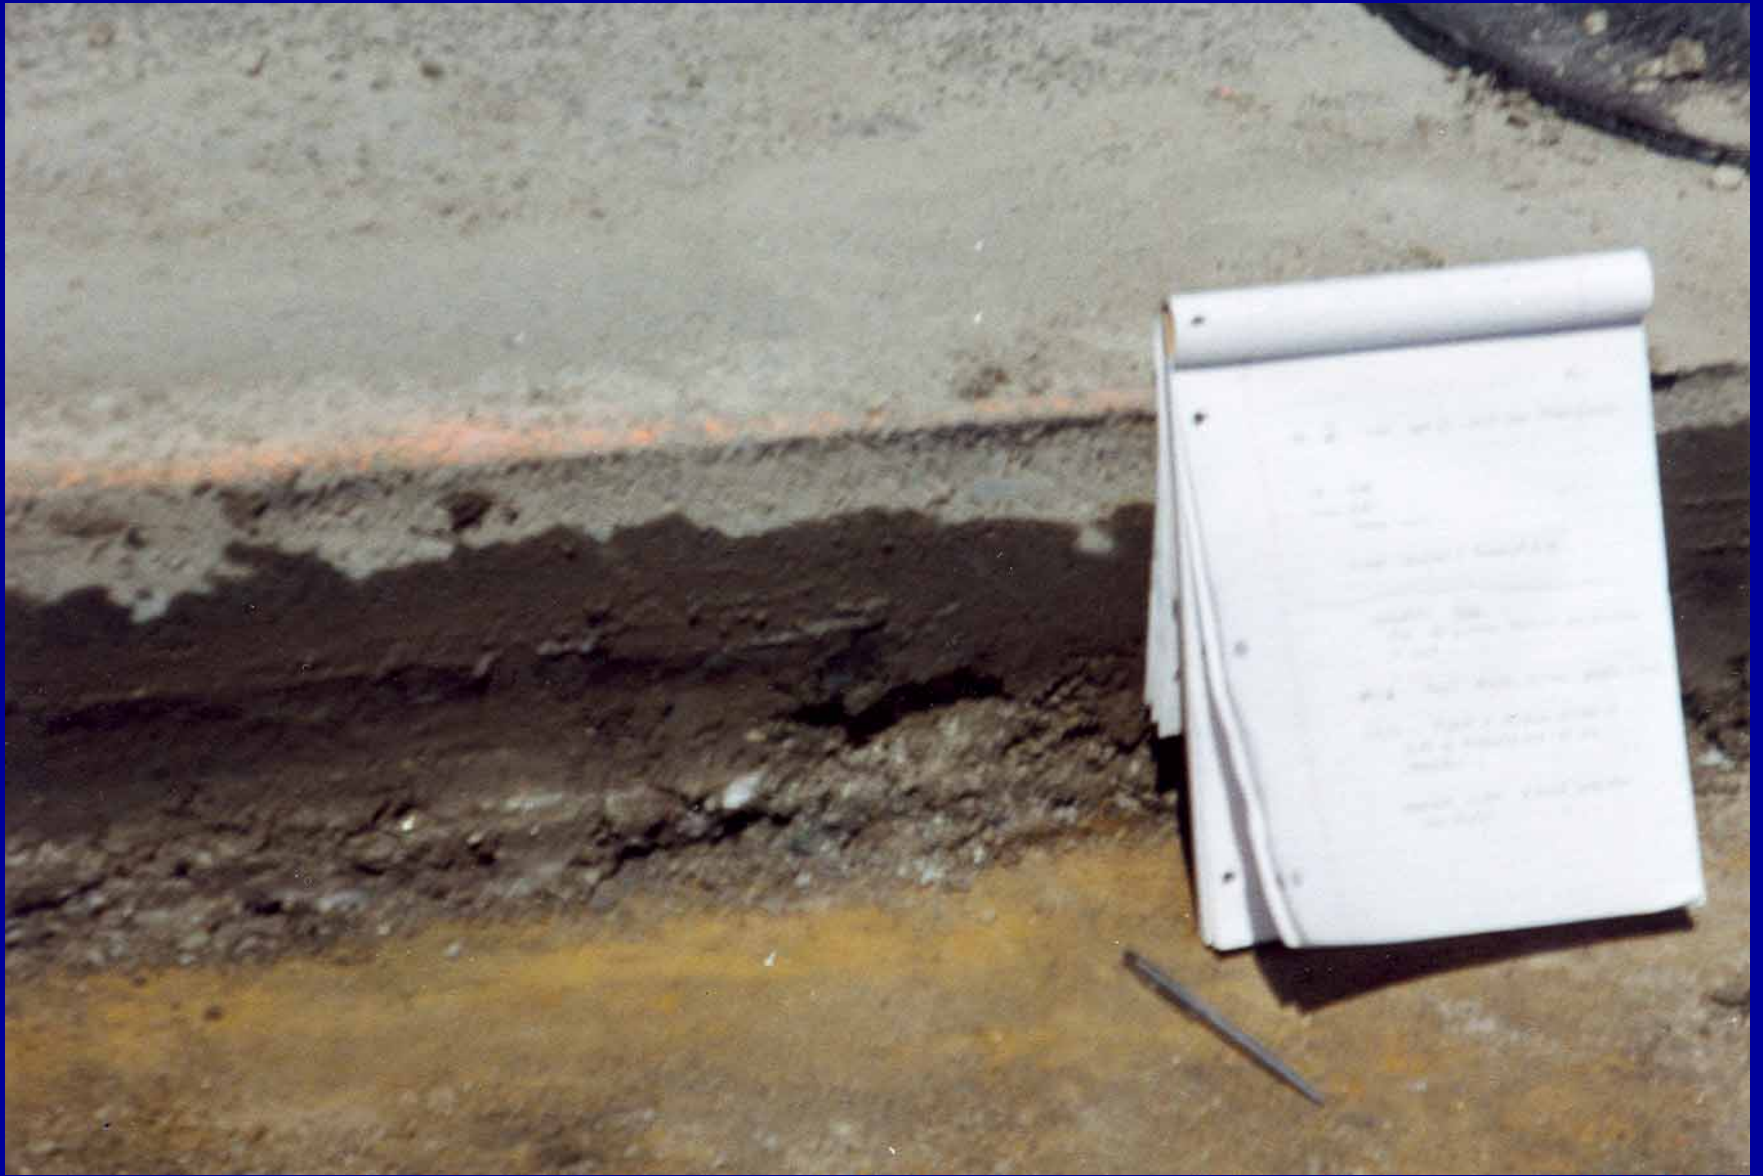
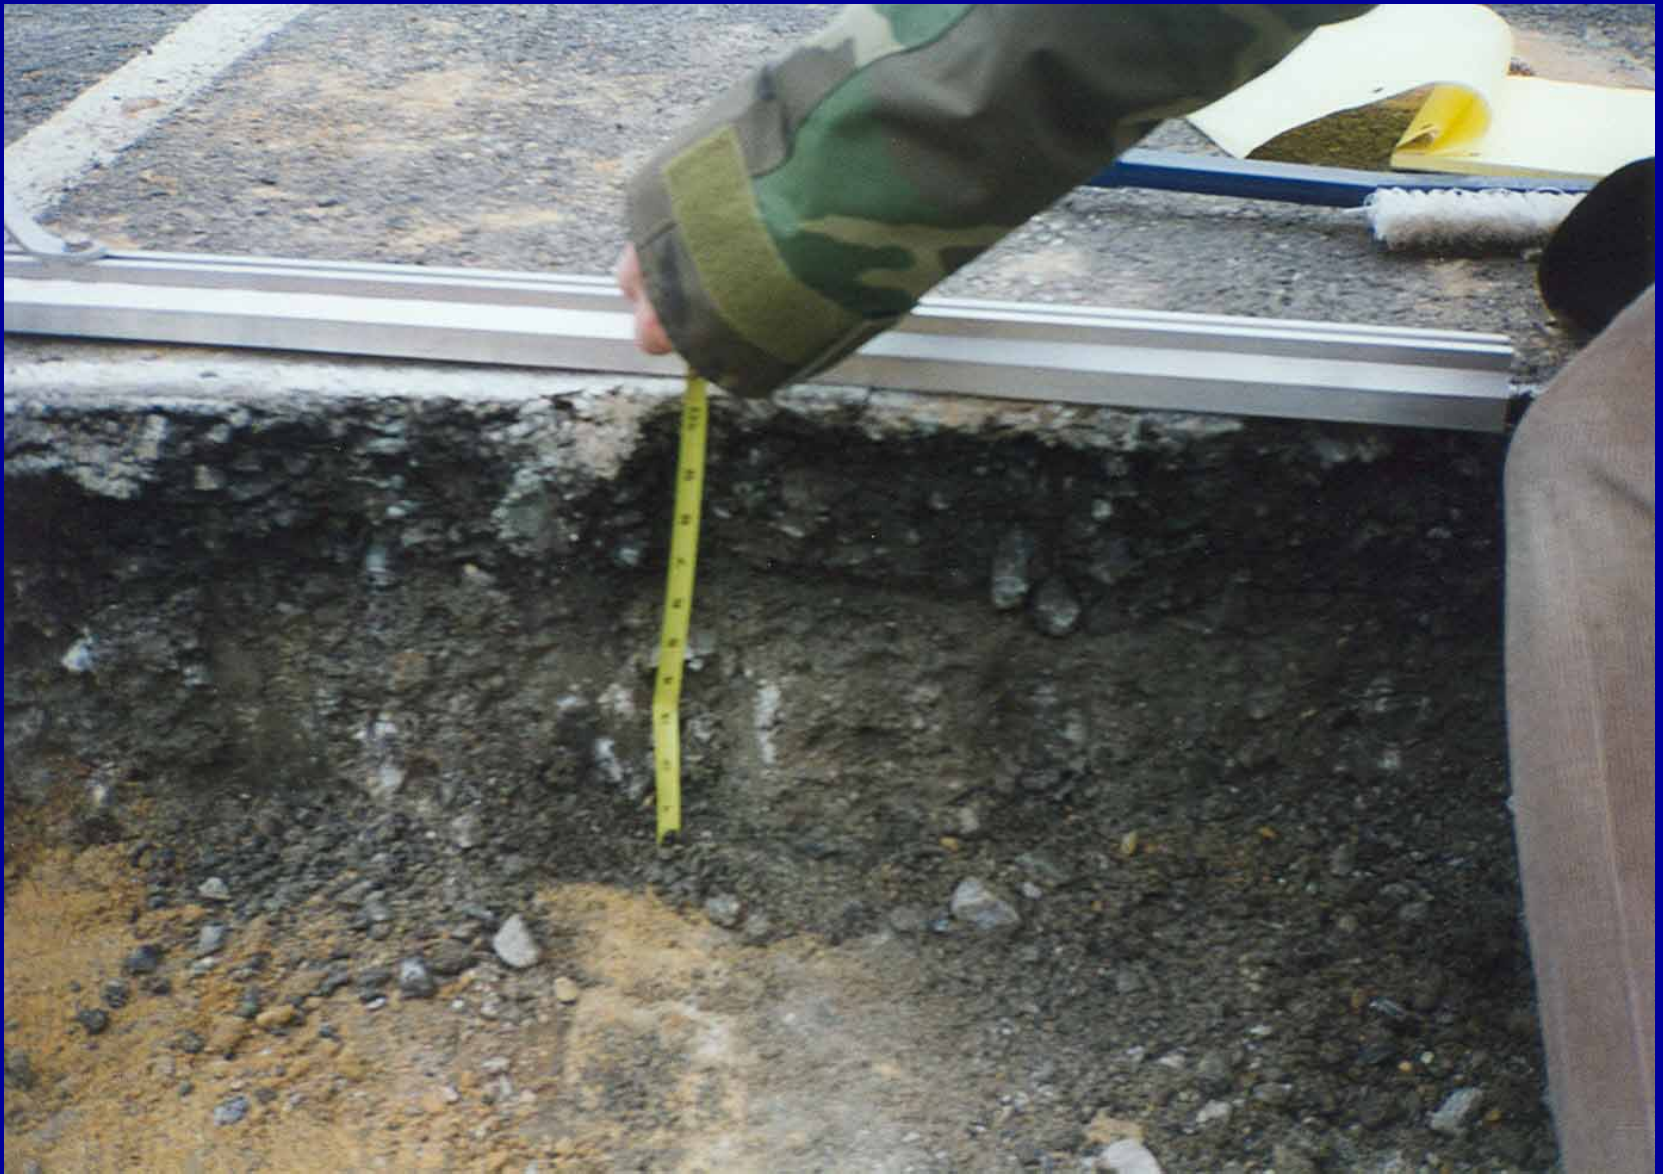
- **Failure occurred in the right wheel path of the truck lane**
- **Failure occurred in the lower part of super-elevated and transition area**
- **Surface course appeared to be relatively porous**
- **Right wheel path and left wheel path had some discoloration**
- **2.75 miles of the pavement of the pavement were serviceable**
- **0.25 miles of the pavement was patched at full depth to the soil cement**

- **AC pavement was wet at the layer interfaces**
- **Fines were found in the base AC samples along with discoloration**
