**2005 Southeastern States
Pavement Management and Design Conference**

Pavement Forensics
Route 3, Lancaster County, Virginia

Mohamed Elfino, PhD, PE
Assistant State Materials Engineer

- **Project Number:0003-051-114, C501**
- **Location:WB Route 3, MP 16.10 – 19.10**
- **Lancaster County, Fredericksburg District**
- **White Stone - Kilmarnock**

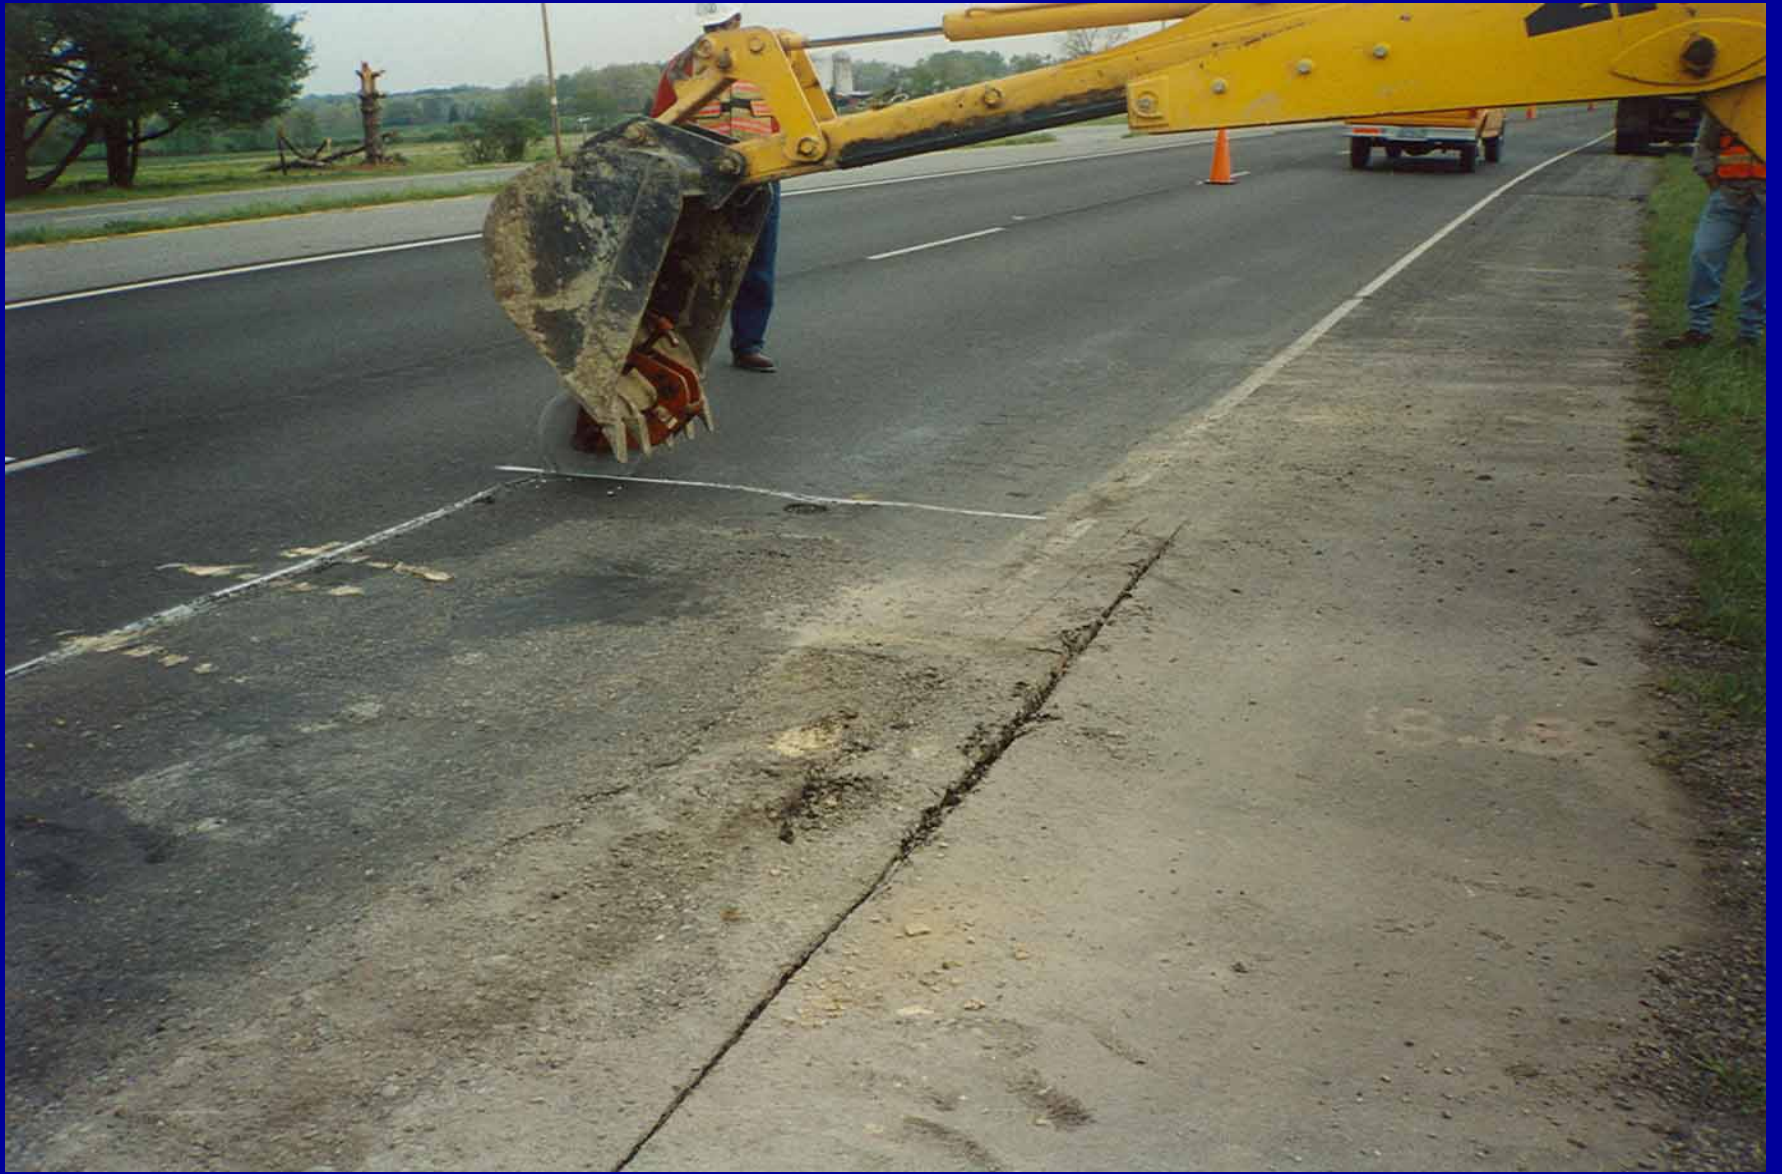
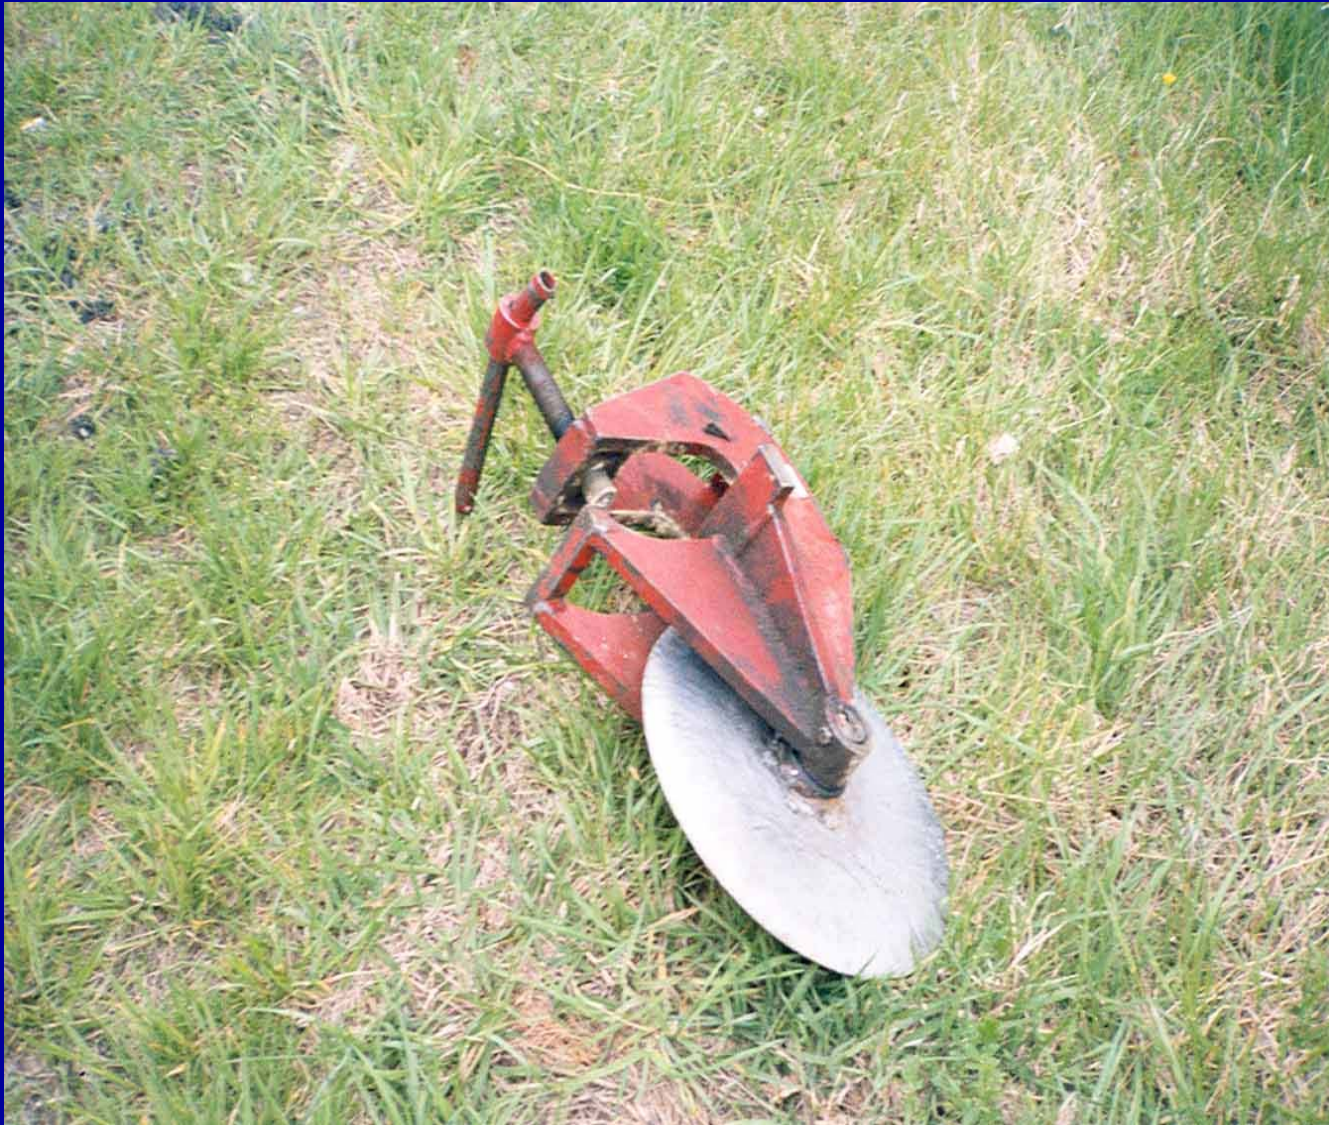
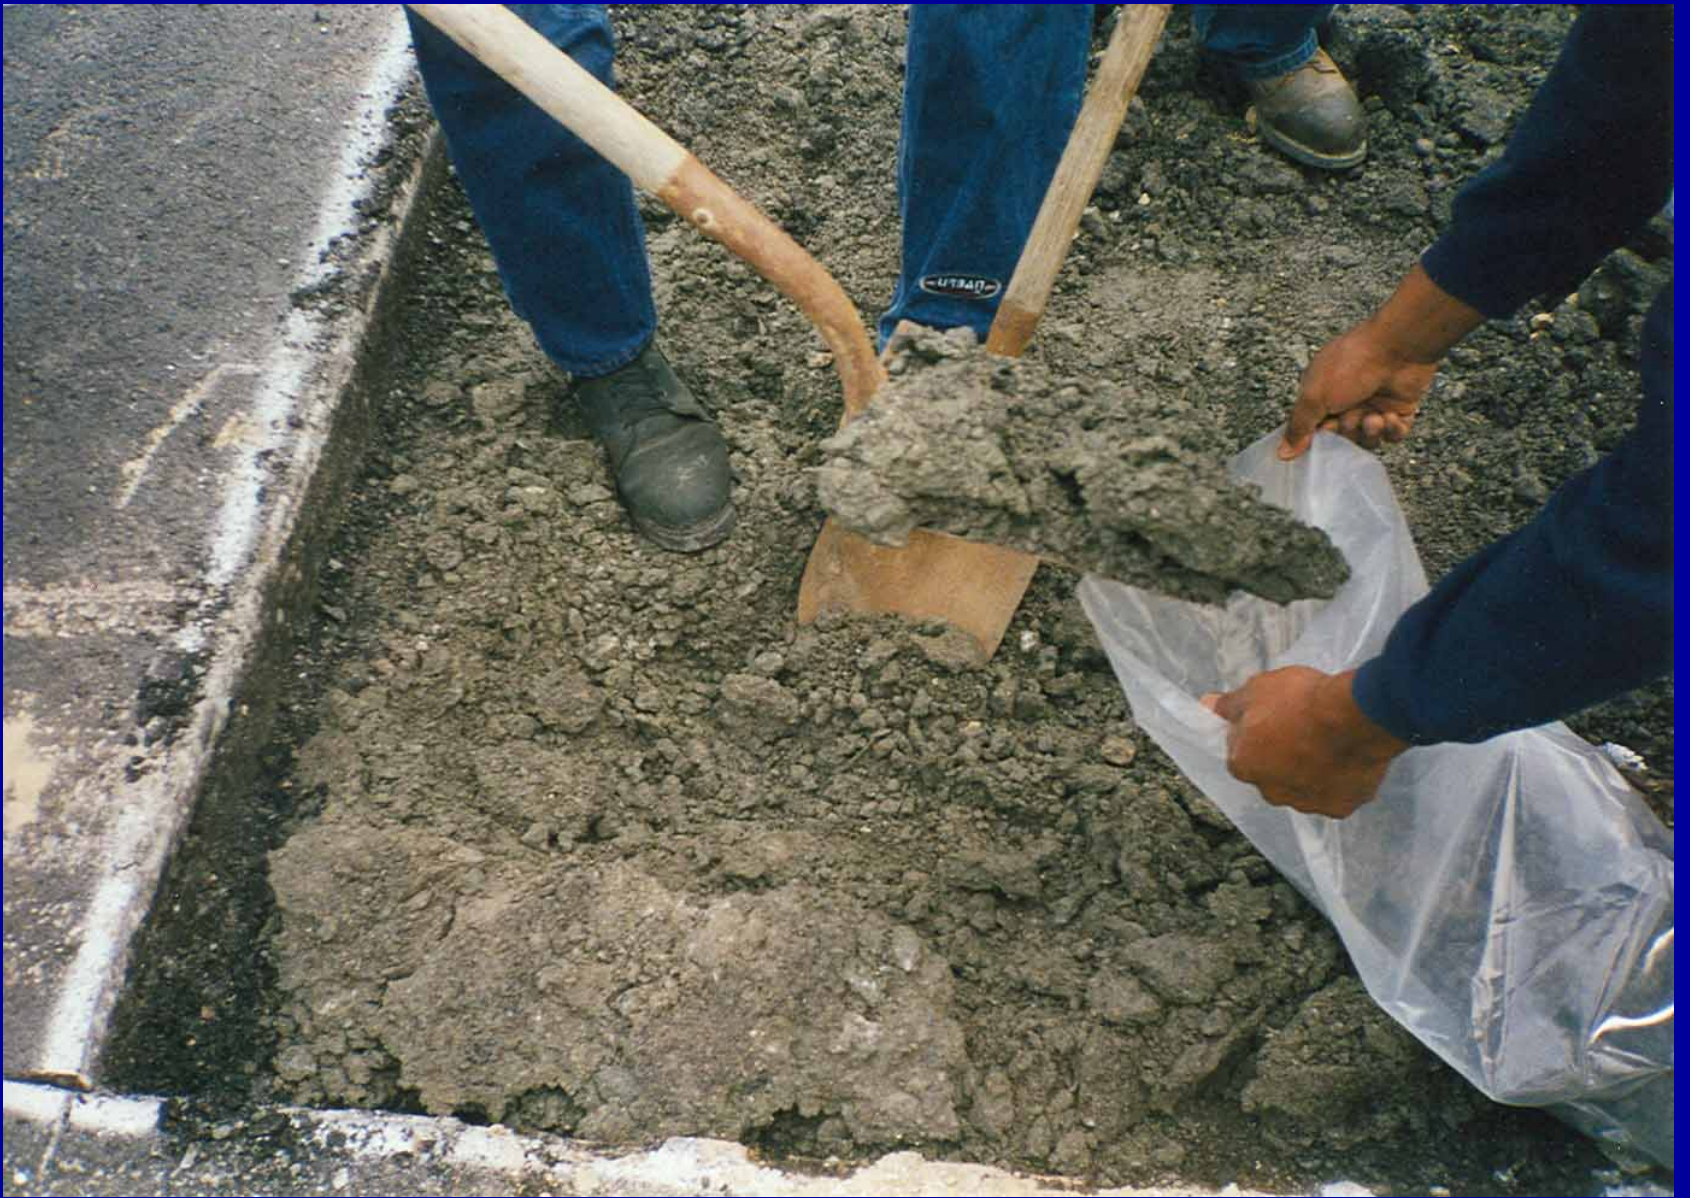
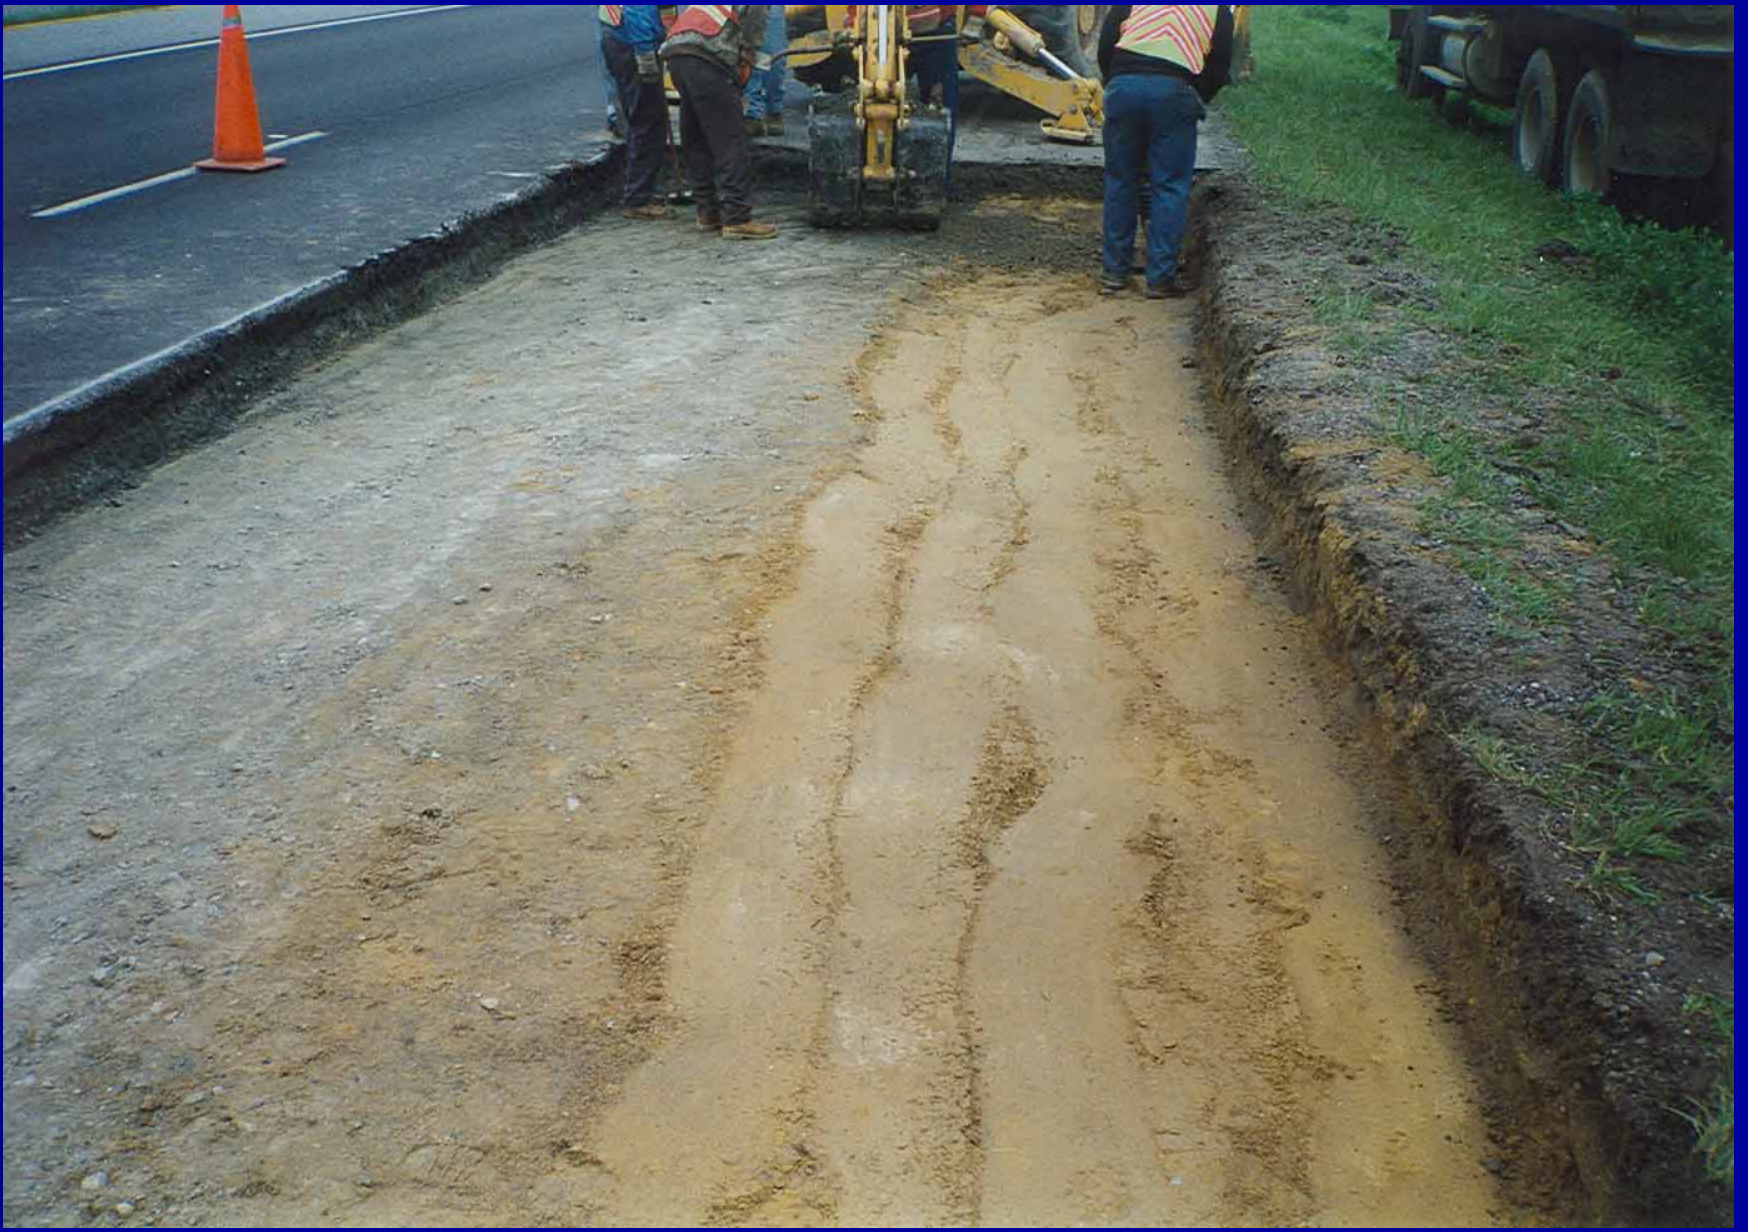
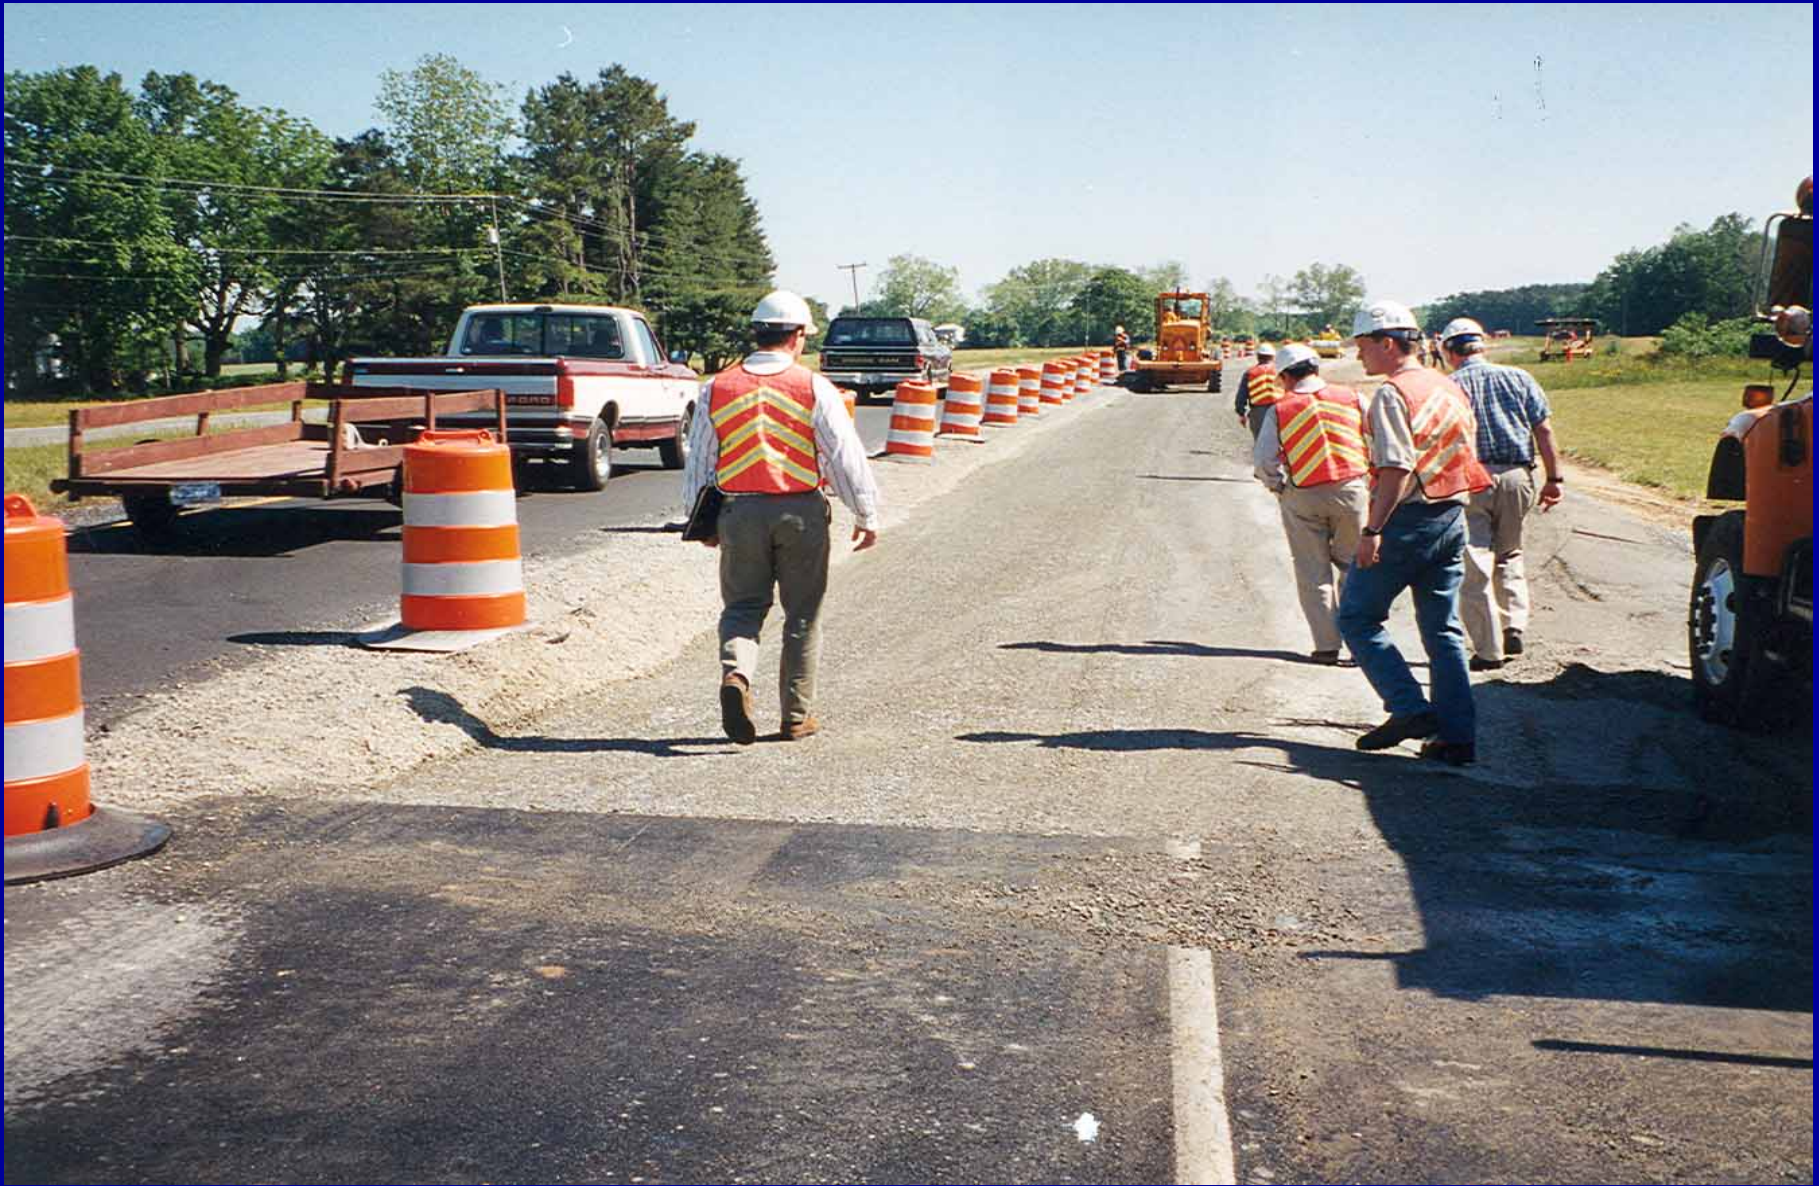
- **FWD testing was done to gather deflection data from the pavement structure and the subgrade**
- **Cores were taken based deflection values obtained from the FWD testing to correlate deflection data with pavement structure/distress**
- **Aggregate subbase samples were taken by removing the asphalt layers using a roller blade cutter**

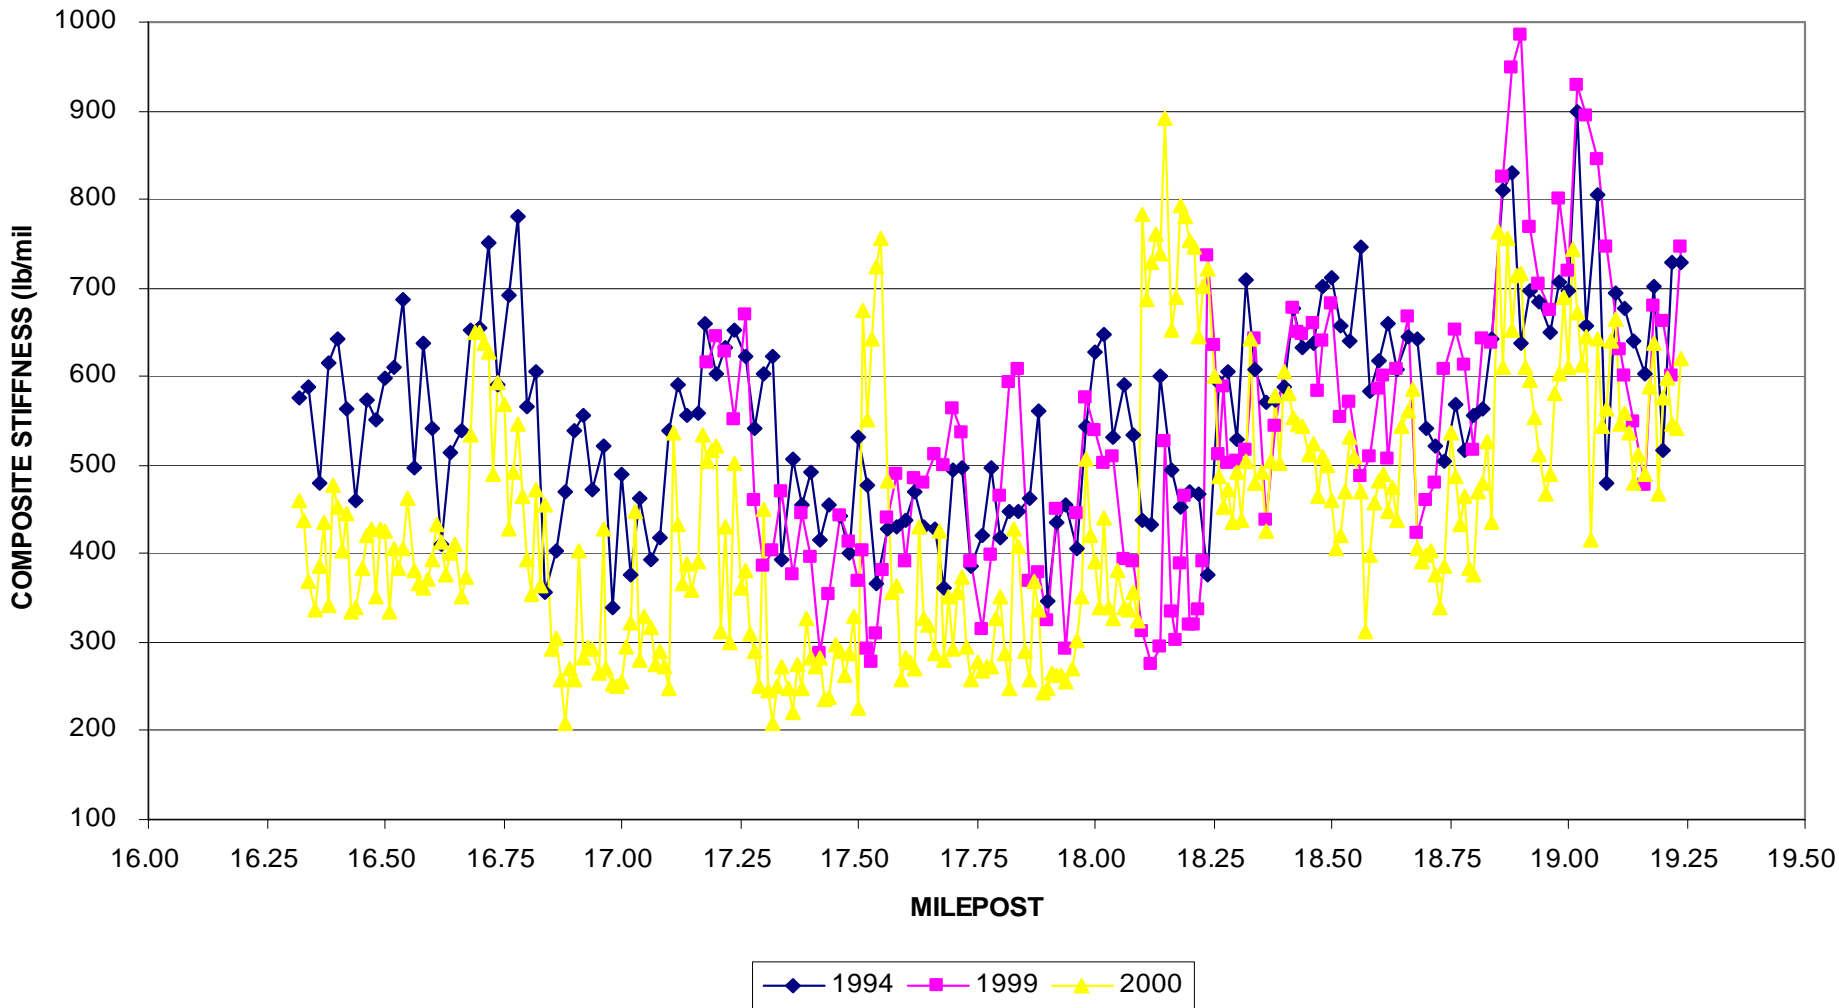
Rte. 3 Lancaster Co.
COMPOSITE STIFFNESS PROFILE
(Travel Lane)

- **The composite stiffness versus station was plotted for 1994, 1999, and 2000 using the FWD deflection data**
- **An average composite stiffness of 500 lbf/mil for all years were obtained, which entails that little to no improvement was made between 1994 ,1999, and 2000**

Average Stiffness	1994 -	558 lb/mil
	1999 -	528 lb/mil
	2000 -	439 lb/mil
