Kentucky Concrete Pavement Forensic Analysis

**Southeastern States Pavement Management
and Design Conference**

May 9, 2006

Concrete Pavement Forensic Analysis

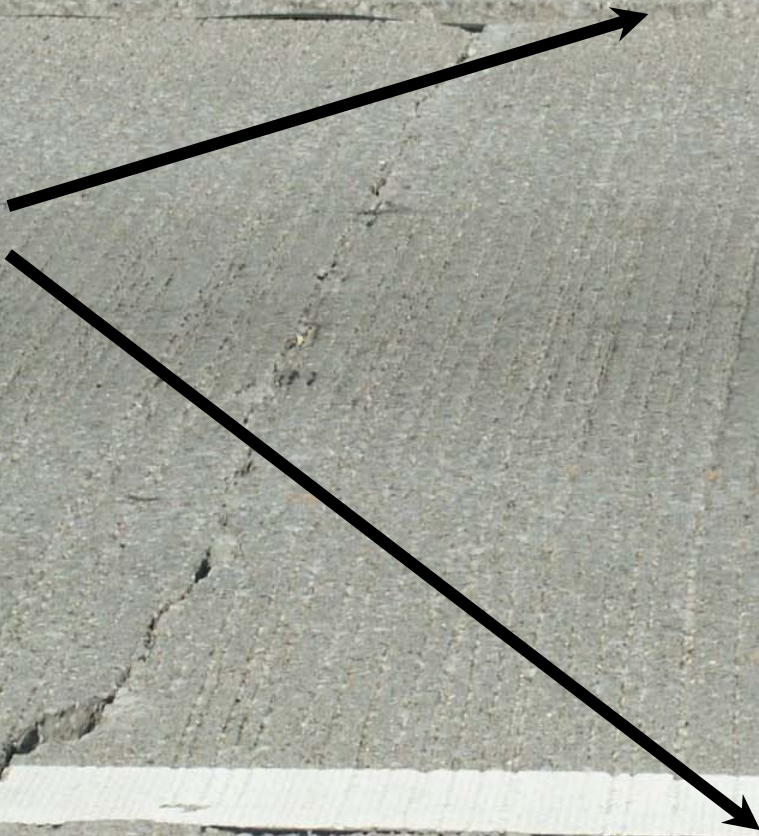
Station 1687+22 Eastbound

1.25" Lane Drop

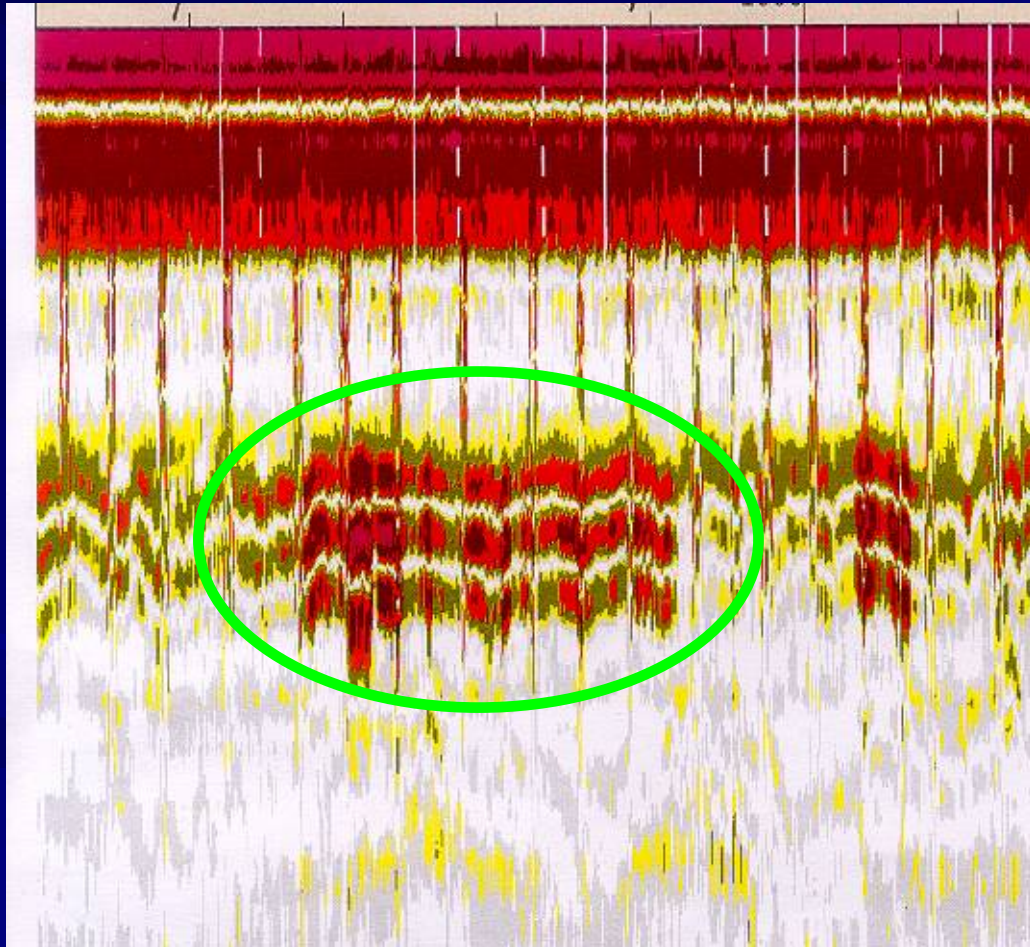
First: used GPR to locate different degrees of saturated sub-base beneath PCCP

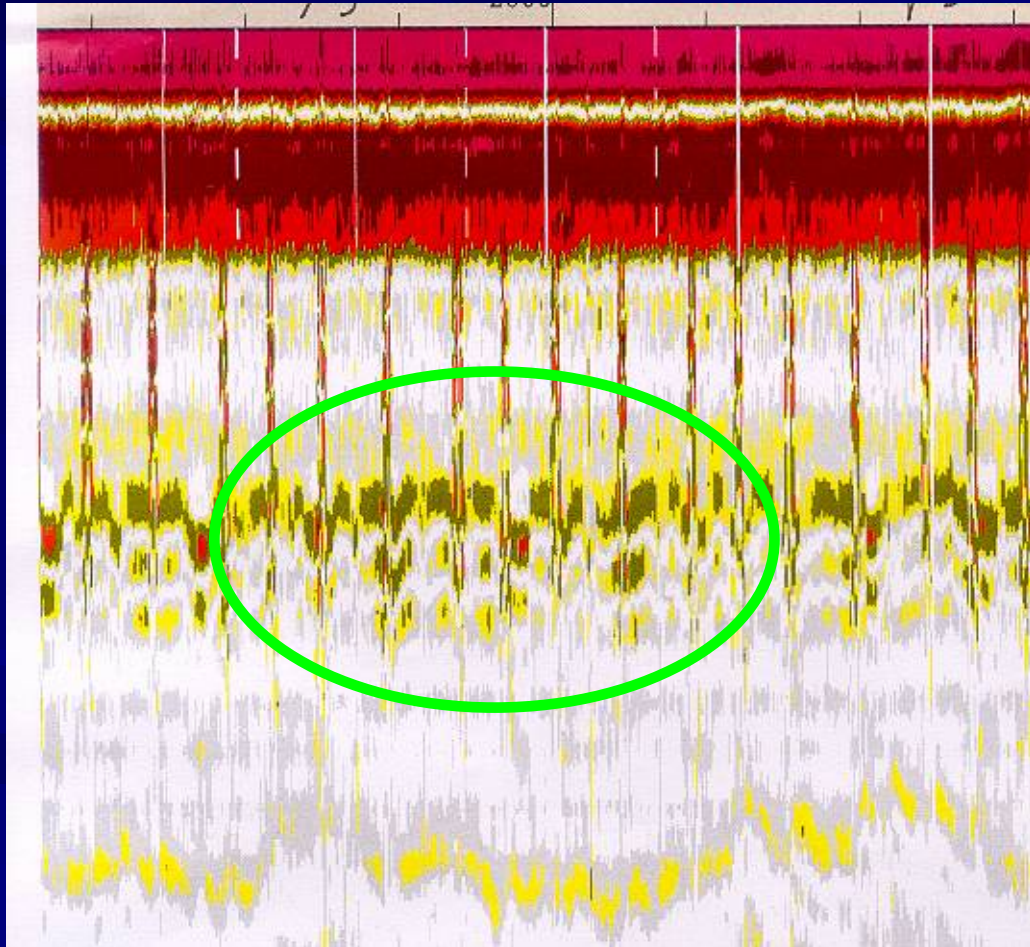
Moderate water beneath PCCP

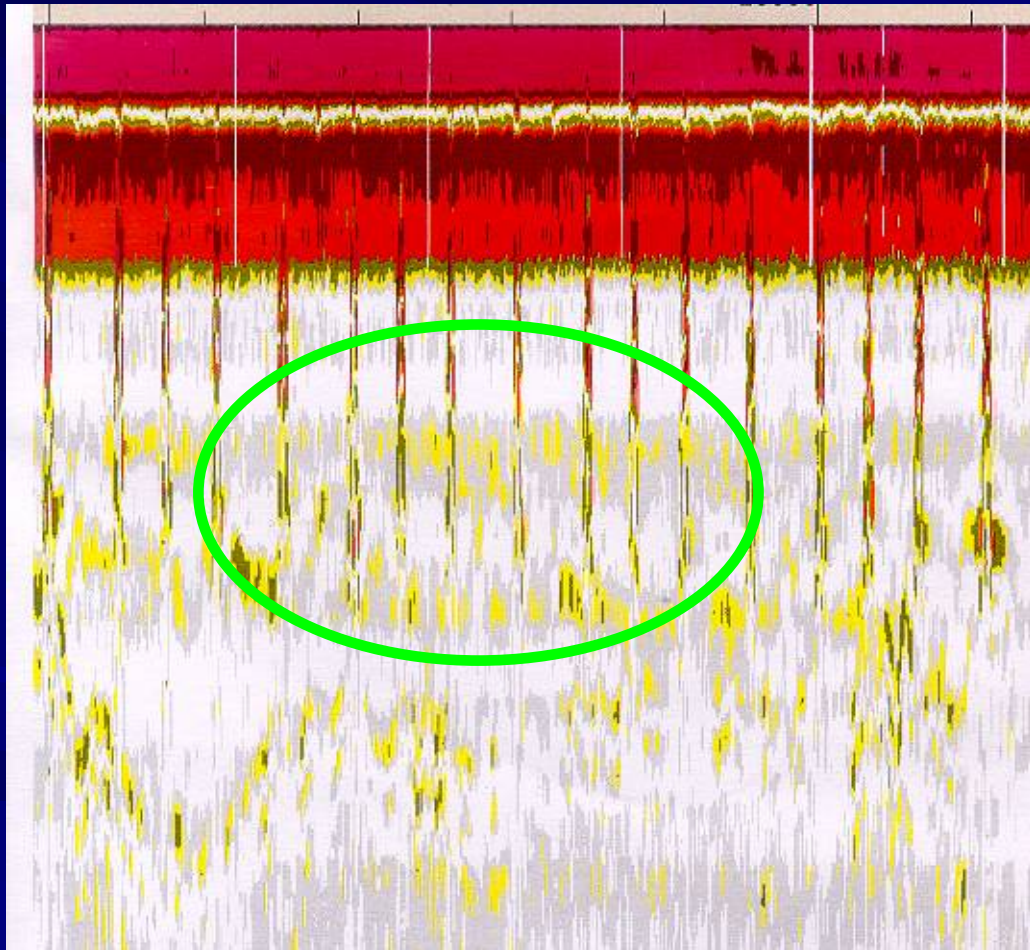
Minimum water beneath PCCP

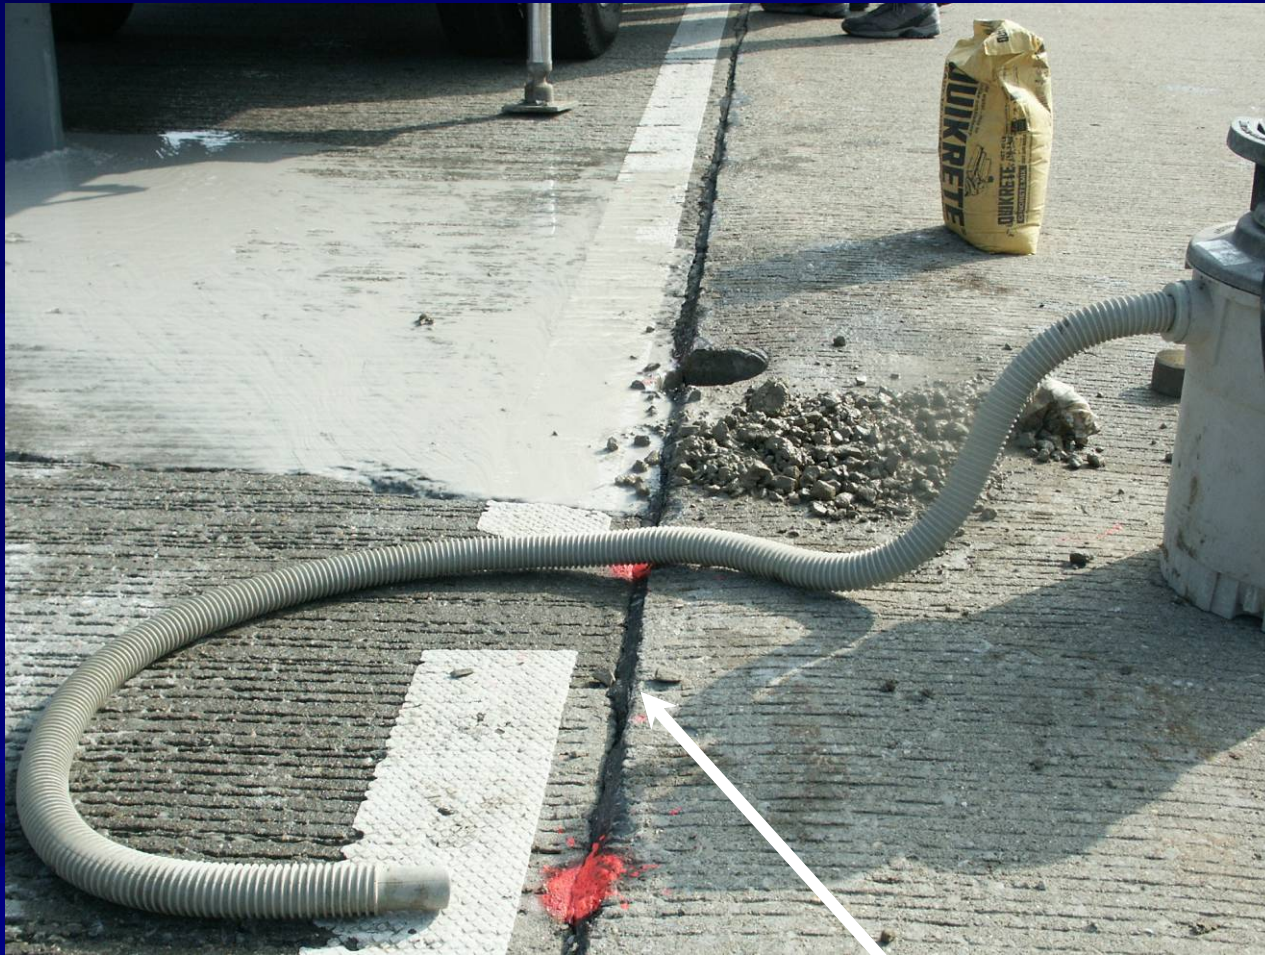
Second: used GPR to locate tie bars between lanes

1.25" Lane Drop

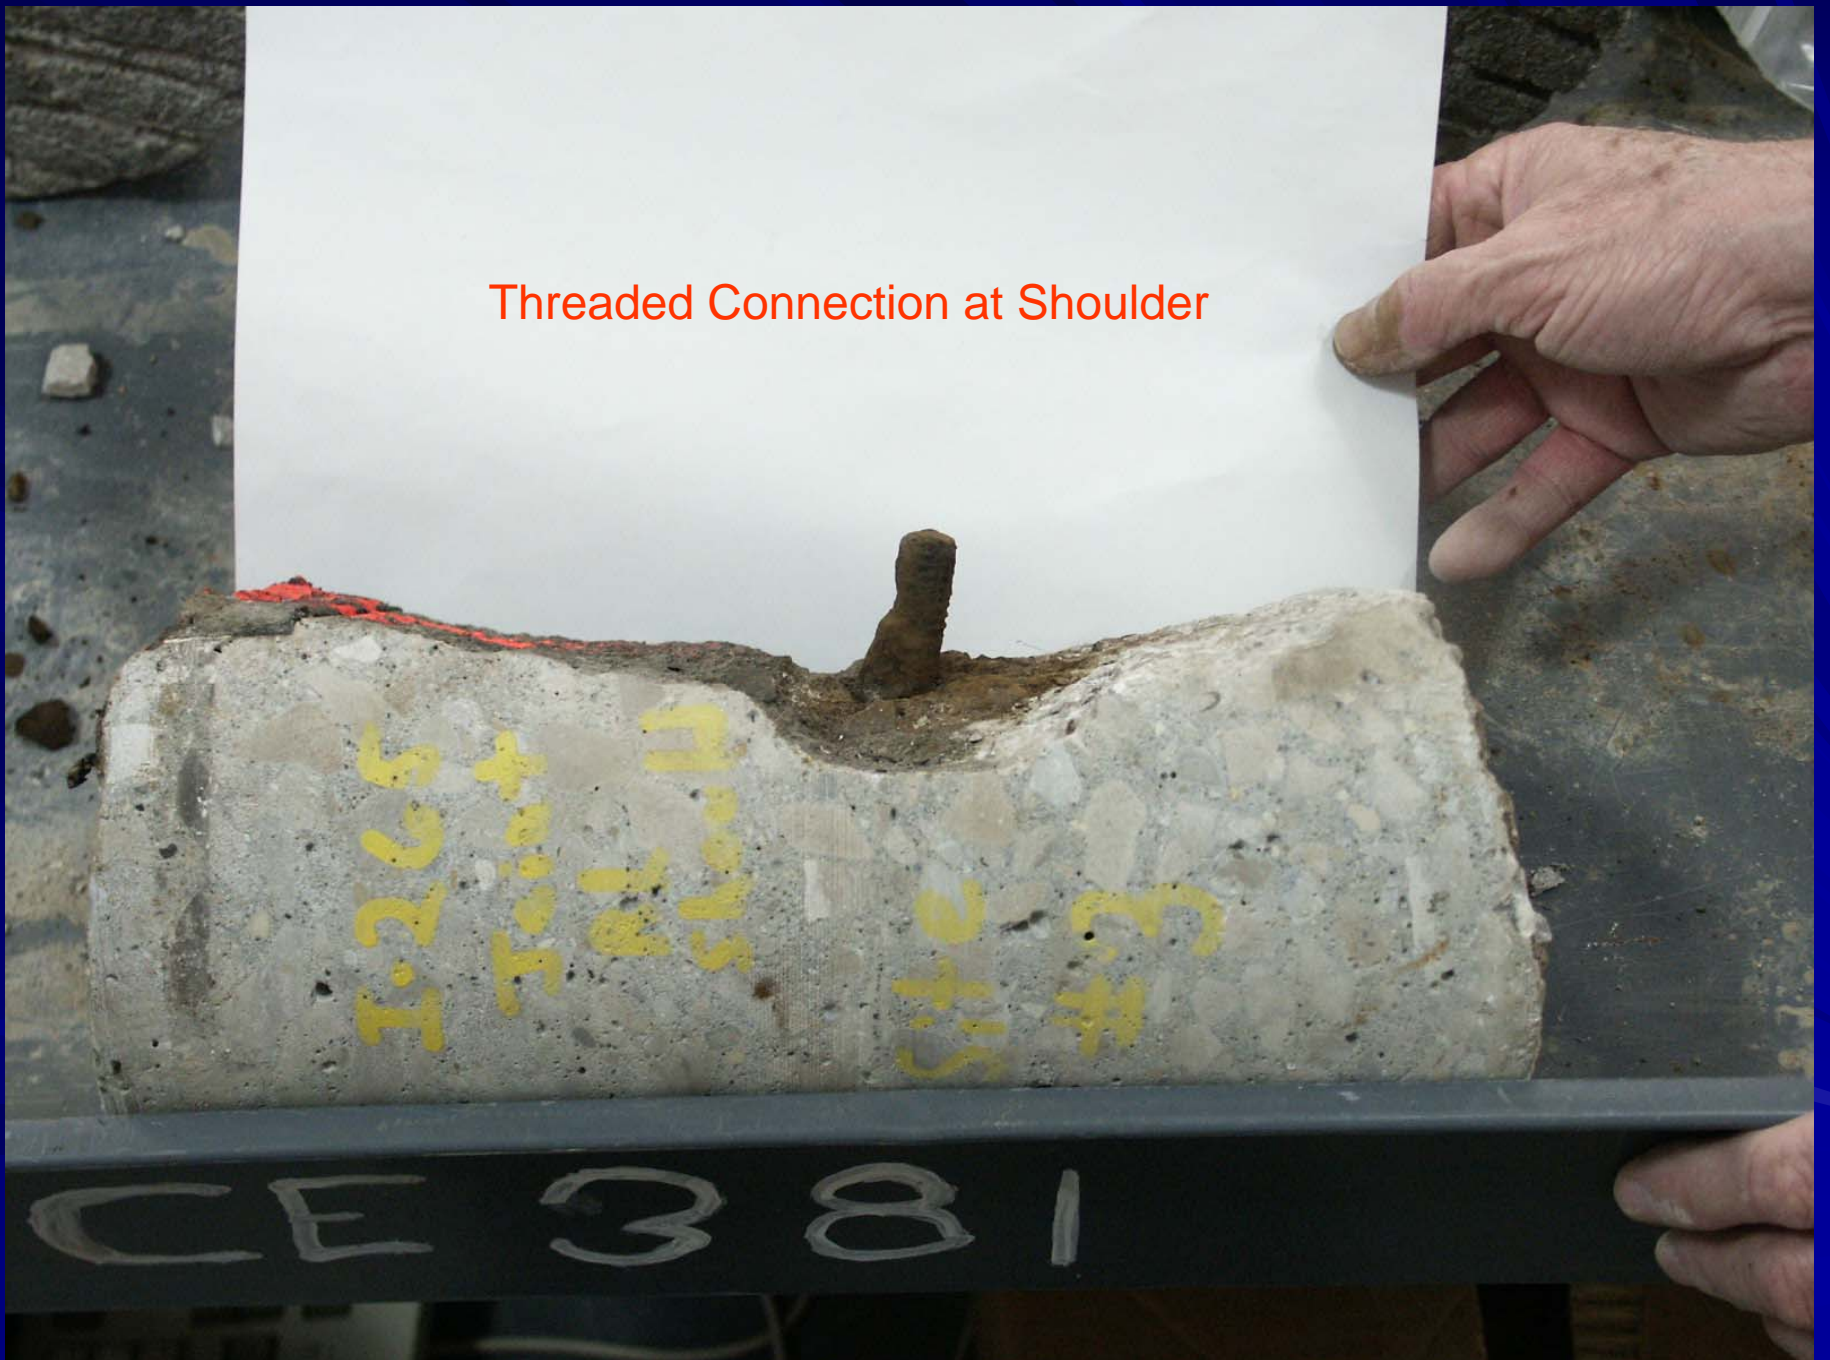
Threaded Connection at Shoulder

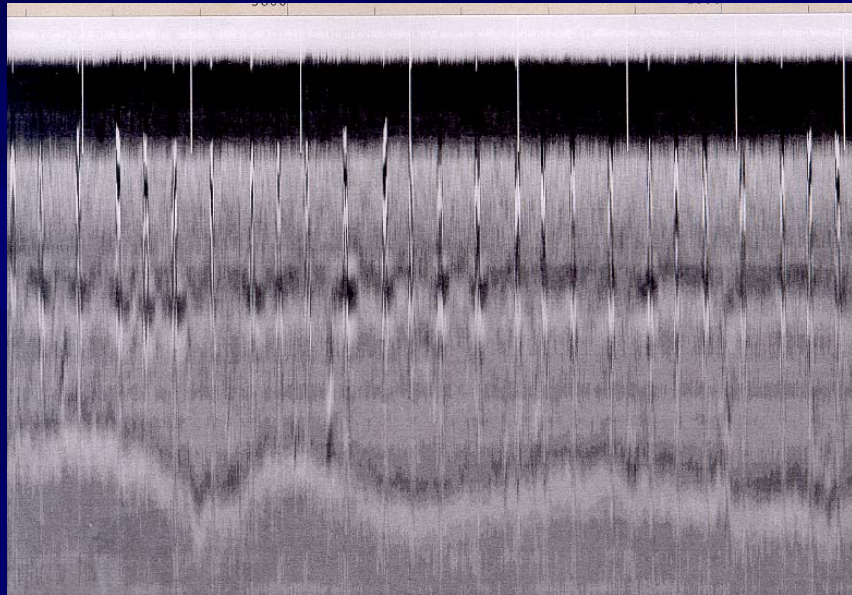
Fourth: GPR was used to find clay layer between D.G.A. and apparent rock roadbed

Station 1582+43
Approx. 2" between lane faulting
PCCP: 9.75" - 10.25"
DGA: 5.75" - 6.25"
Clay soil: 8" - 10"

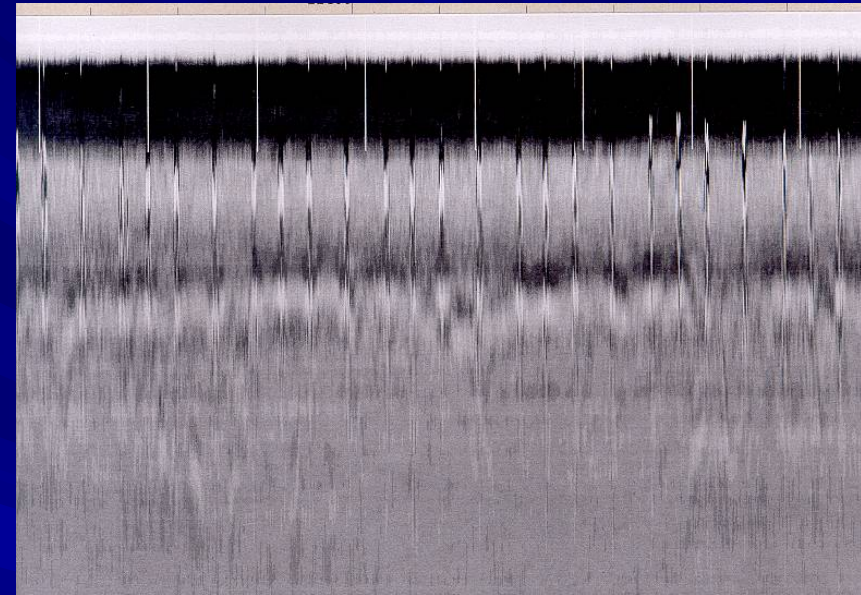
Station 1699+73
No between lane faulting
PCCP: 10.00" - 10.25"
DGA: 4.75" - 5.25"
Apparent rock roadbed:

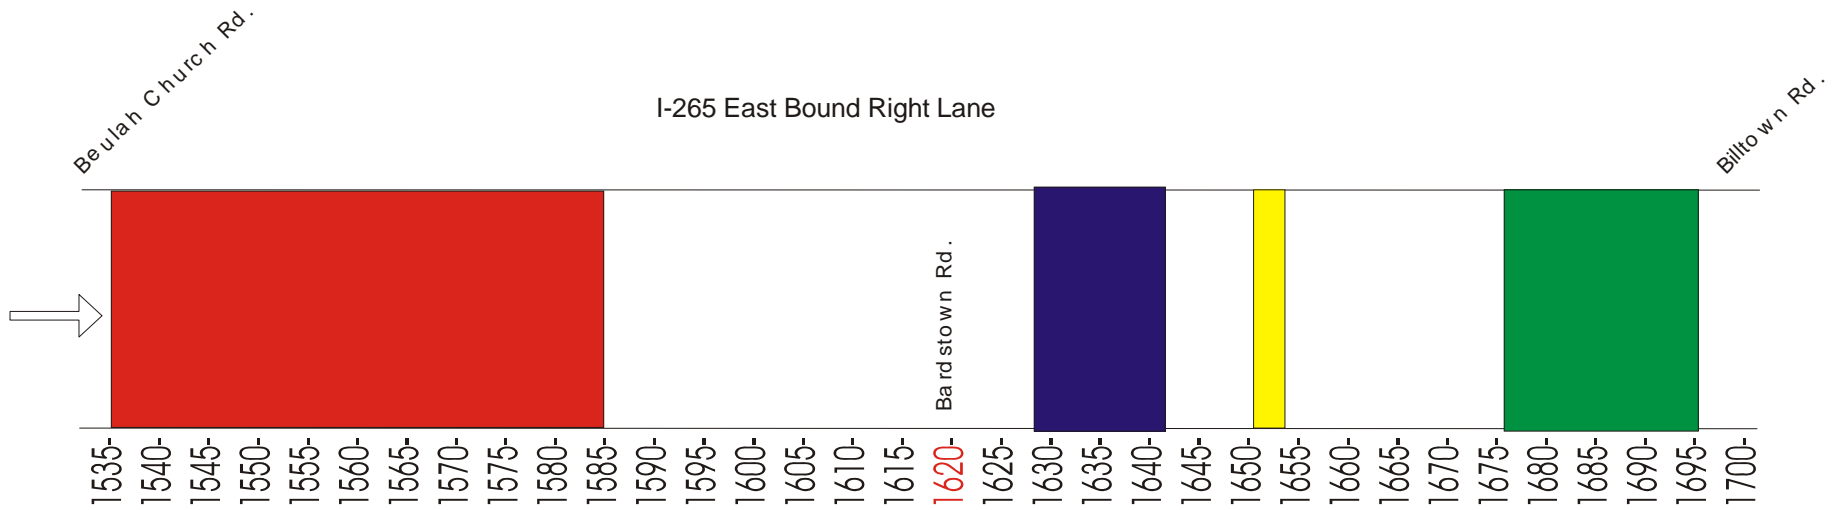
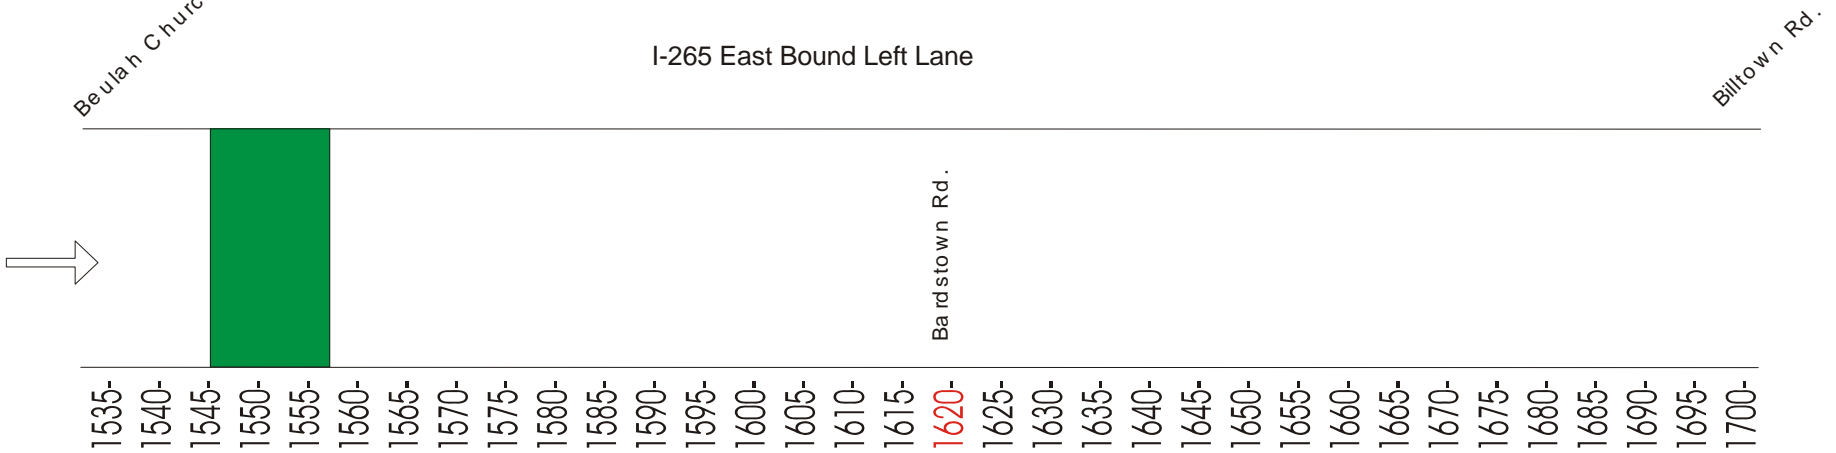
Red: 1" or more settlement, less than 50% load transfer, & moderate to severe water

Dark Blue: 1" settlement and severe water

Yellow: 1" settlement (possible slab jacking)

Green: Less than 50% load transfer, some settlement and/or water

Presence of Clay layer (yes/no)

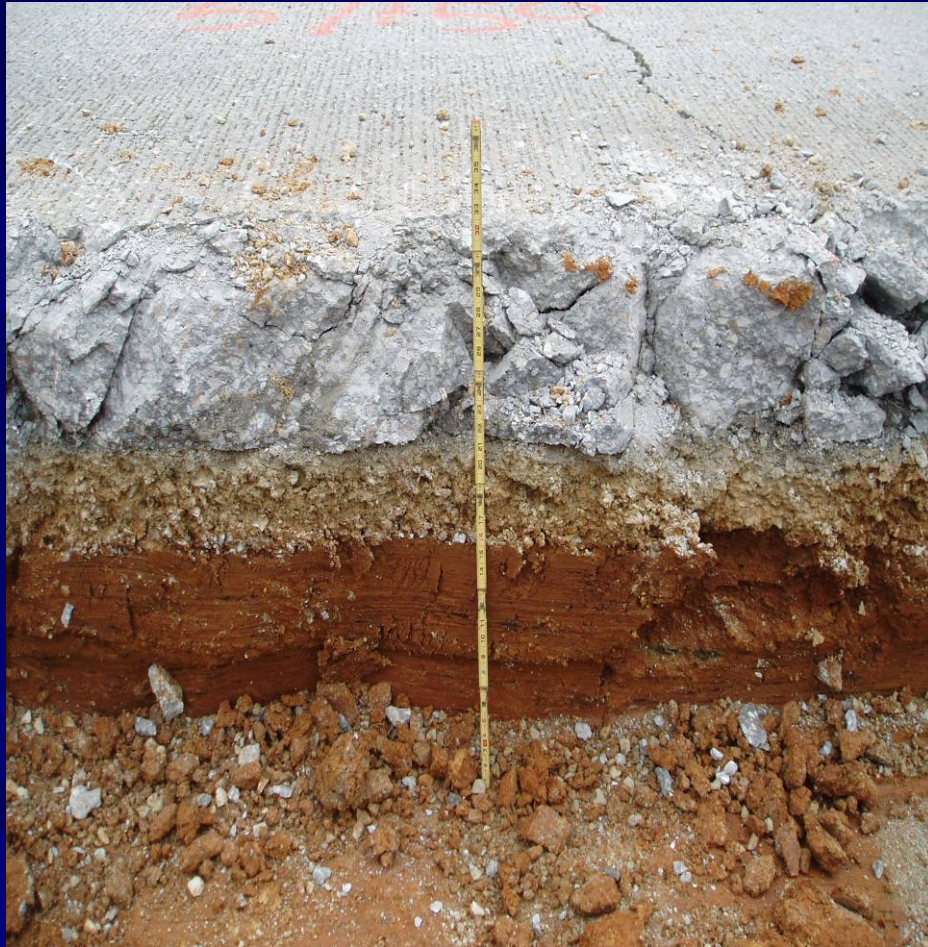
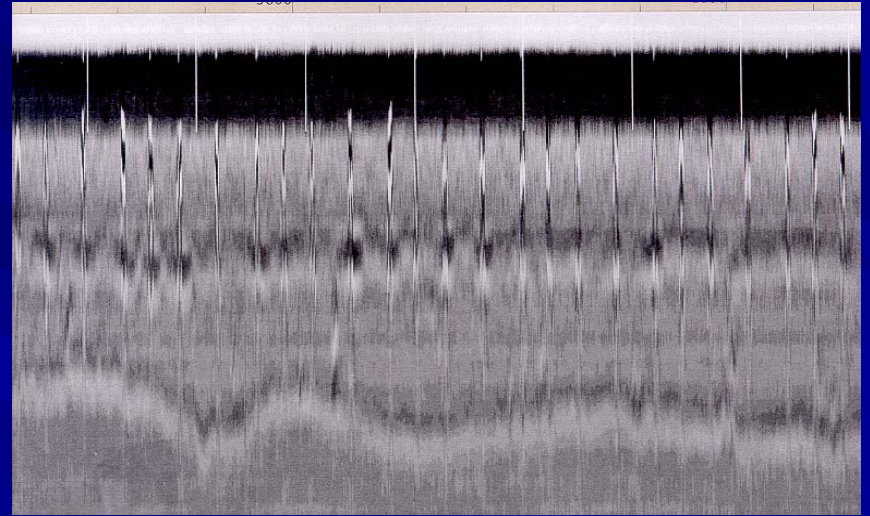
I-265 pavement structure after excavation

- Provided that traffic predominately travels in the right driving lane, over time the saturated clay beneath the DGA layer has compressed thus allowing for differential settlement of the right driving lane

- Break and remove existing concrete pavement, excavate sub-grade (clay layer), replace with number 2 size stone, place new concrete pavement, and install edge-drains
- Project currently under construction approx. \$14 million

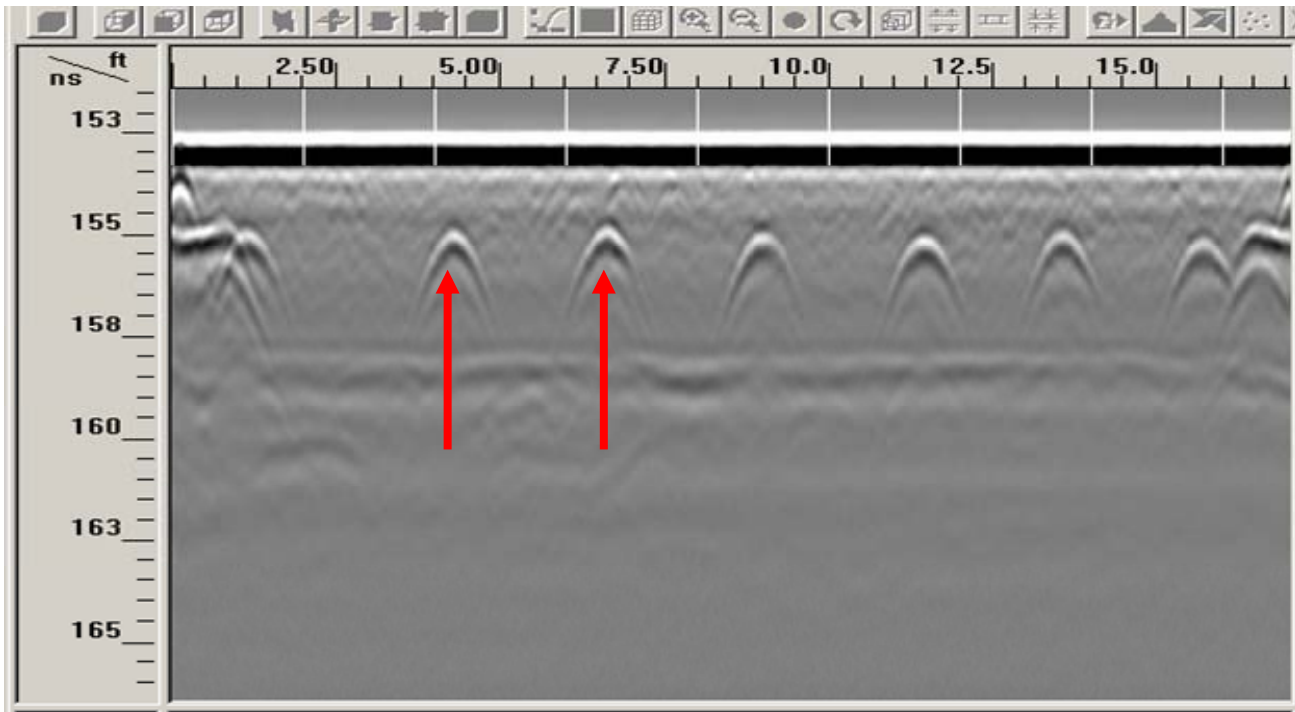
Tie bar spacing between shoulder and right driving lane (30"):
Northbound station 765+00

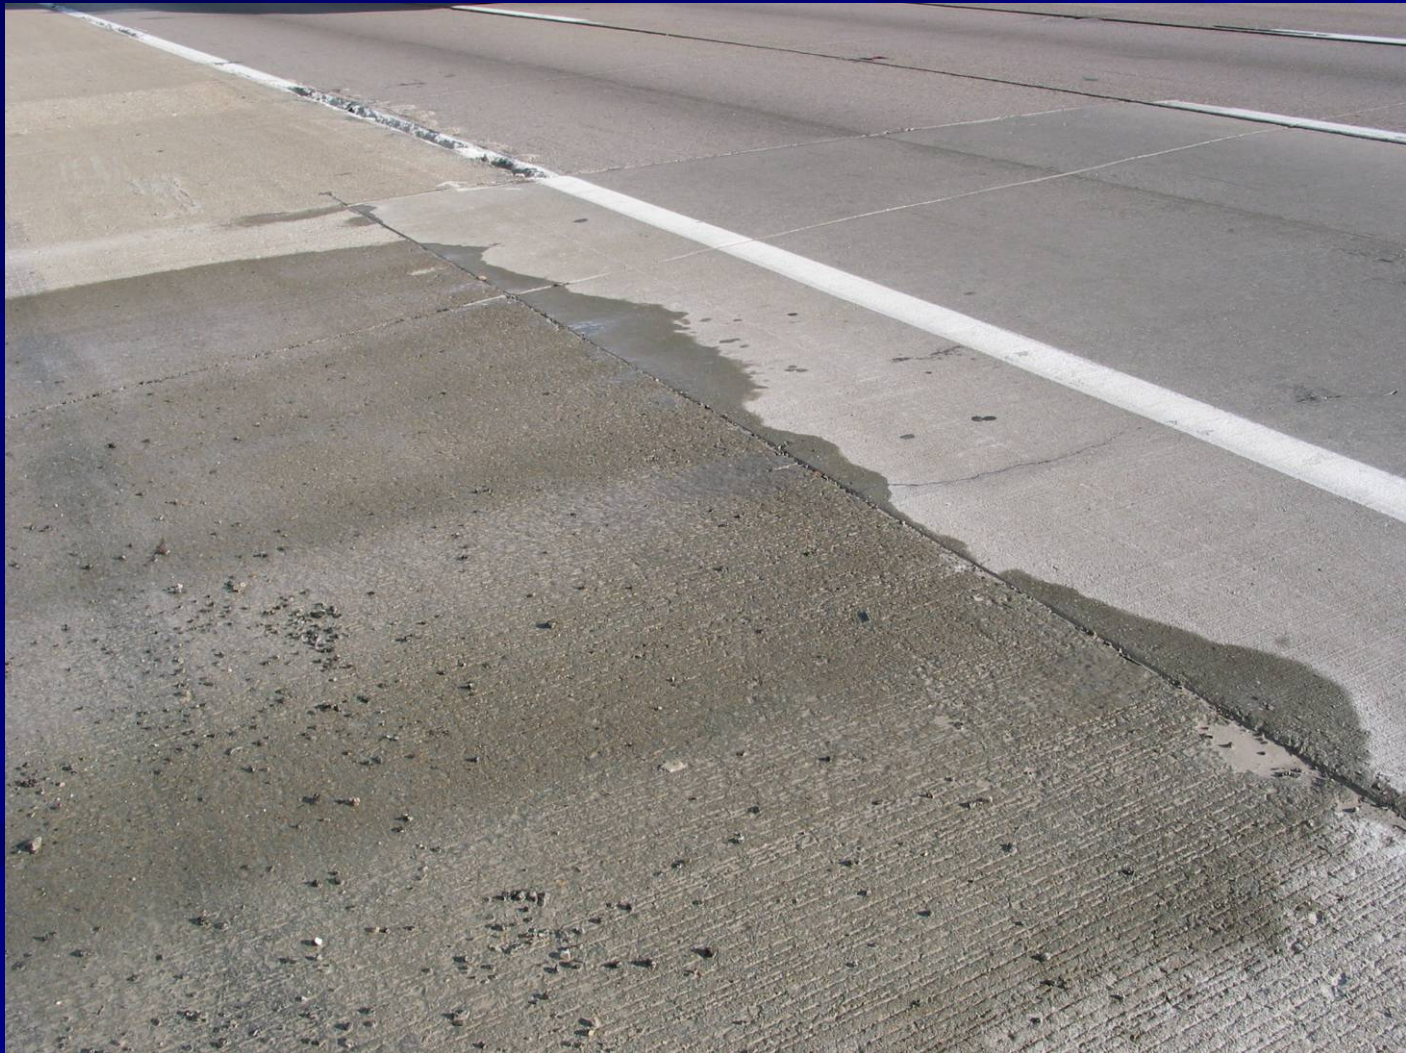
Water bleeding out of shoulder joint in patched area

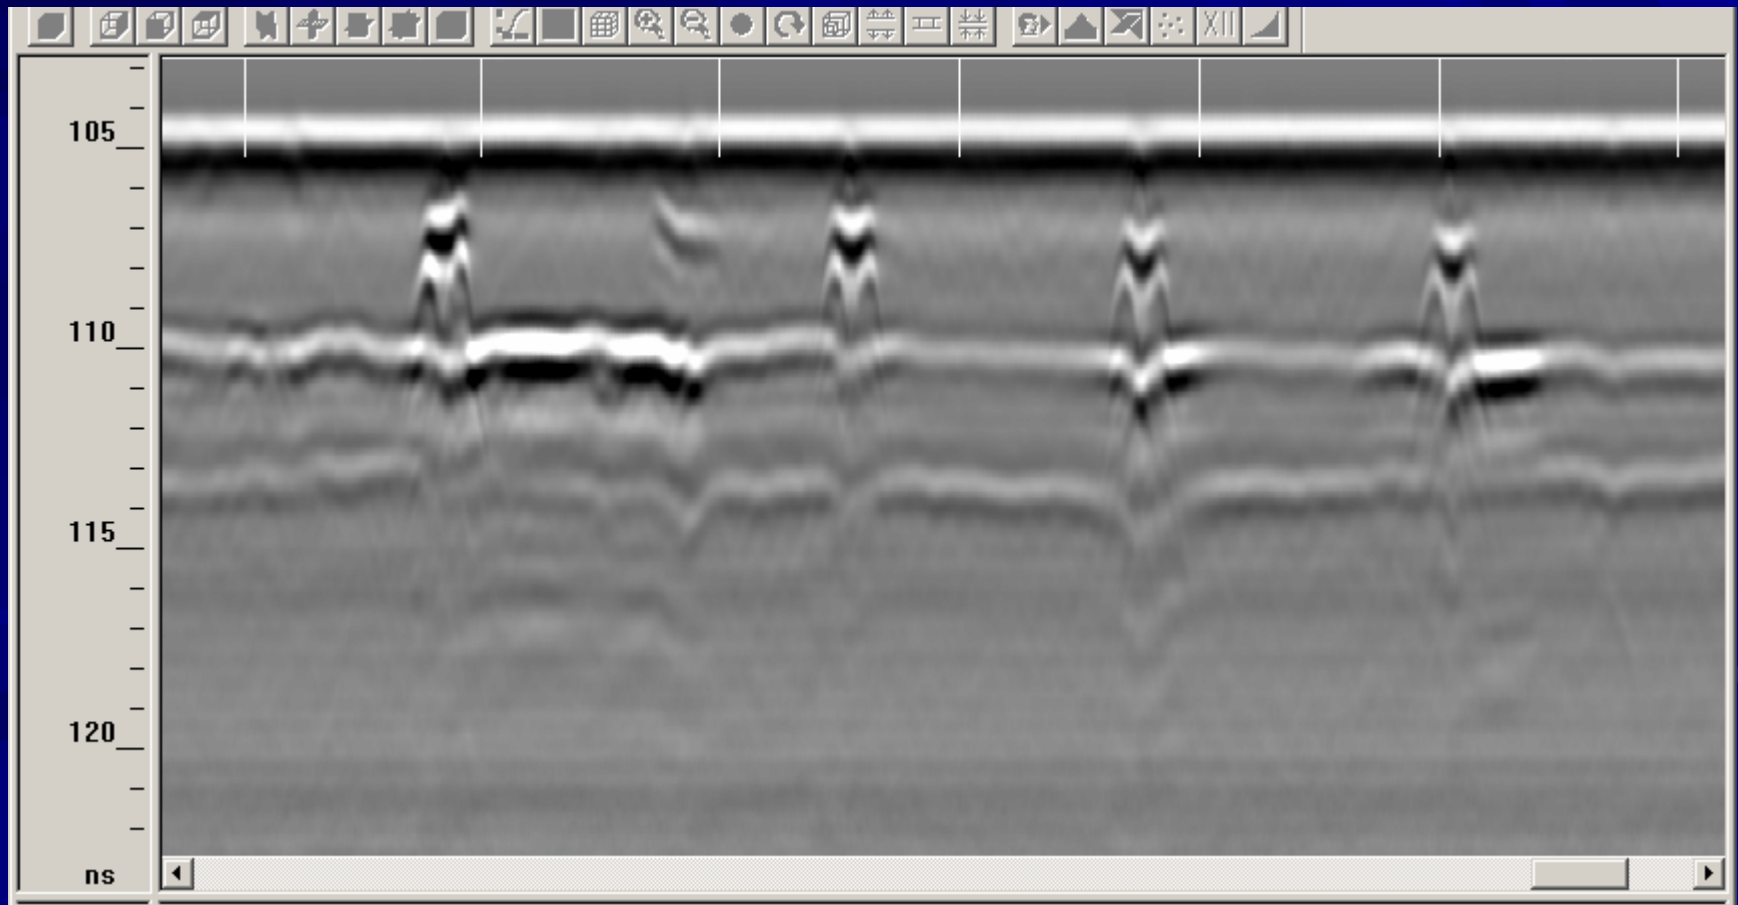
GPR data showing wet and dry sub-grade conditions beneath the concrete layer

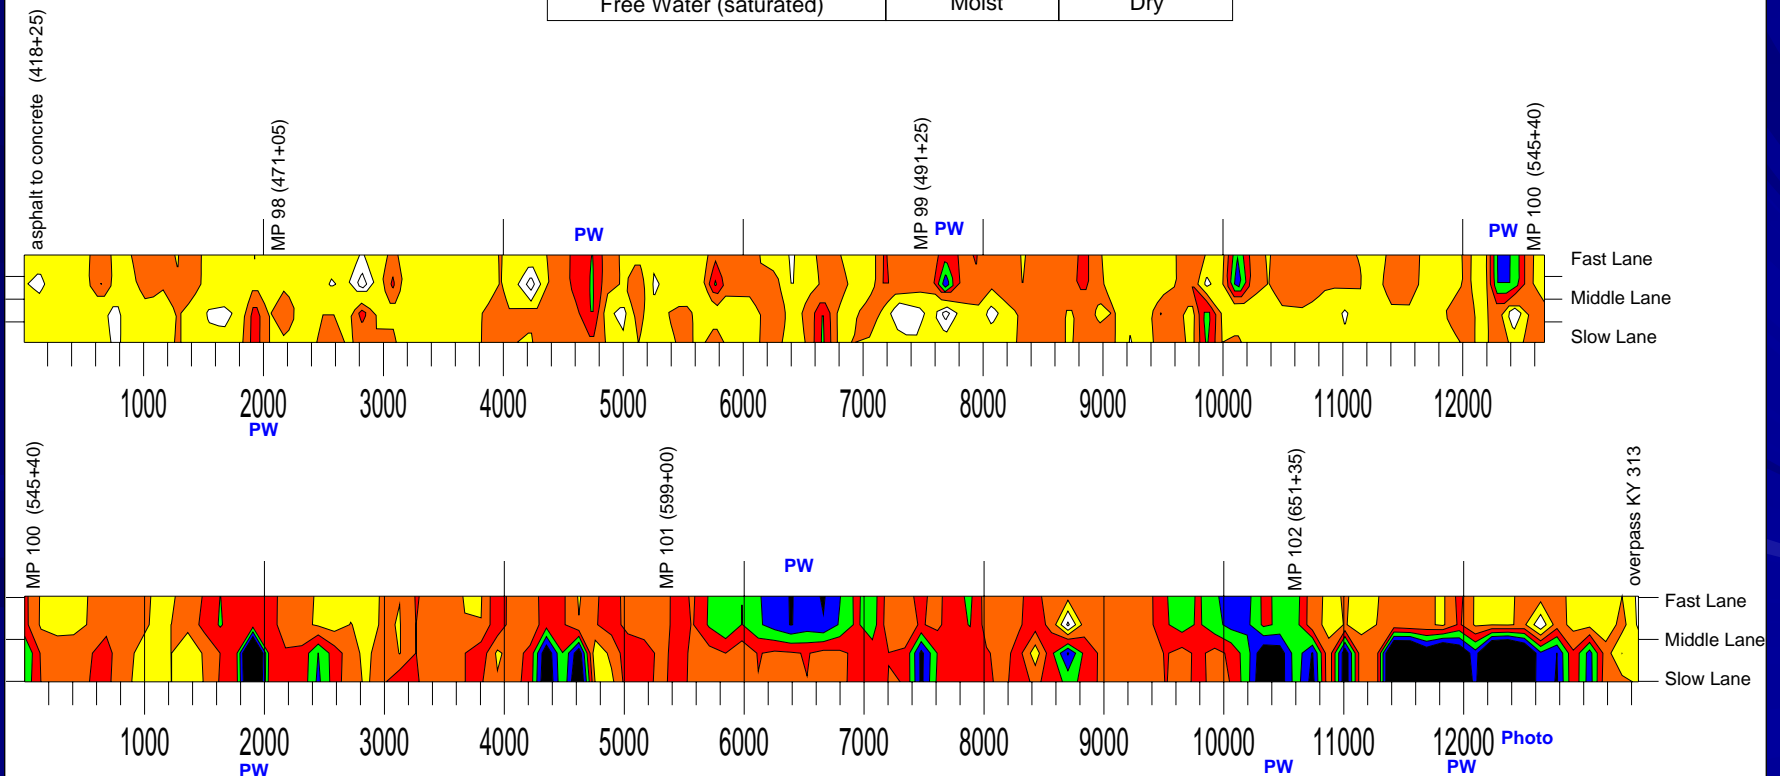
Northbound I-65: degree of moisture beneath concrete
 approx.milepoints 97.5 (asphalt to concrete) to 102.5 (KY 313 overpass)

PW = Pumping water from long. joint onto shoulder

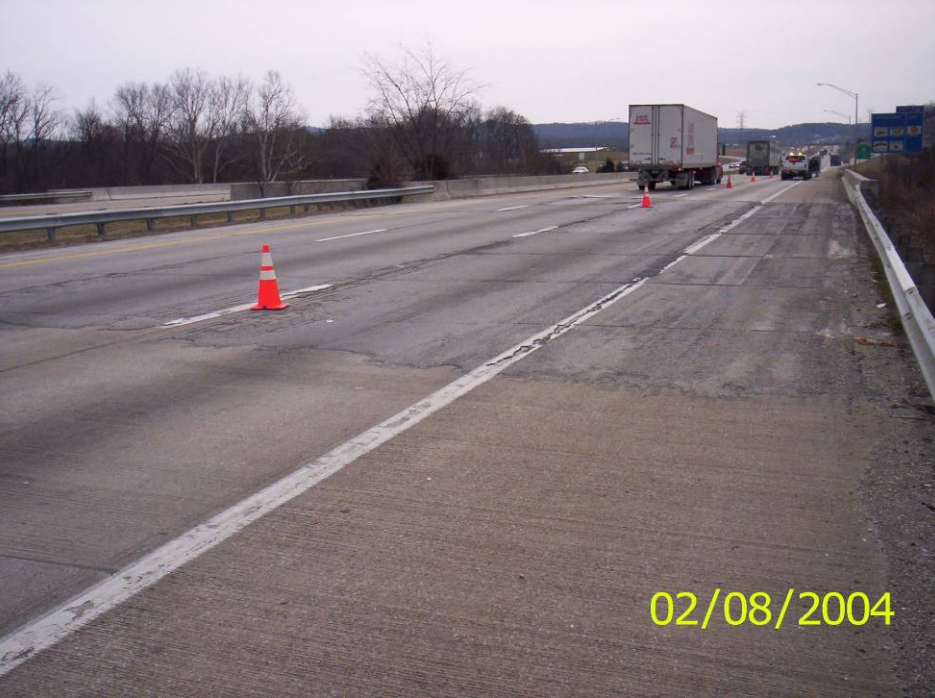
02/08/2004

Asphalt overlay

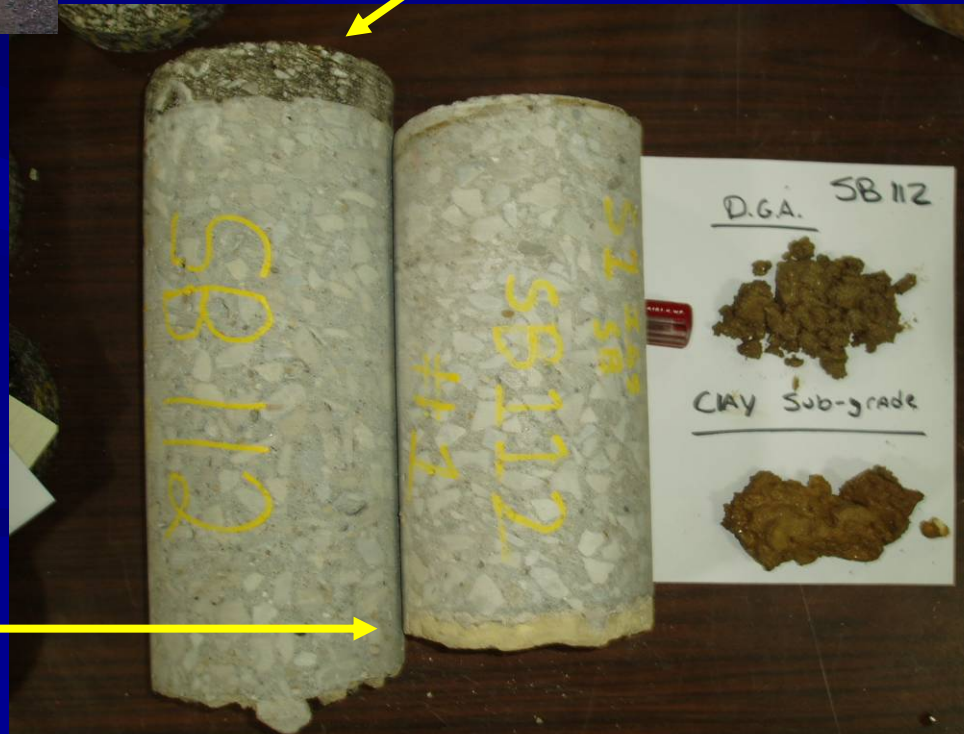
Foam jacking
