WisDOT Non-Cementitious Repair Materials Study

Prashant Ram
Applied Pavement Technology, Inc.

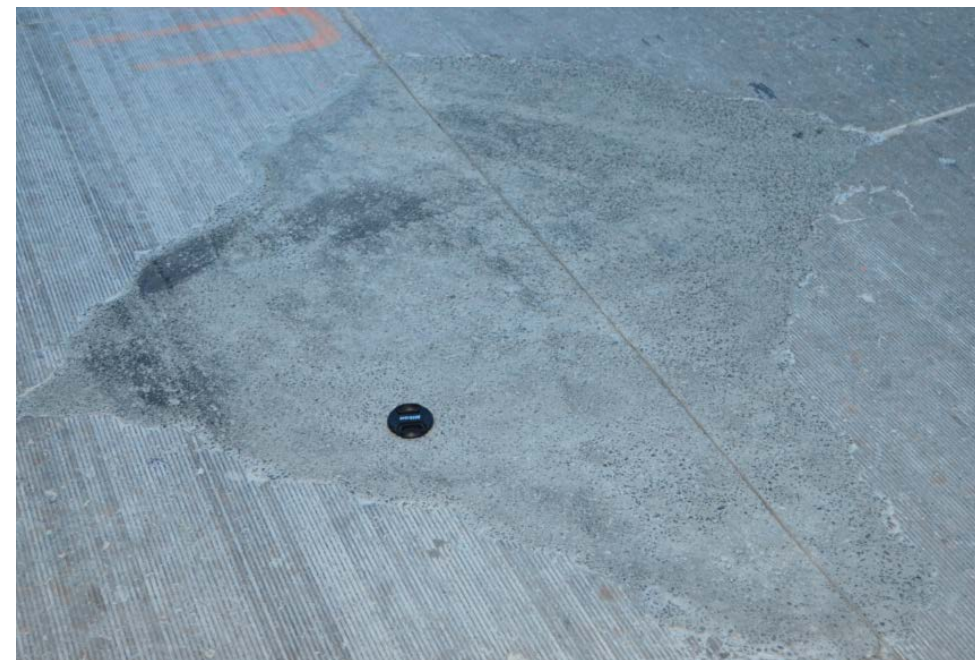
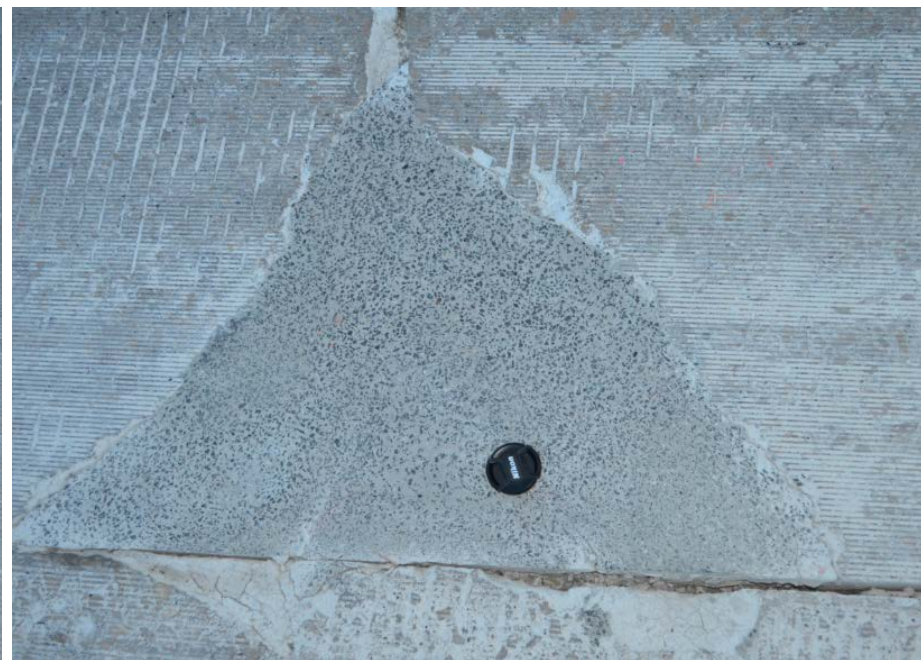
RM-1 Repairs (1/2)

- 8000 PDRs on the Madison Beltline in 2014 and 2015
- Jan 2016: Several instances of sudden failures
 - » WisDOT investigation showed underlying concrete to be in deteriorated condition
- Jan 2018: Another round of failures
- Summer 2018: Removal and replacement of all RM-1 repairs

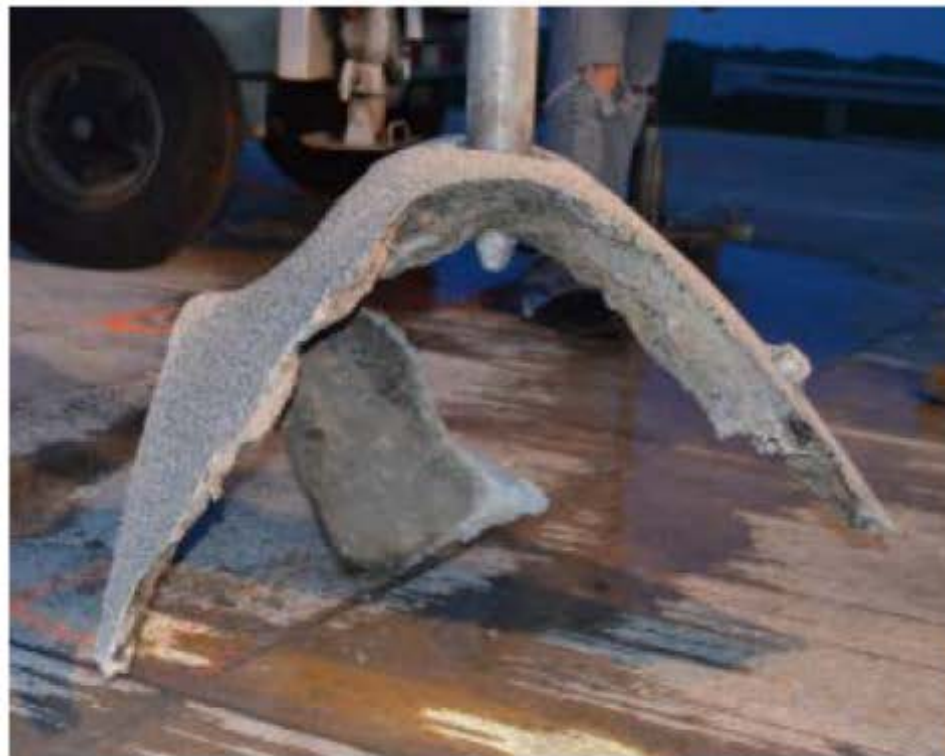
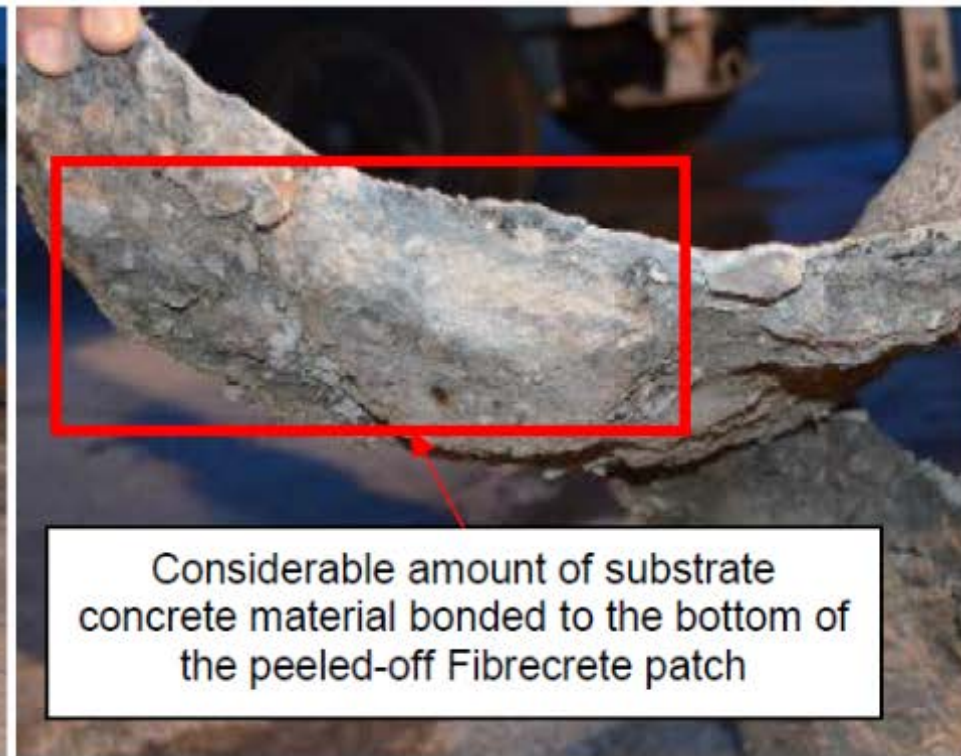
RM-1 Repairs (2/2)

Considerable amount of substrate concrete material bonded to the bottom of the peeled-off Fibrecrete patch

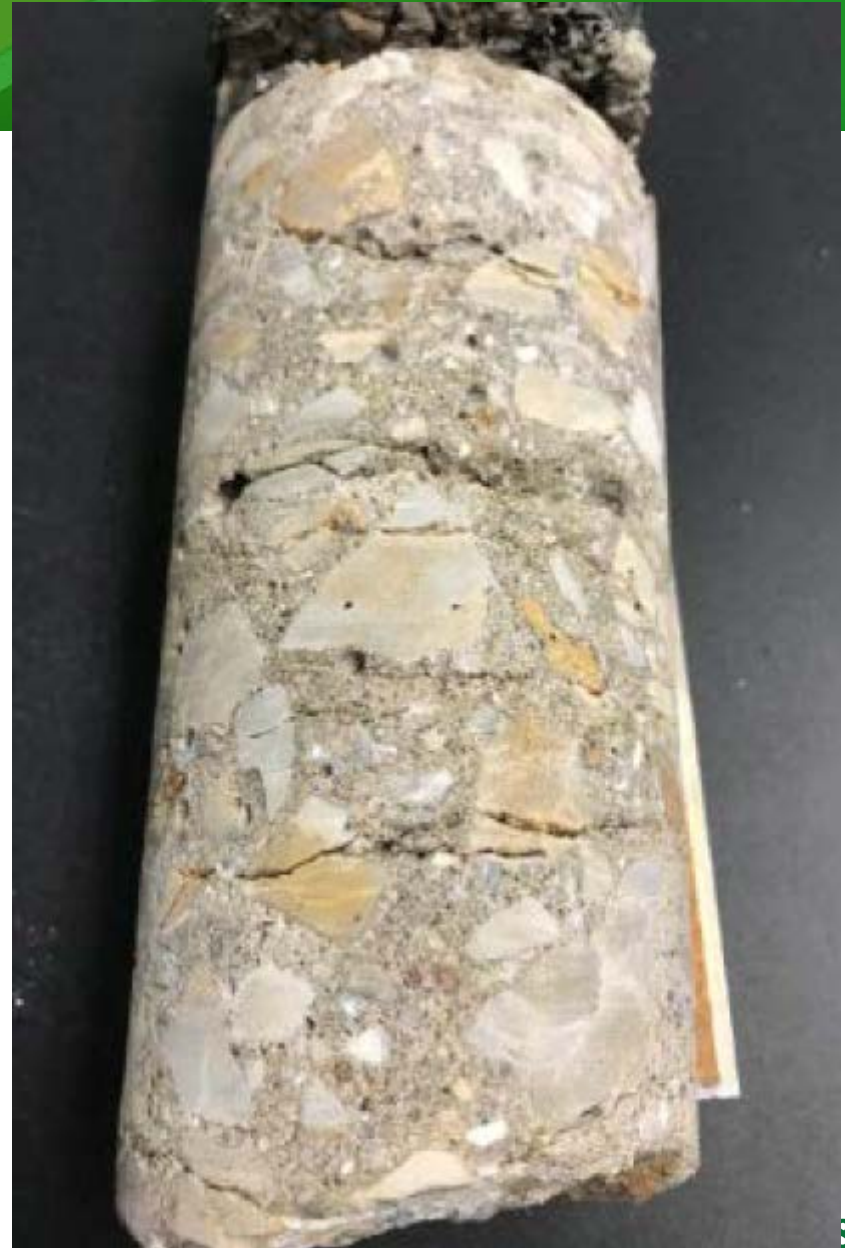
RM-1 Cores (2/2)

- Multiple parallel cracks through the entire depth
- Potentially suggests freeze-thaw-related damage

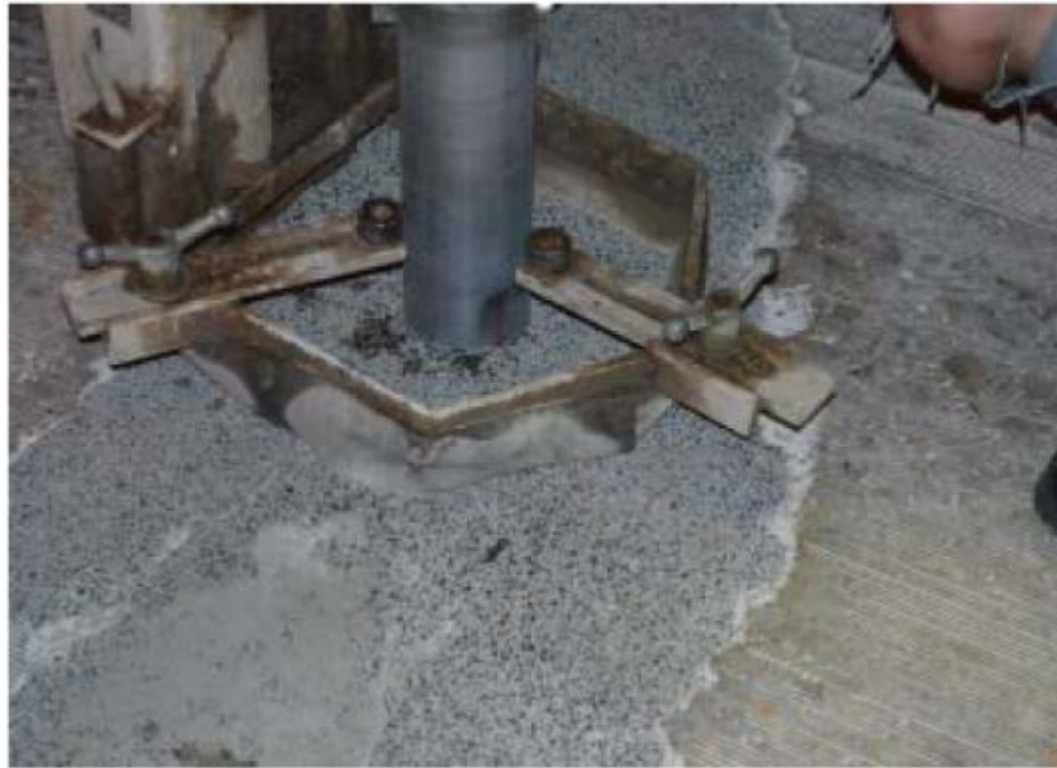
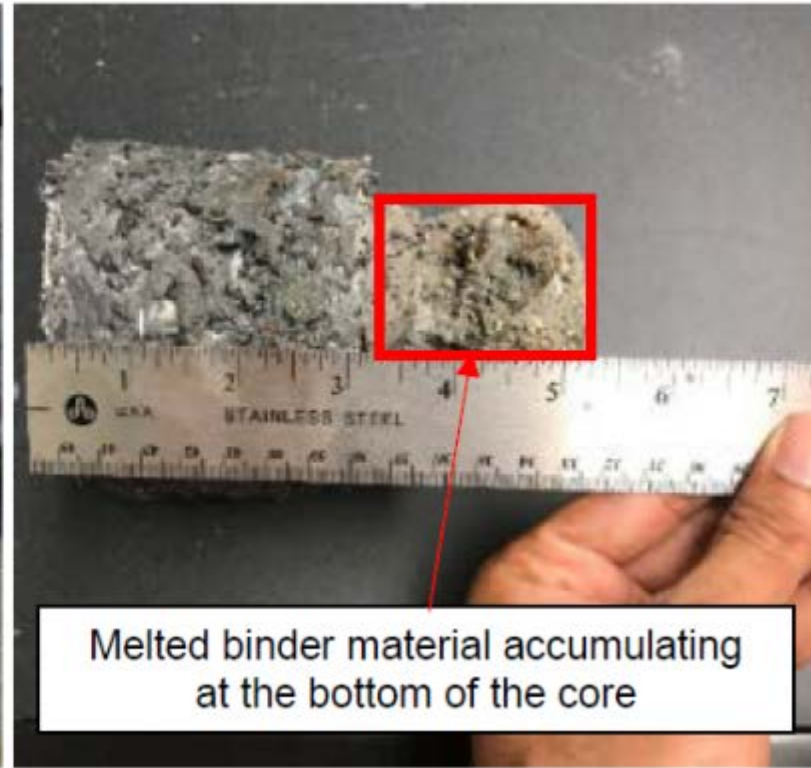
Coring Issues

- Non-cementitious repair materials typically used to repair heavily distressed areas in Wisconsin: spalled joints, transverse cracks, corner breaks, MRD
- Repair boundaries not demarcated using saw-cuts for vast majority of repairs
- Coring materials was challenge since binder melts and gums up coring drill
 - » Diamond grinding concerns

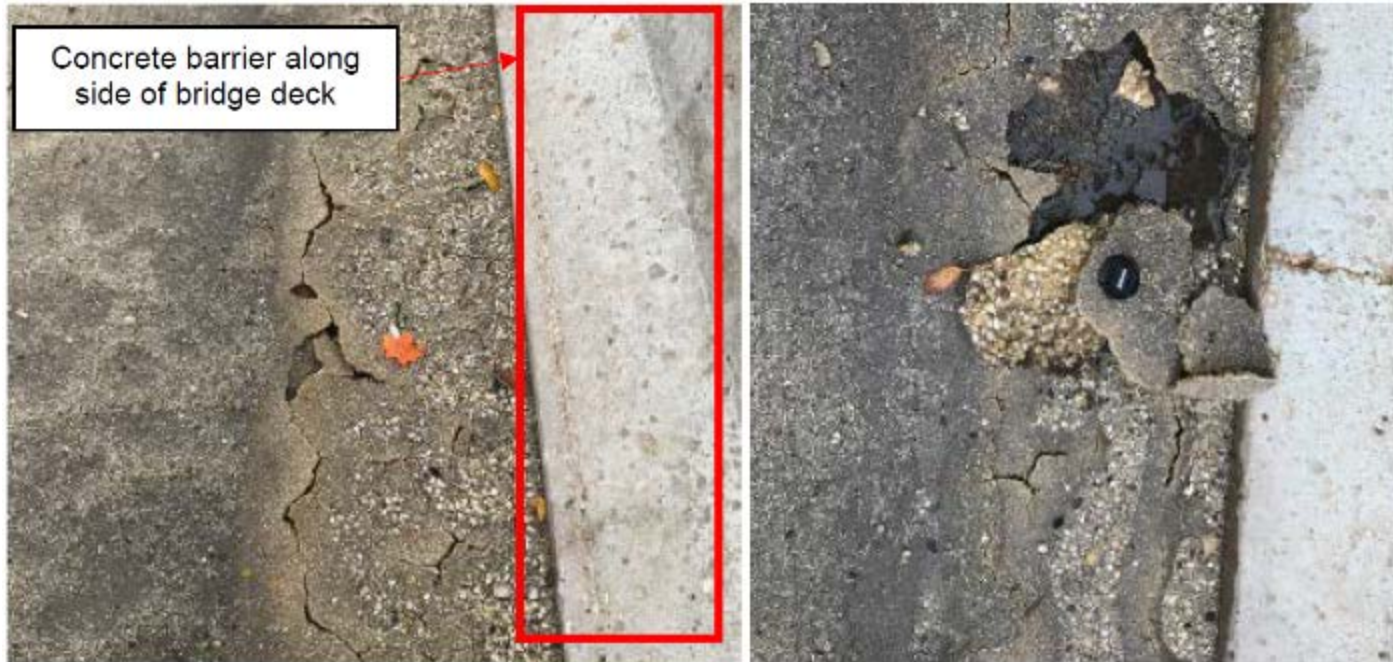
RM-2: Issues Noted

- Top 0.25-inches peeling off; isolated to edge
- Potential causes: under-catalyzed binder, moisture in mix aggregates, accumulation of excess moisture

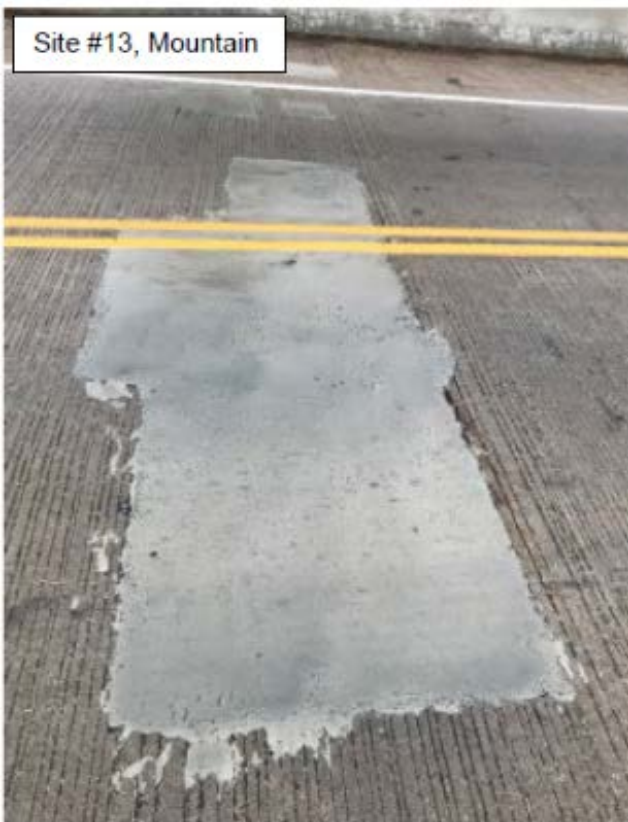
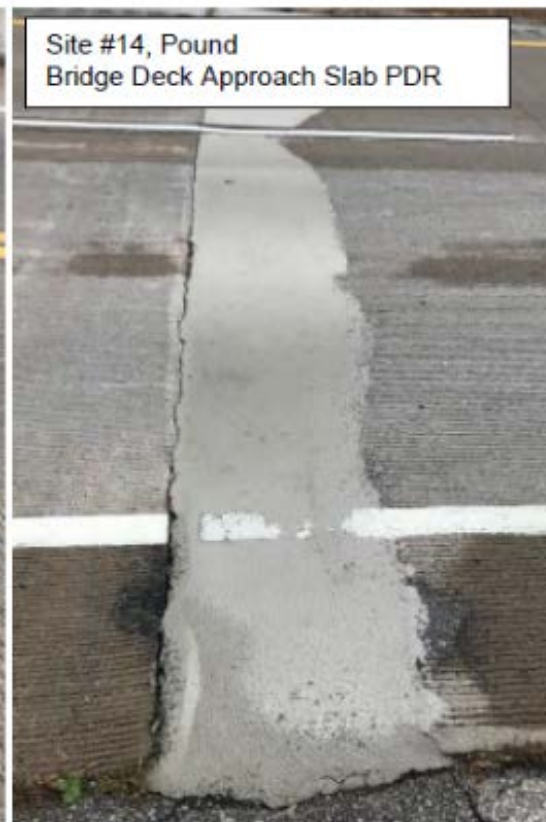
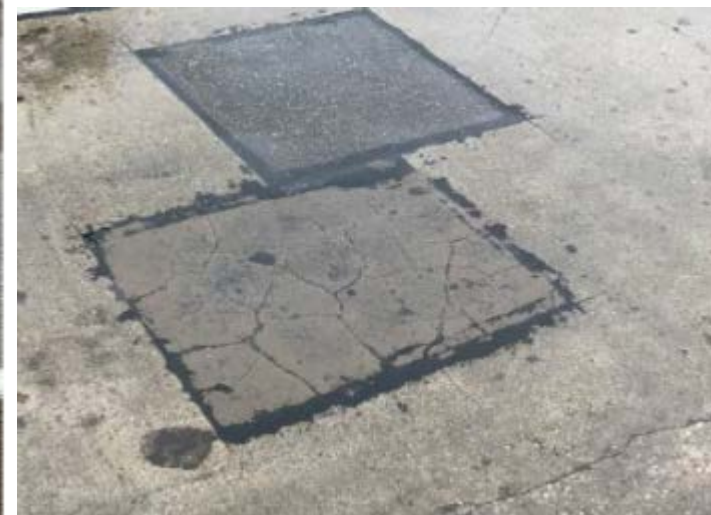
RM-4 Repairs—Bridge

Surface map cracking on some bridge deck repairs

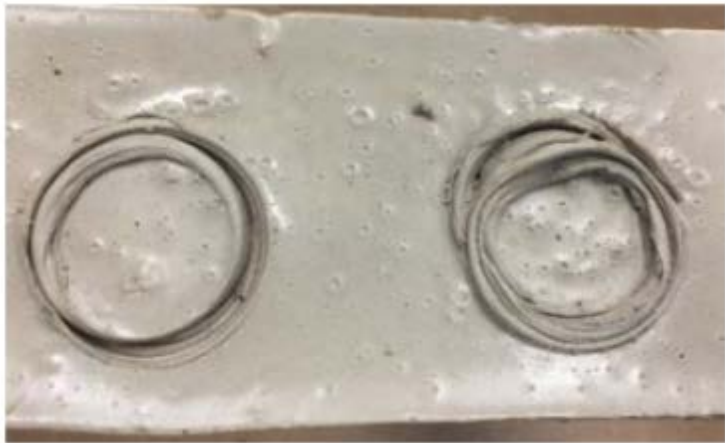
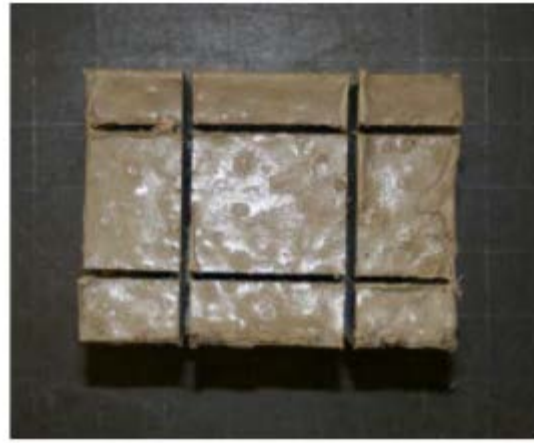
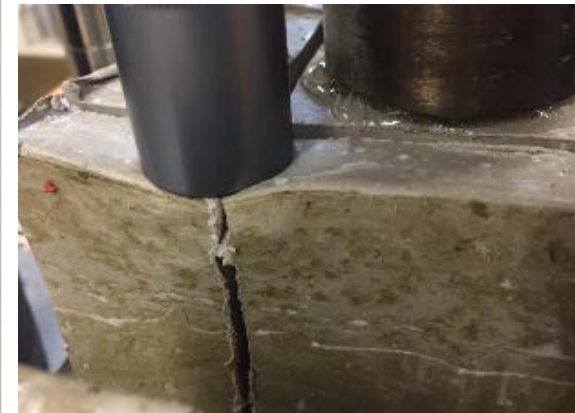
Bond Testing Issues: RM-4 and RM-5

- Specimen prep issues due to material melting
- Specimen too soft; unable to support loading from testing equipment
- Test largely unsuccessful
