Andrew Johnson, Ph.D., P.E.
State Pavement Design Engineer
SCDOT Office of Materials and Research

## I-95 Florence County

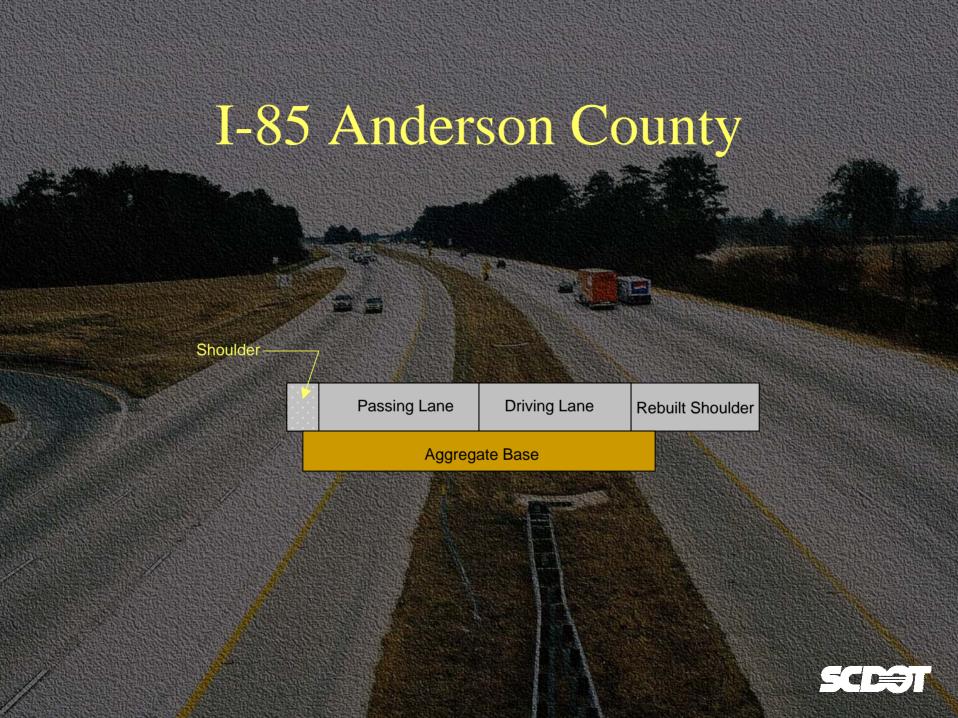
- Staging plan:
  - Very complex, required 27 pages to describe
  - First Step: Remove 10-foot asphalt shoulder
     and replace with 8 inches PCC at night.
    - No tie bars, dowels, or sealant. Joints matched to mainline.

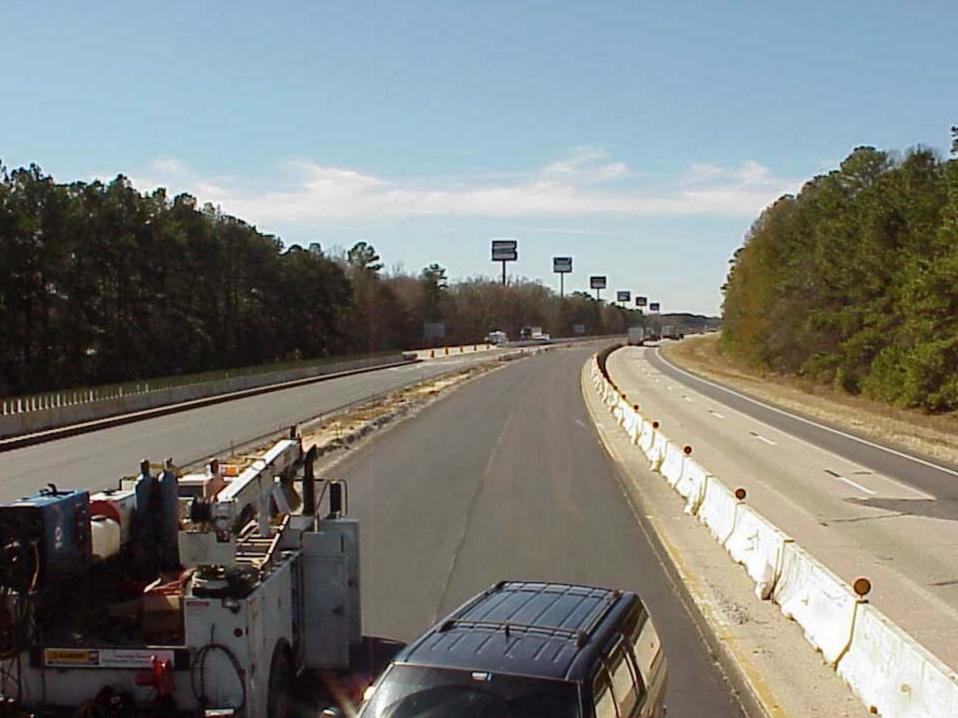
- Staging plan:
  - Shift traffic right by 8 feet, place temporary barrier wall in original passing lane.

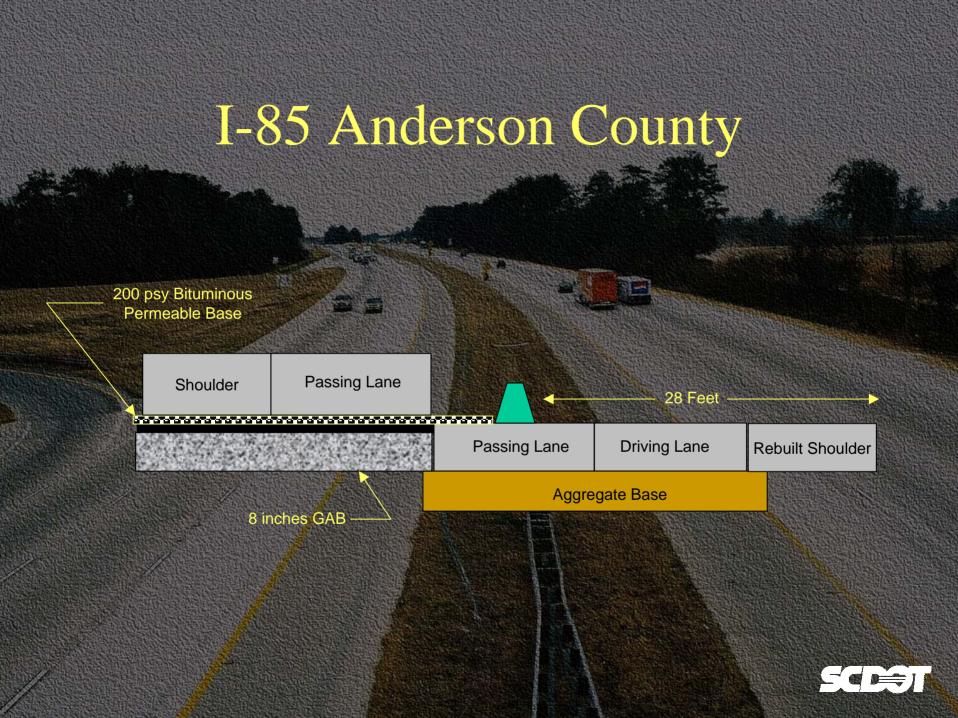
- Staging plan:
  - Construct pavement and base in median :
    - 12 inches Plain Jointed PCC
    - 2 inches Bituminous Permeable Base
    - 2 inches AC Surface
    - 8 inches Graded Aggregate Base
    - Edge drain
  - Construct new asphalt lane in northbound median and diversion lane across median.

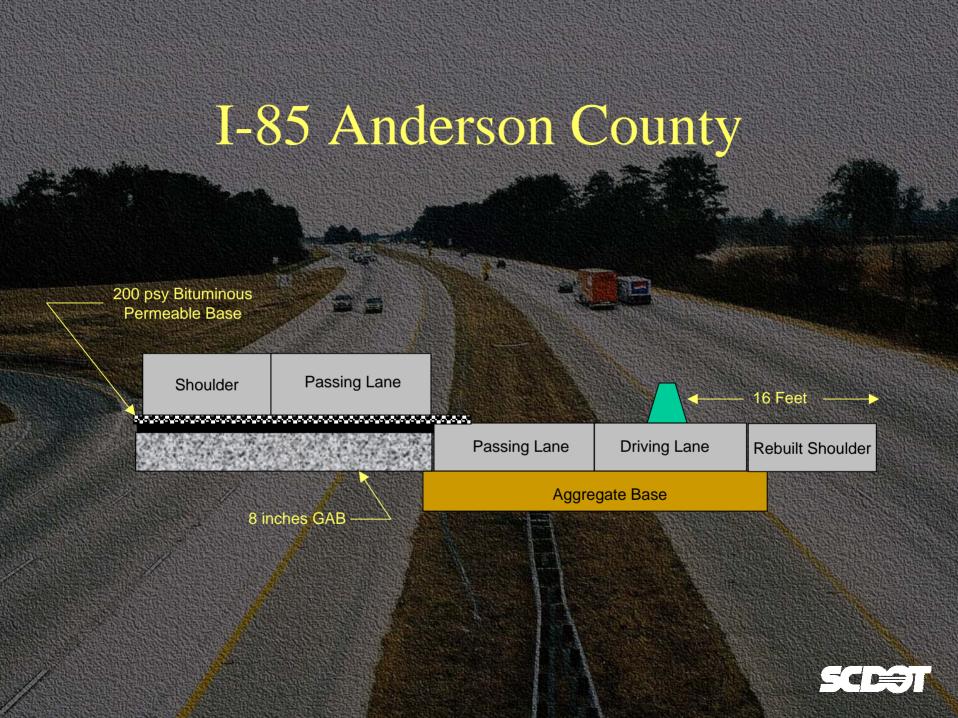
- Staging plan:
  - Move temporary barrier wall to center of old driving lane in southbound lane. Shift one lane of traffic to new payement, one lane to northbound lane.

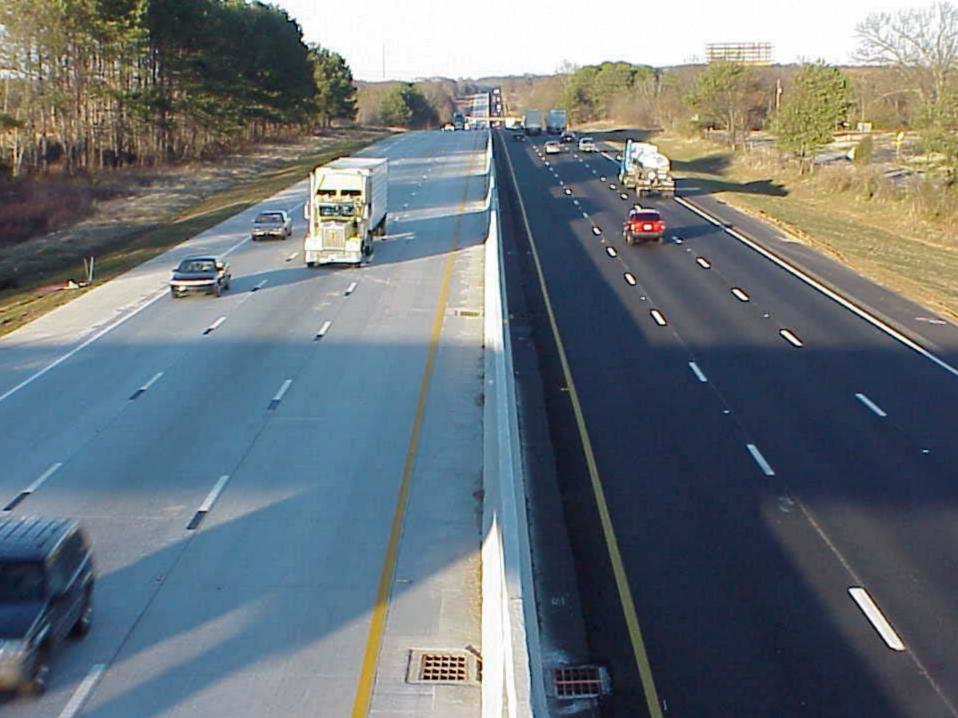
- Improvements over original design:
  - 12-inch versus 9-inch slab
  - 15-foot versus 25-foot slabs
  - Dowels versus aggregate interlock at joints
  - Tied PCC versus asphalt shoulders
  - Positive drainage versus bathtub with erodible base.

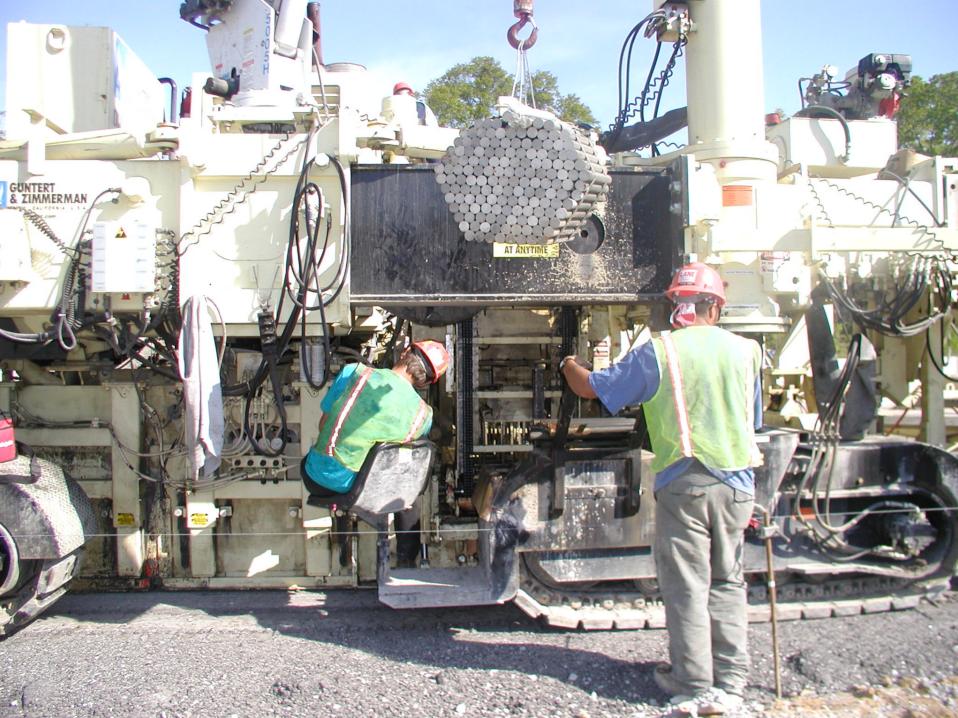
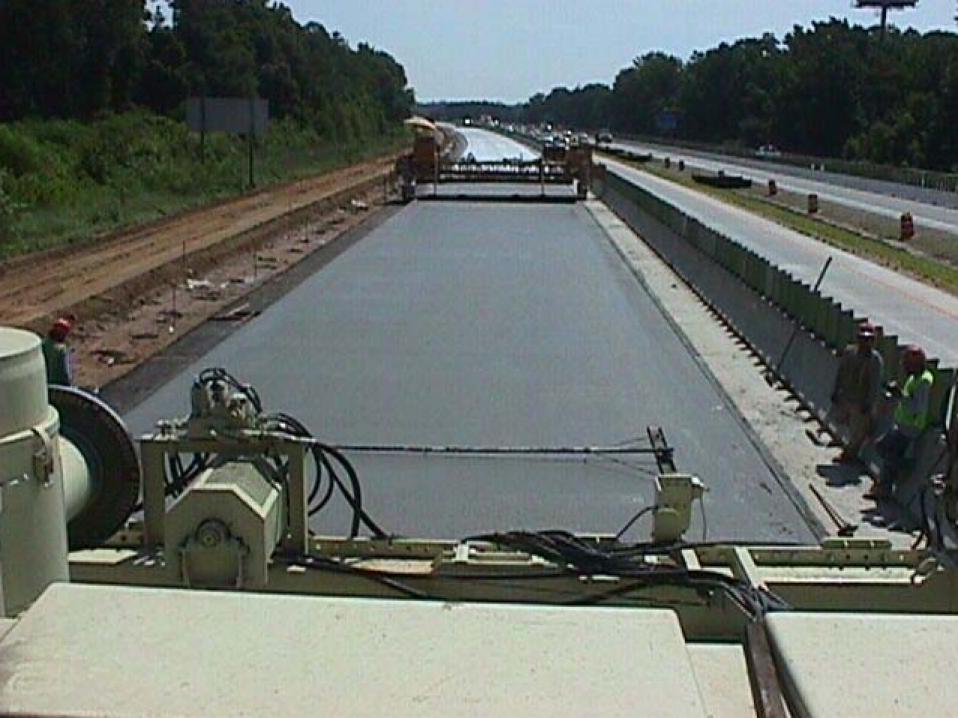
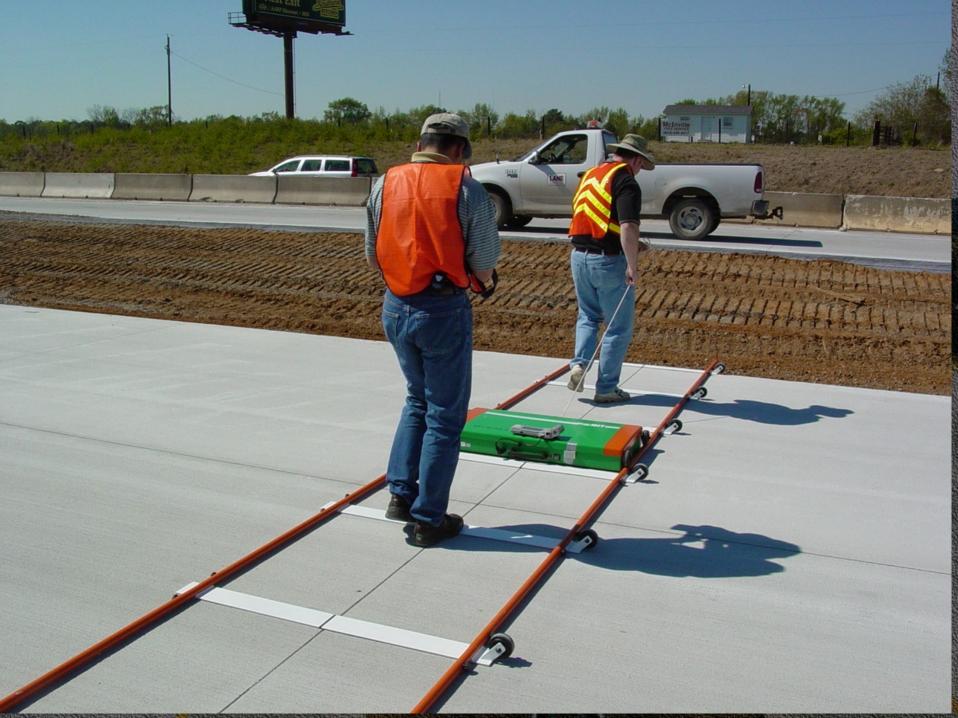
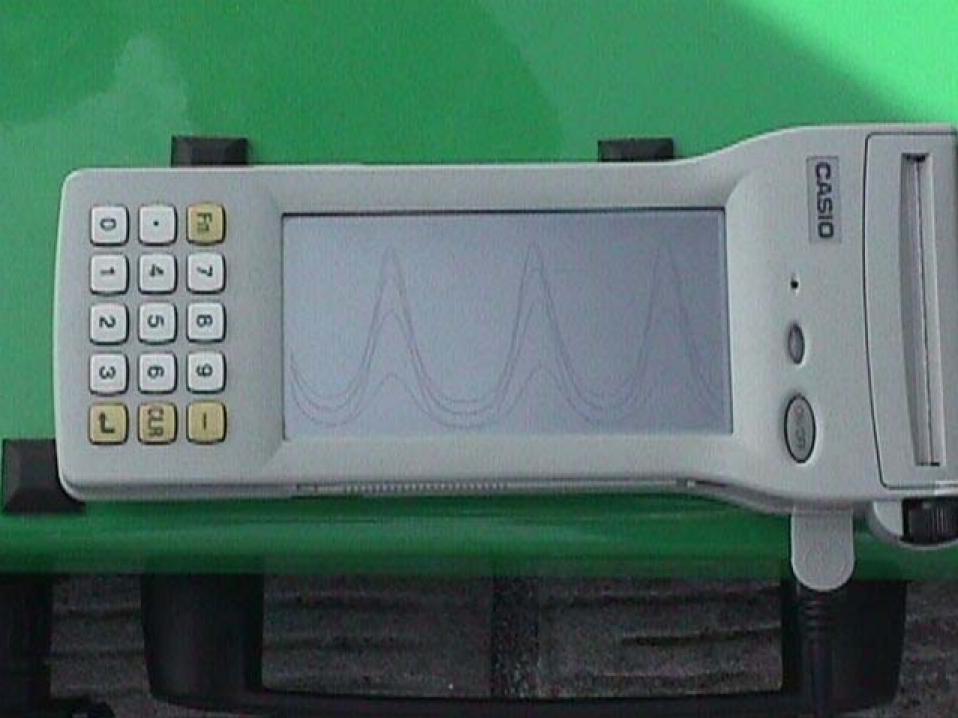
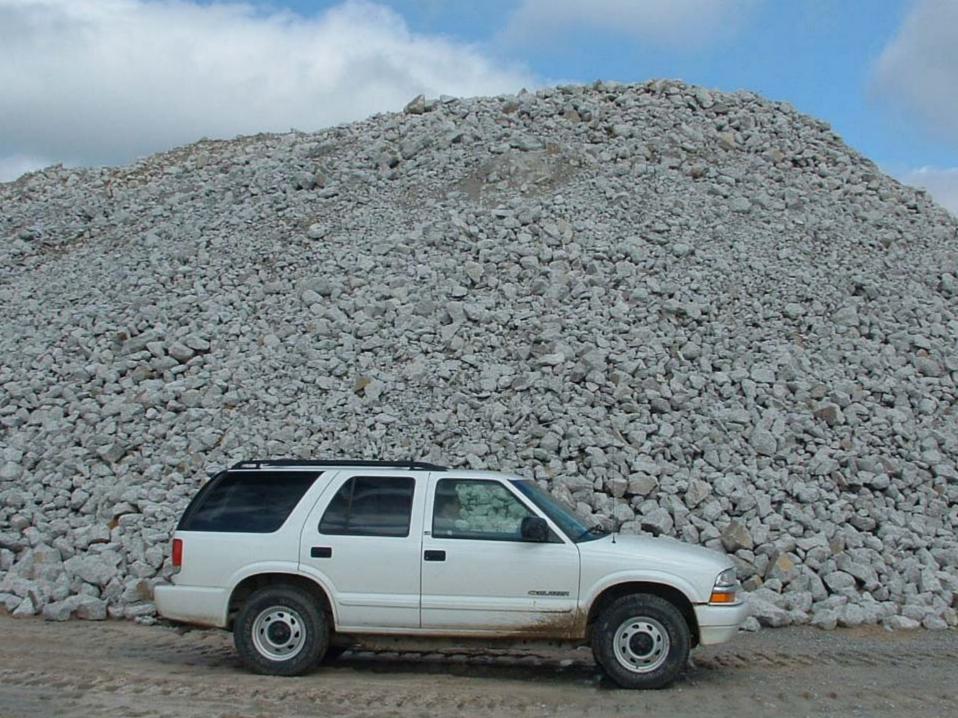
- New features:
  - PCC flexural strength requirement raised from 550 psi to 650 psi at 14 days to reduce pavement thickness by one inch.
  - Allowed the use of old PCC as coarse aggregate for new PCC.
  - Allowed the use of automatic dowel bar inserter in lieu of chairs.
  - Required diamond grinding of new surface for better rideability.

- Removed existing 10" PCC.
- Repaired base with new cement treatment where necessary.
- New pavement over existing base:
  - 11" Plain Jointed PCC (15' joint spacing)
  - 2" Asphalt Surface
  - 8" Graded Aggregate Base (new lanes)
- Traffic control/staging similar to I-85.

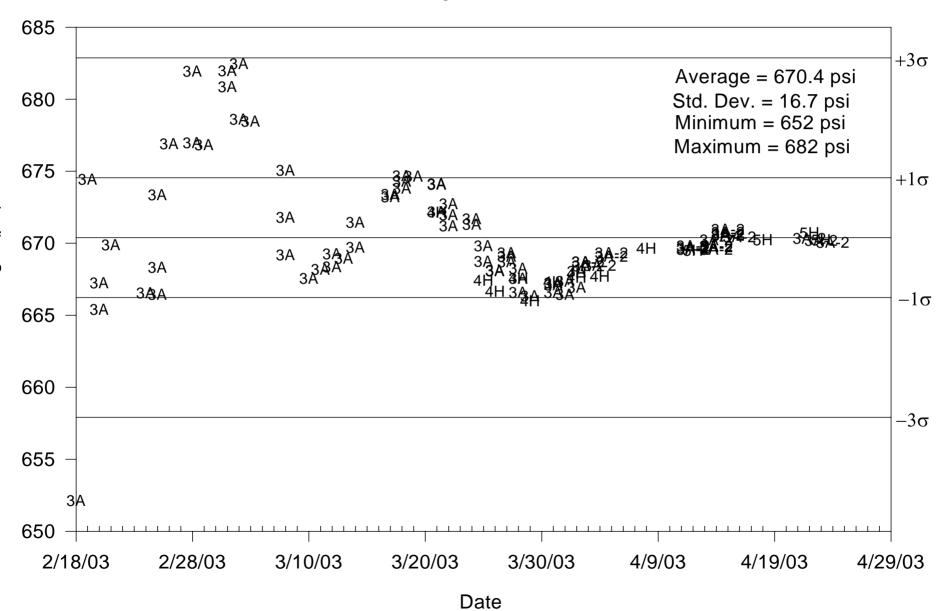
#### Phase I Concrete Breaks - I-95 Florence

Strength versus Time

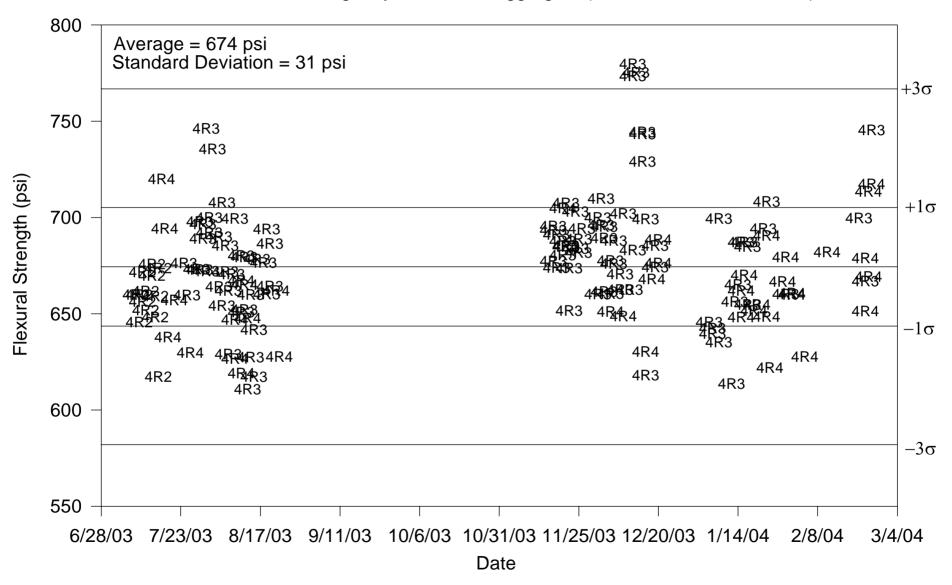
#### I-95 Flexural Breaks, Phases 2 and 3

Mixes using recycled coarse aggregate (Mixes 4R2, 4R3, and 4R4)

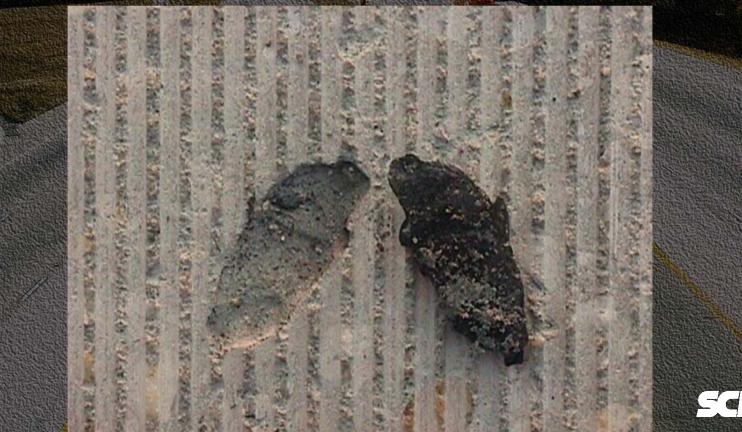
• Some contamination was encountered early from joint sealant, backer road, and wood
