Laser Scanner: an Iowa DOT evaluation study

Omar Smadi
Iowa State University/CTRE

Southeastern Pavement Management and Design Conference
Savannah, Georgia

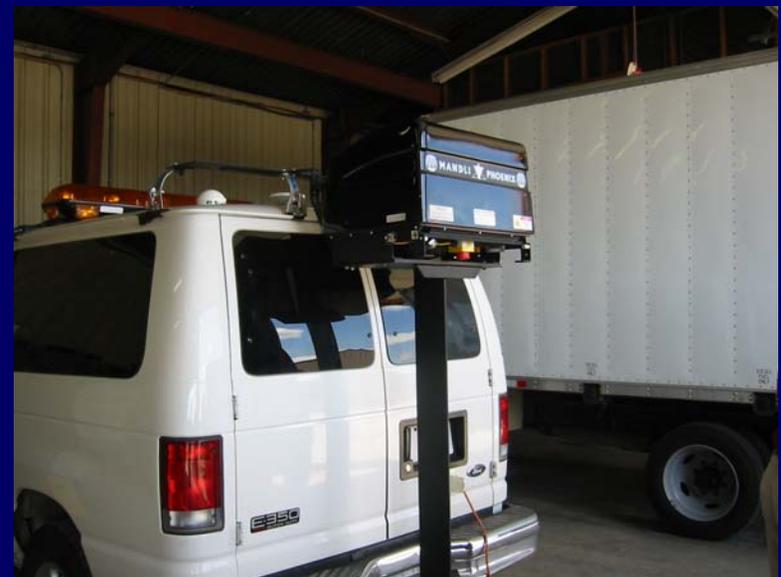
Laser Scanner System

- MANDLI's Pavement Profiler Scanner (PPS) – Developed by Phoenix Scientific
- Uses a phase-measurement laser radar
- Scanner is rear mounted

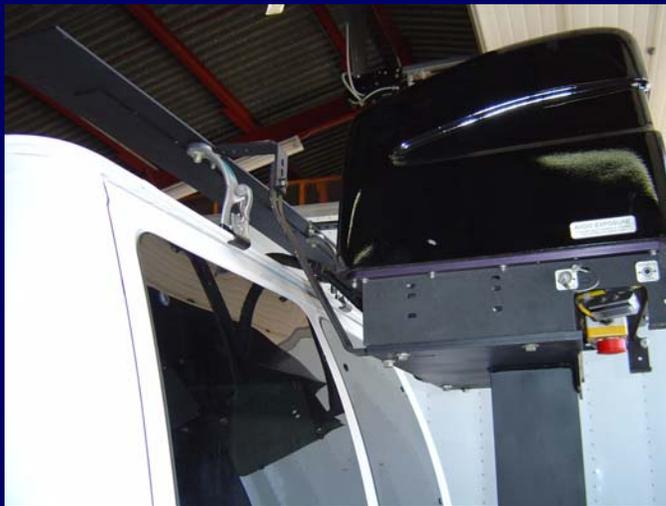
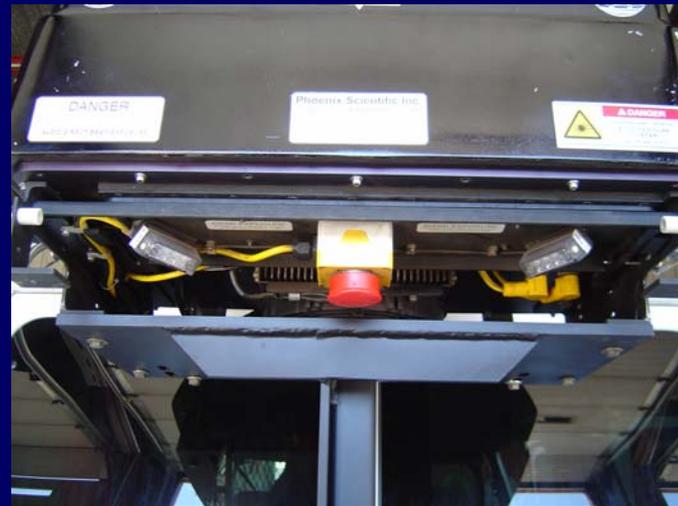
Major System Components (cont.)

- Scanner Mount
- Distance Measurement Instrument
- System Controller and LCD Monitor

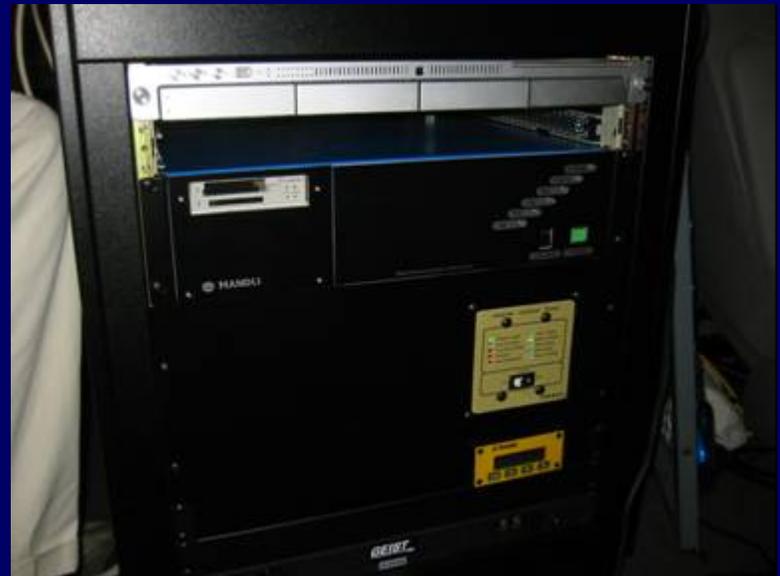
- Scanner was mounted on the Iowa DOT Videolog van
- The van was updated with new computers and other equipment (GPS unit, DMI, etc...)
- Data collection in July to coincide with Roadware
- Collect IRI and Rutting
- 6 control sites + State DOT routes in 7 counties
