# 2006 Southeastern States Pavement Management And Design Conference

# Jointed Plain Concrete Pavement, Case study

Mohamed Elfino, PhD, PE  
VDOT/ Materials Division

Shabbir Hossain, PhD, PE  
Virginia Transportation Research Council

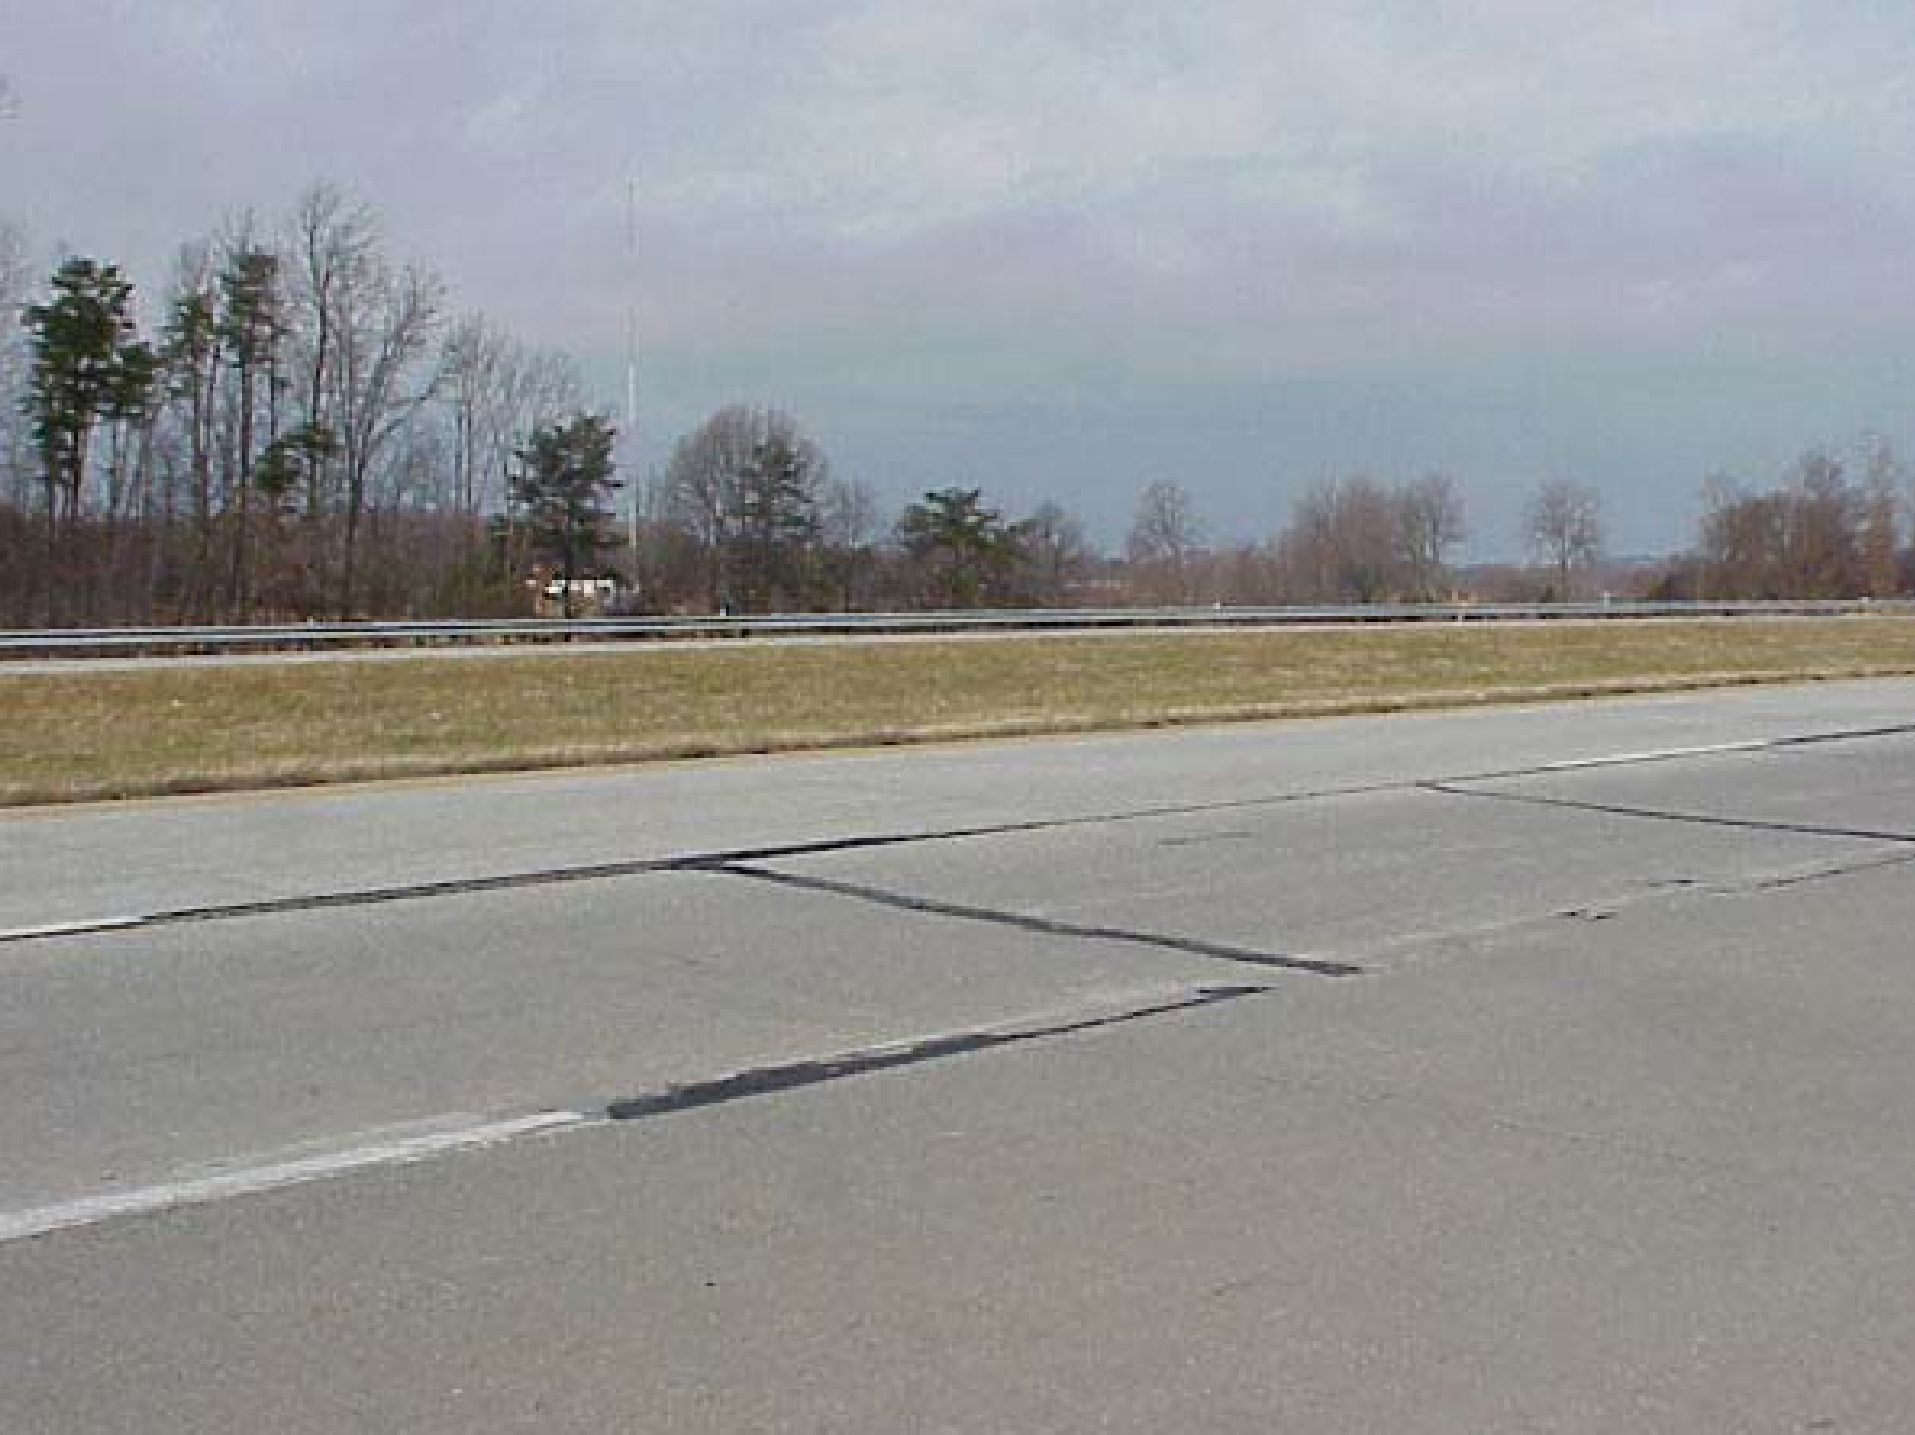
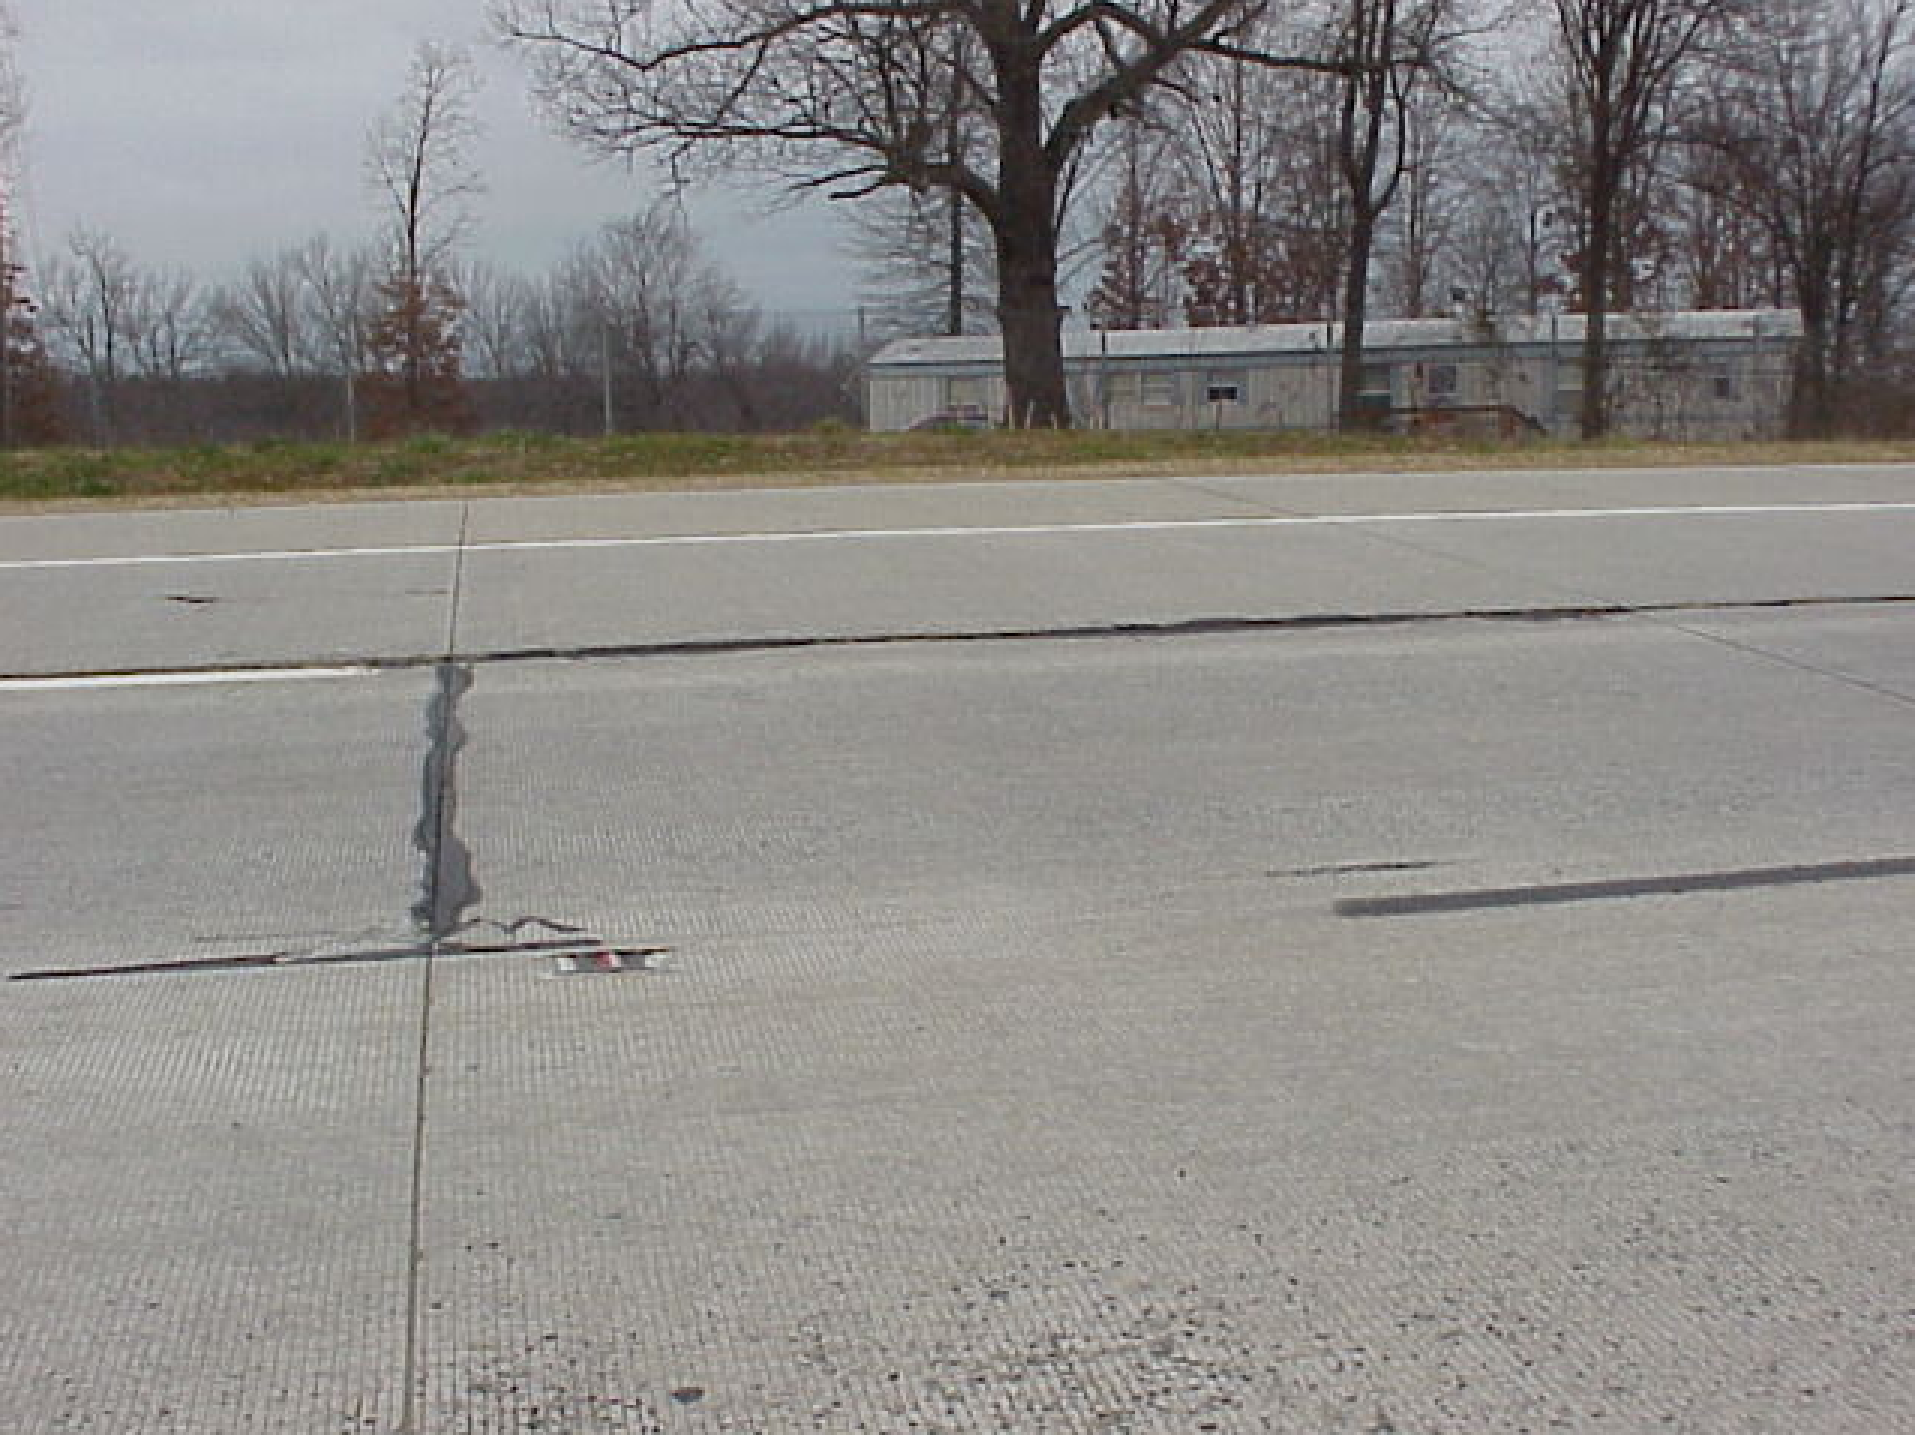
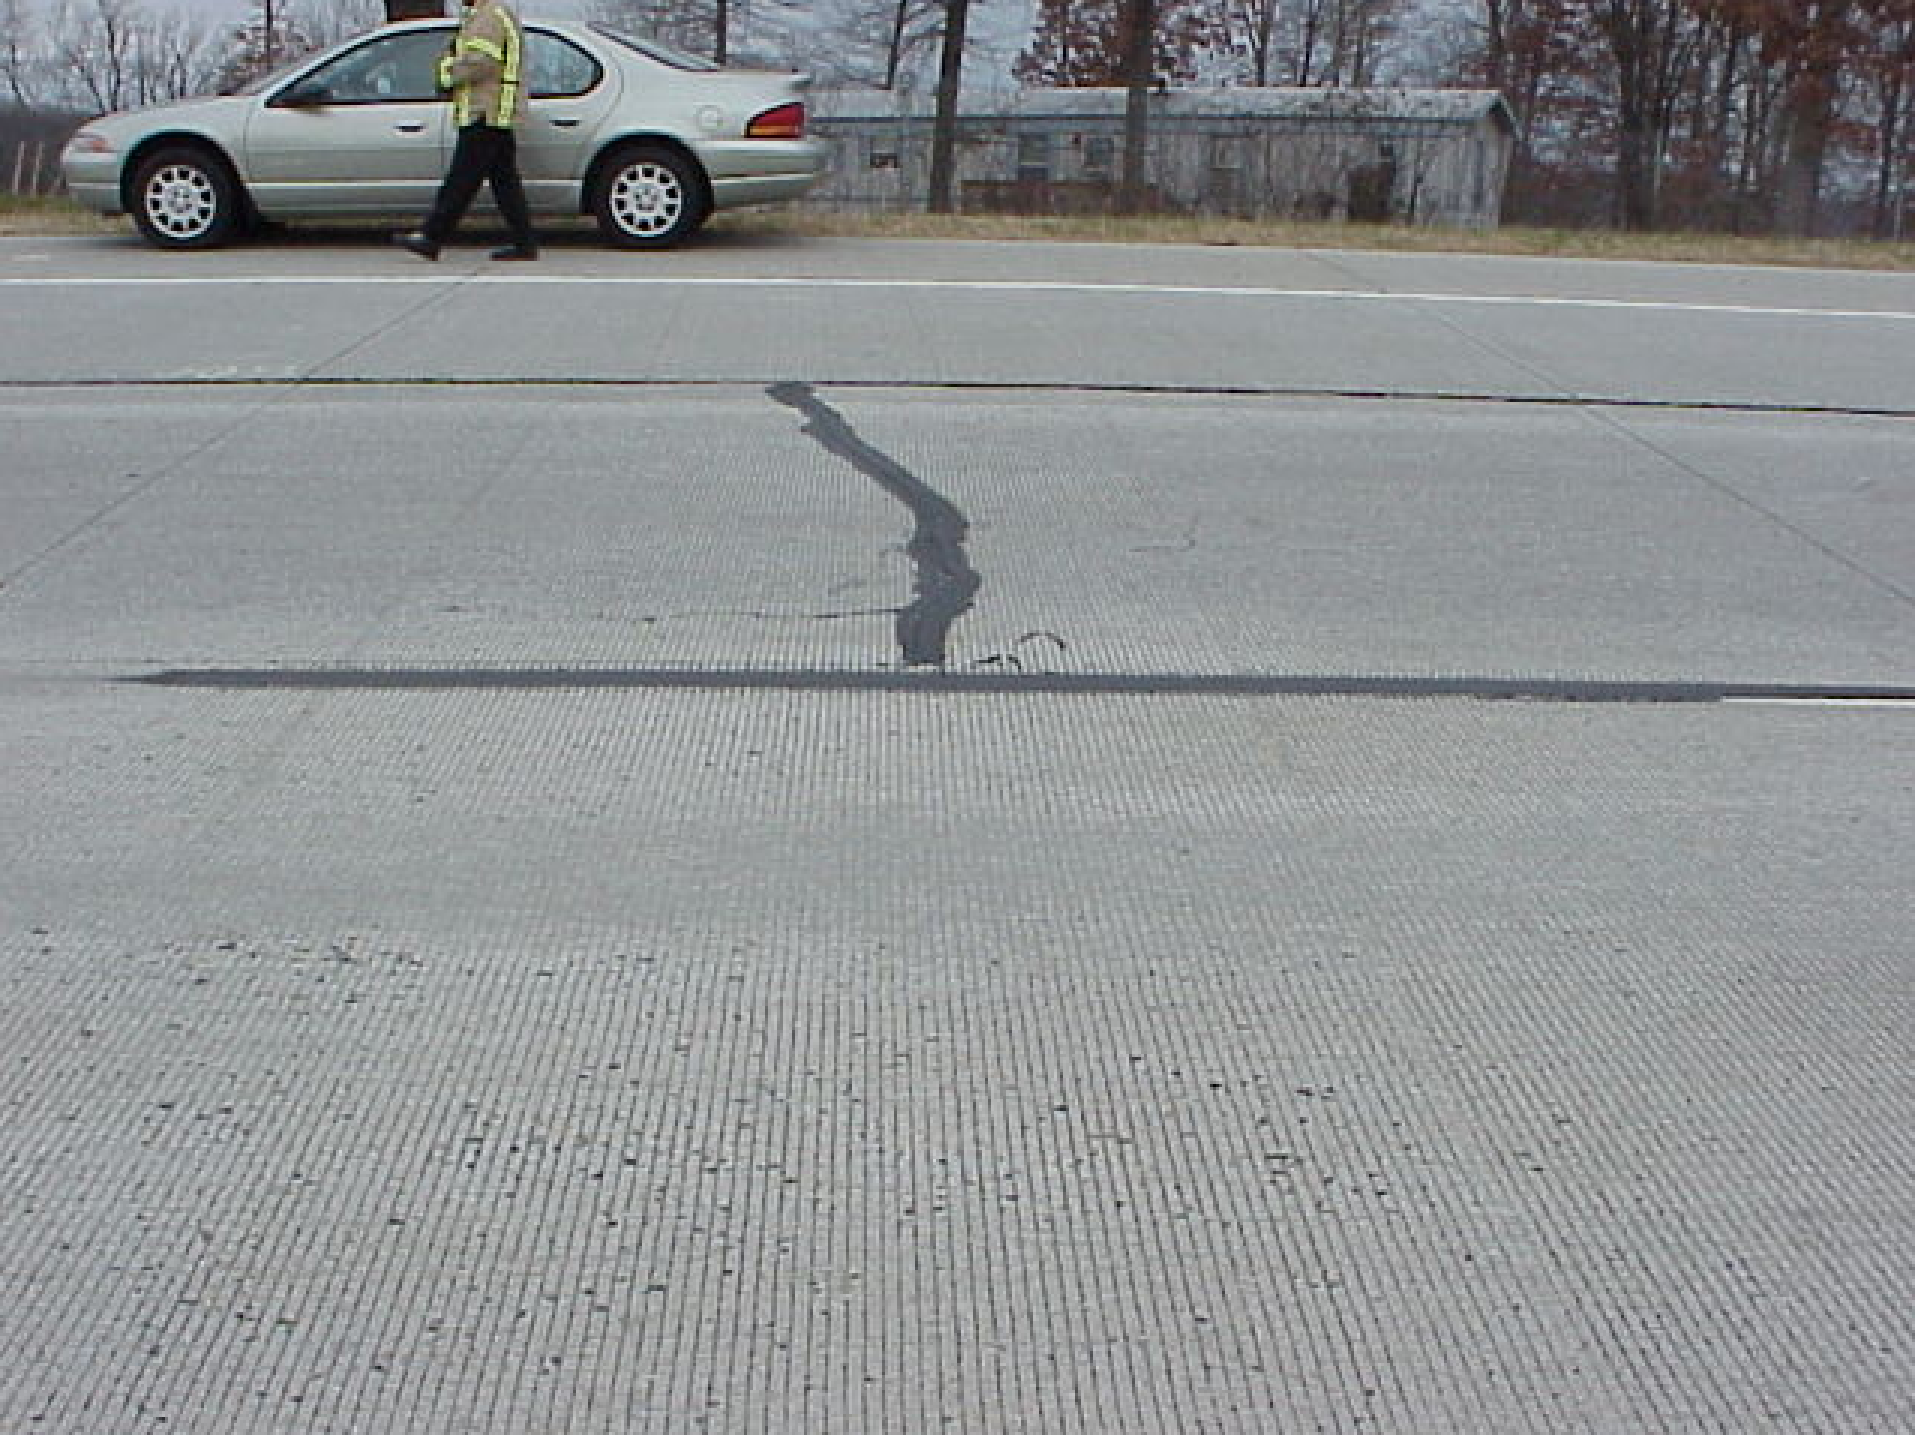
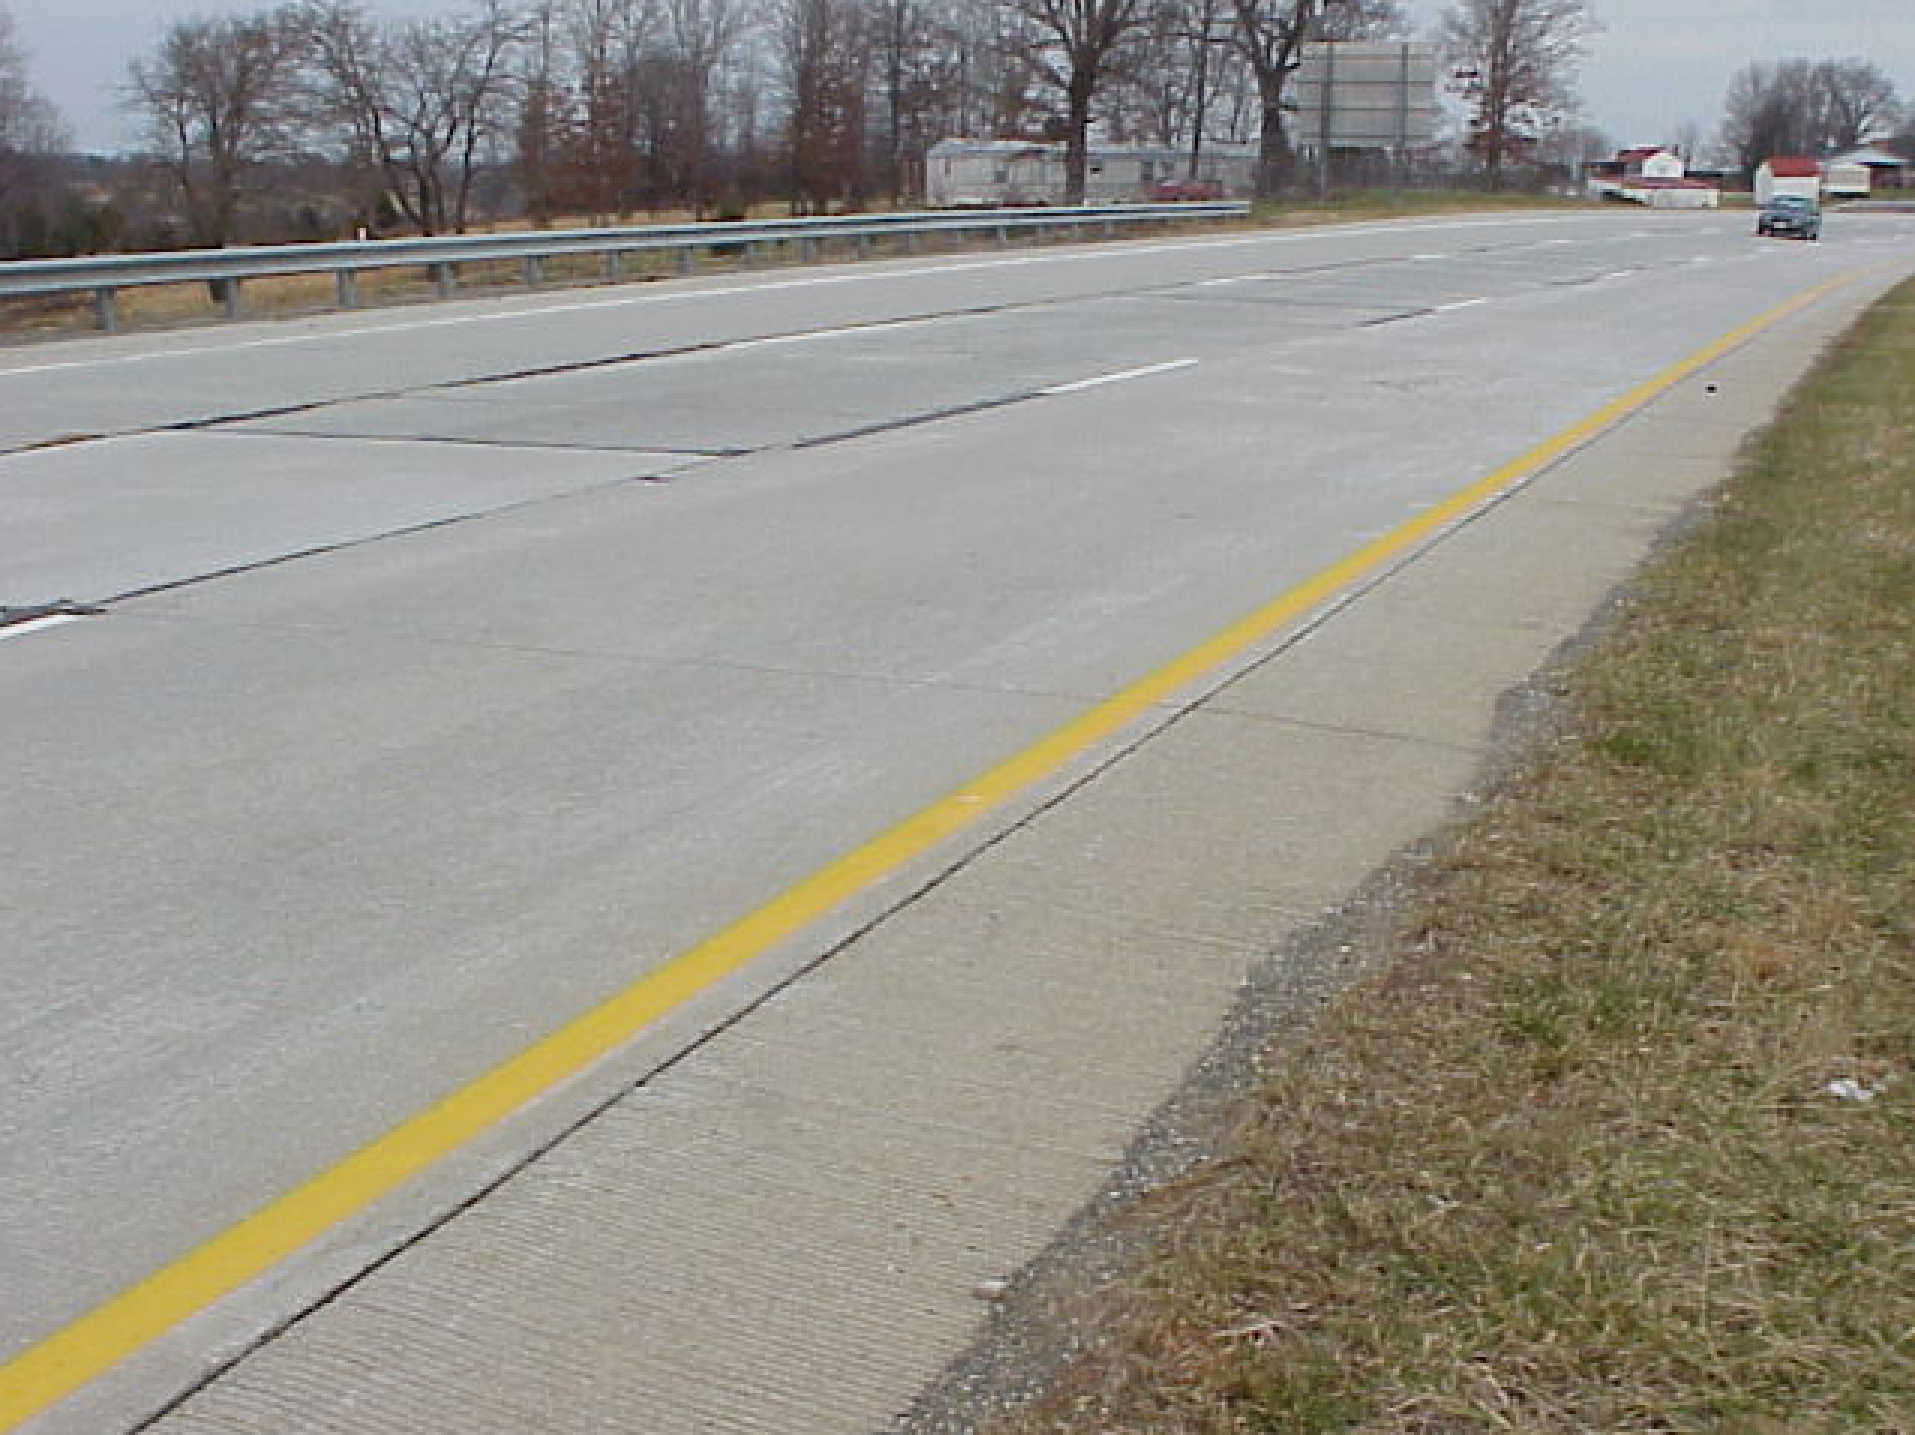
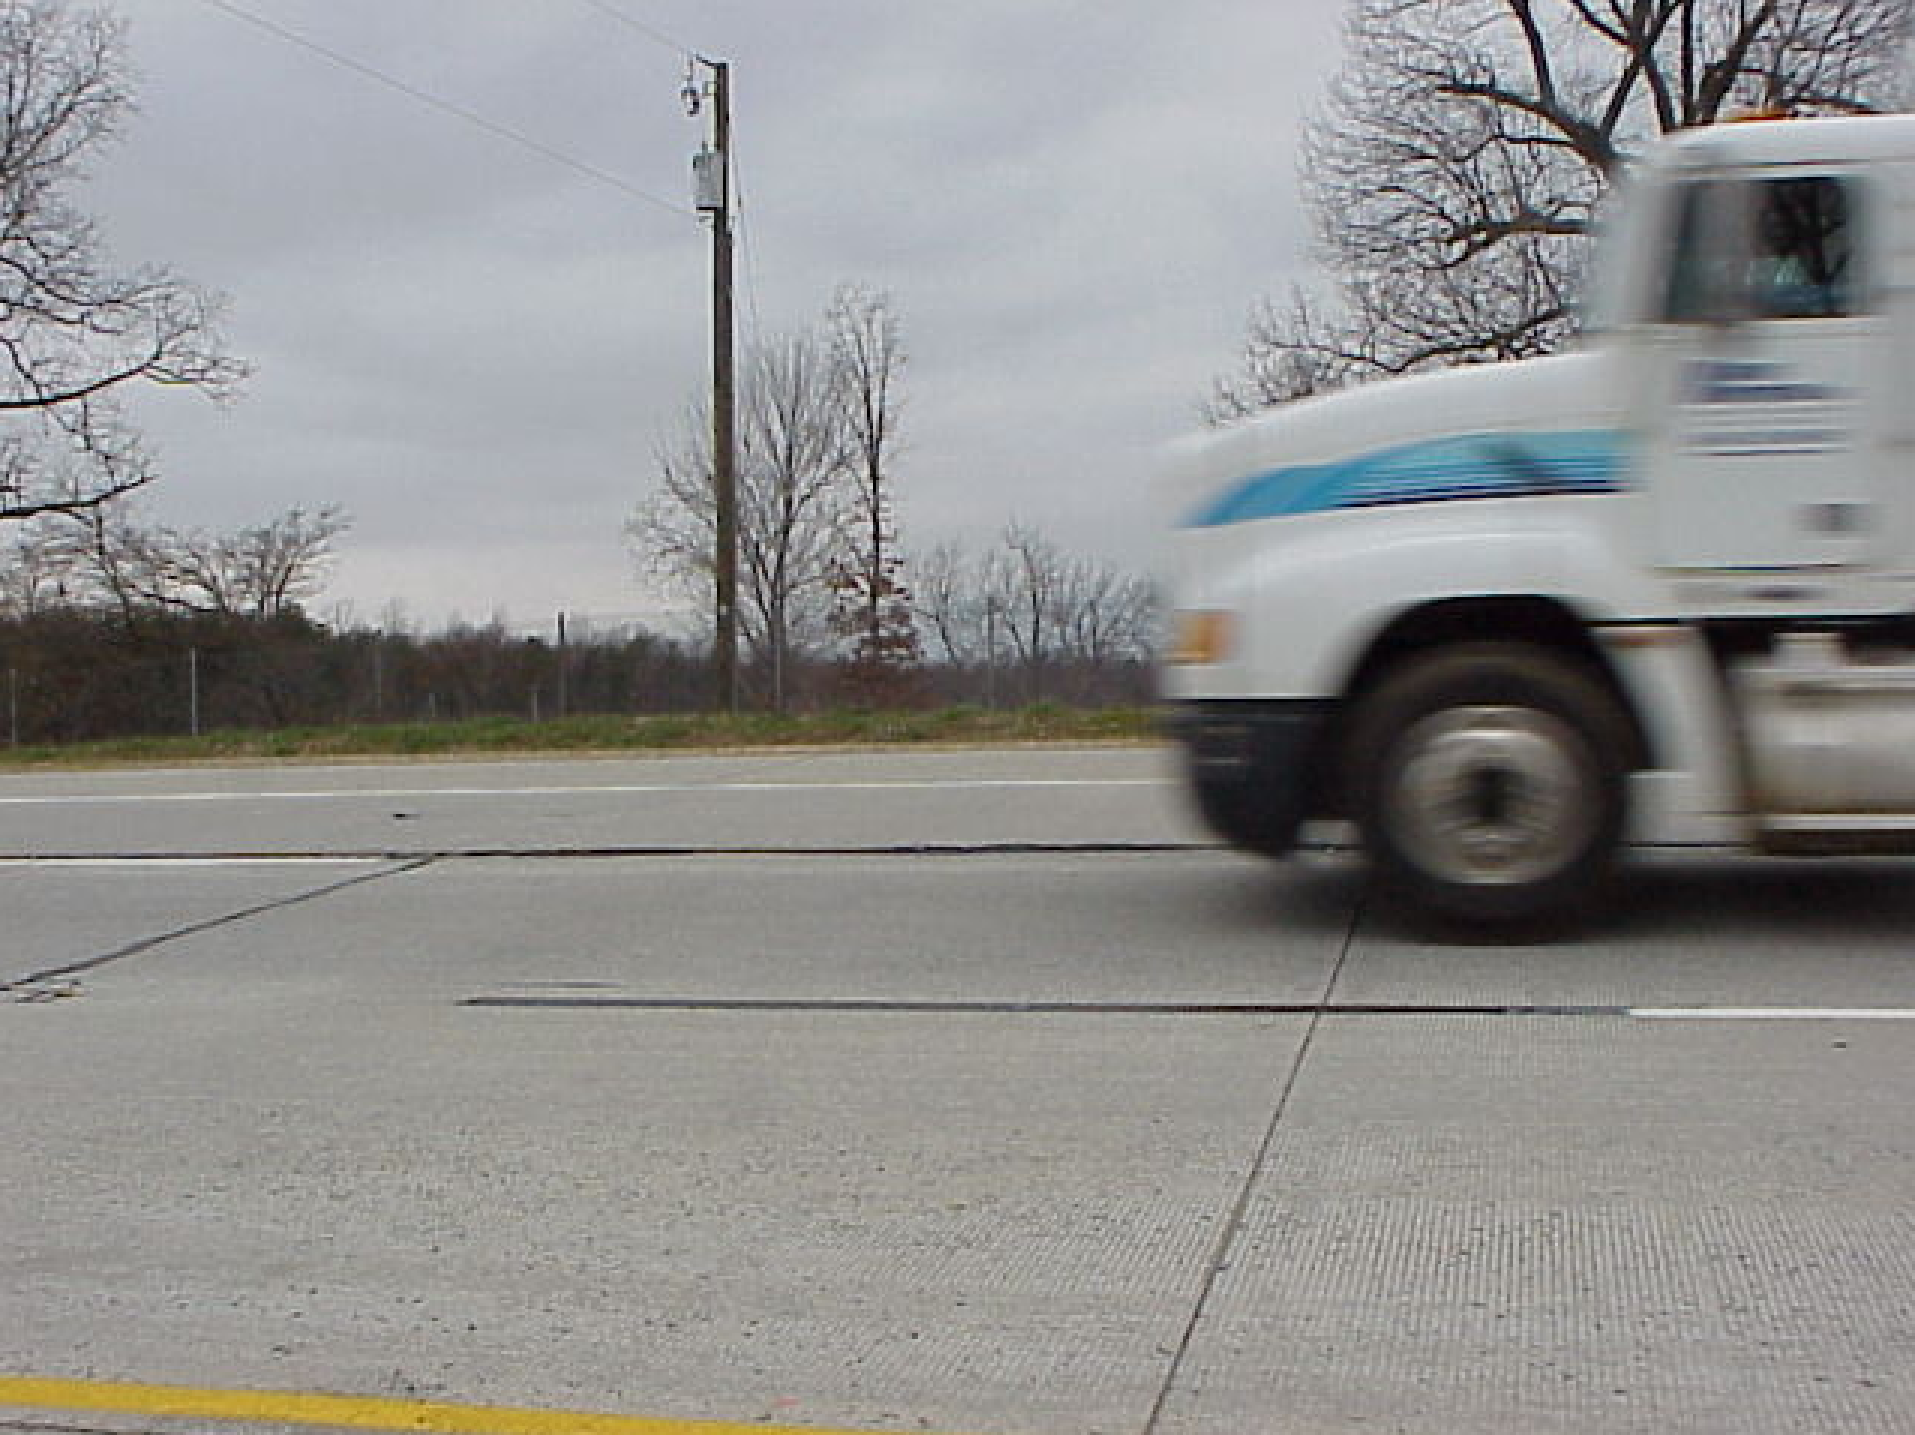
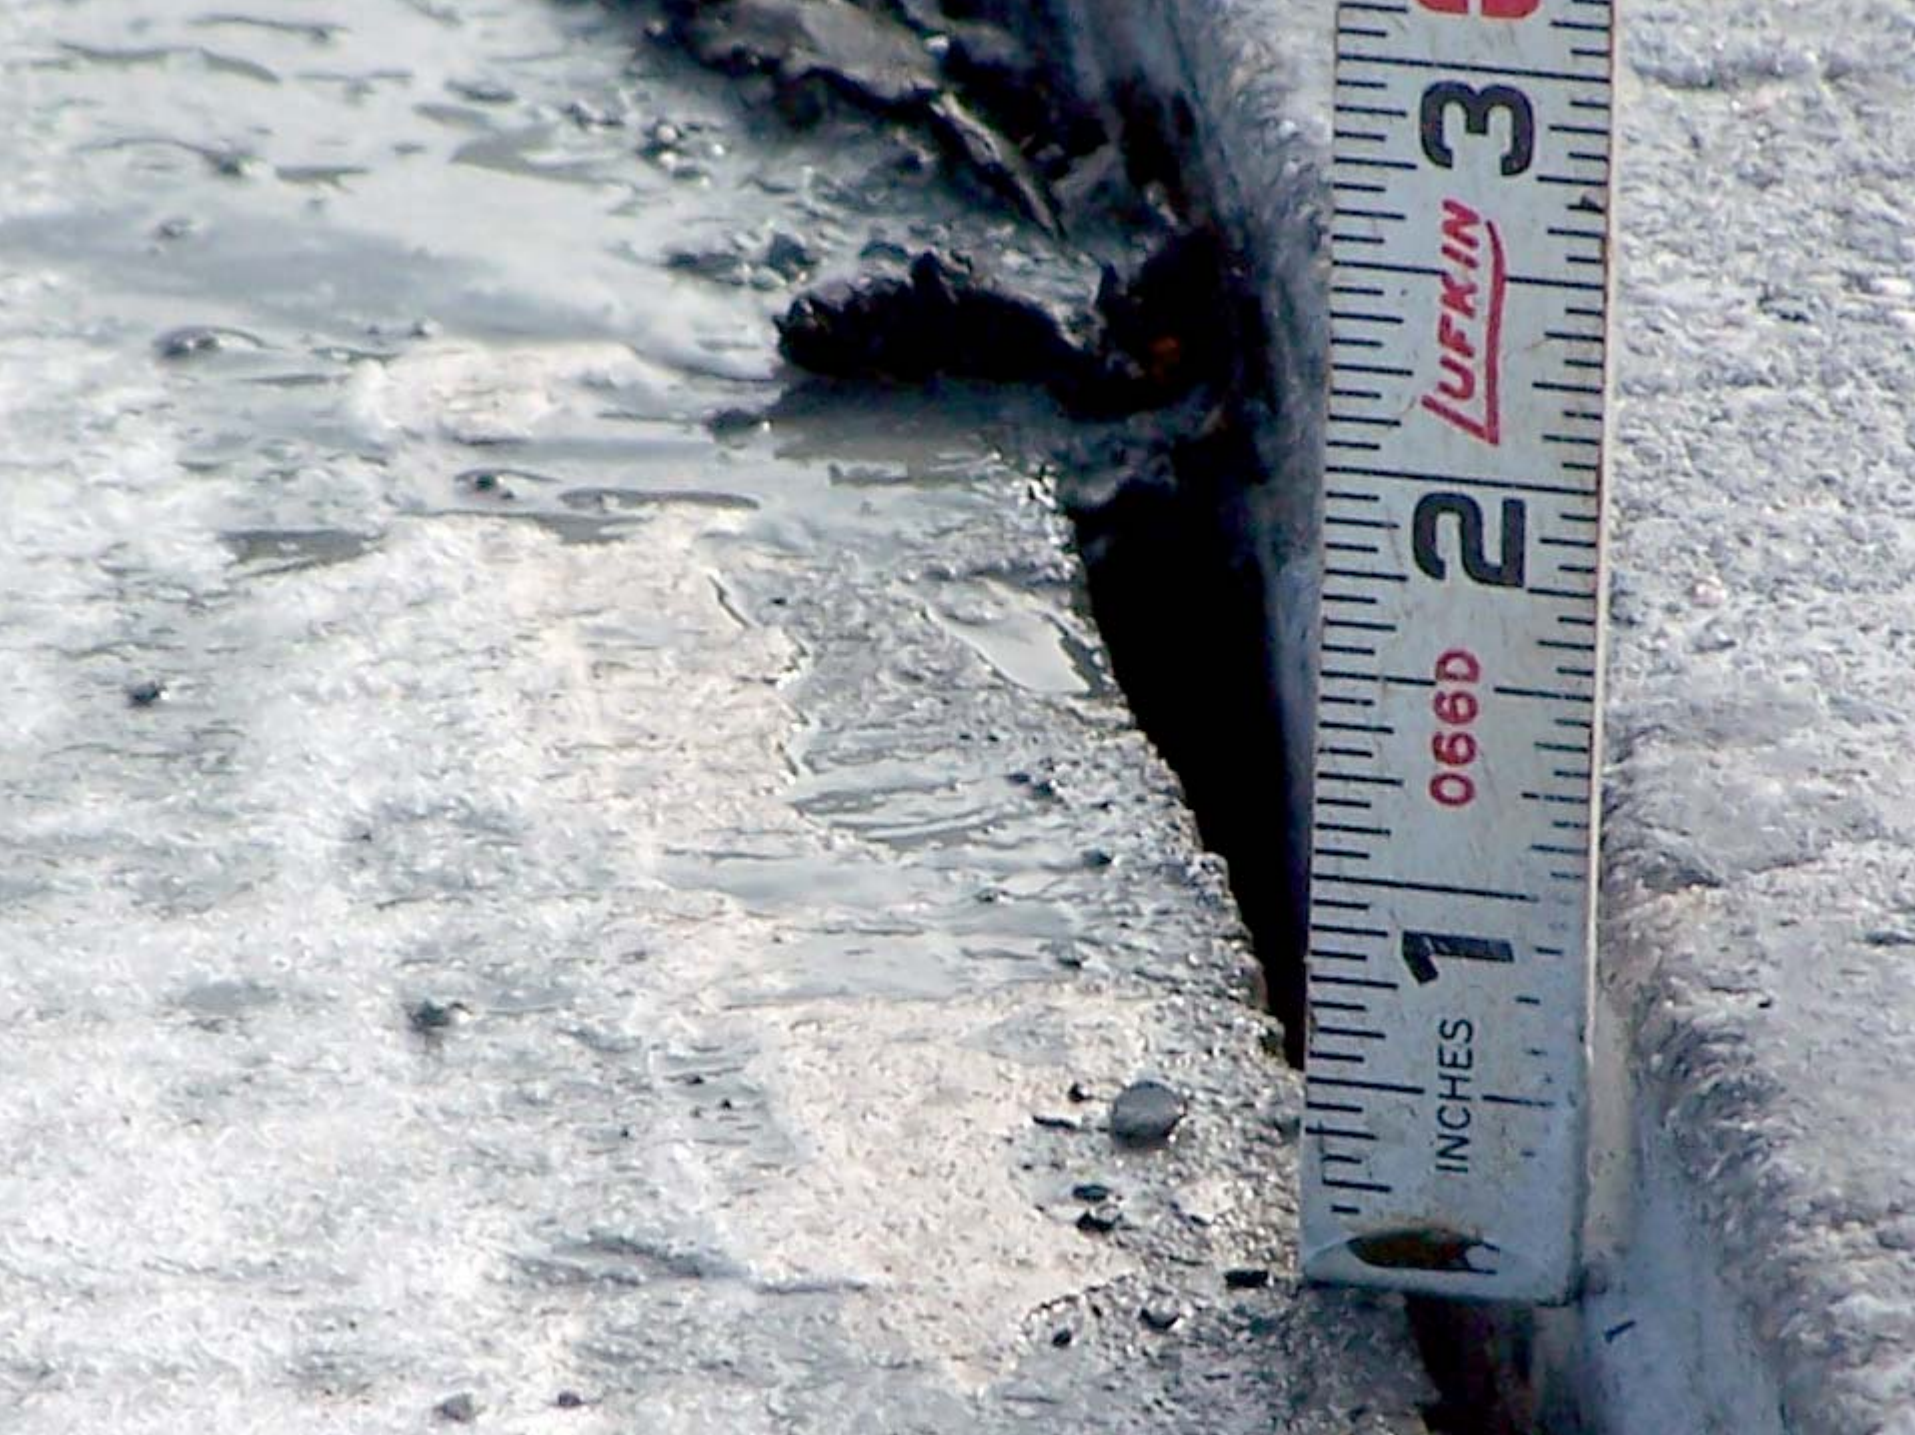
- Isolated areas of the 2.8-mile-long project showed signs of premature failure (since 1998), mainly mid-slab cracking, faulting, settlement, and spalling.

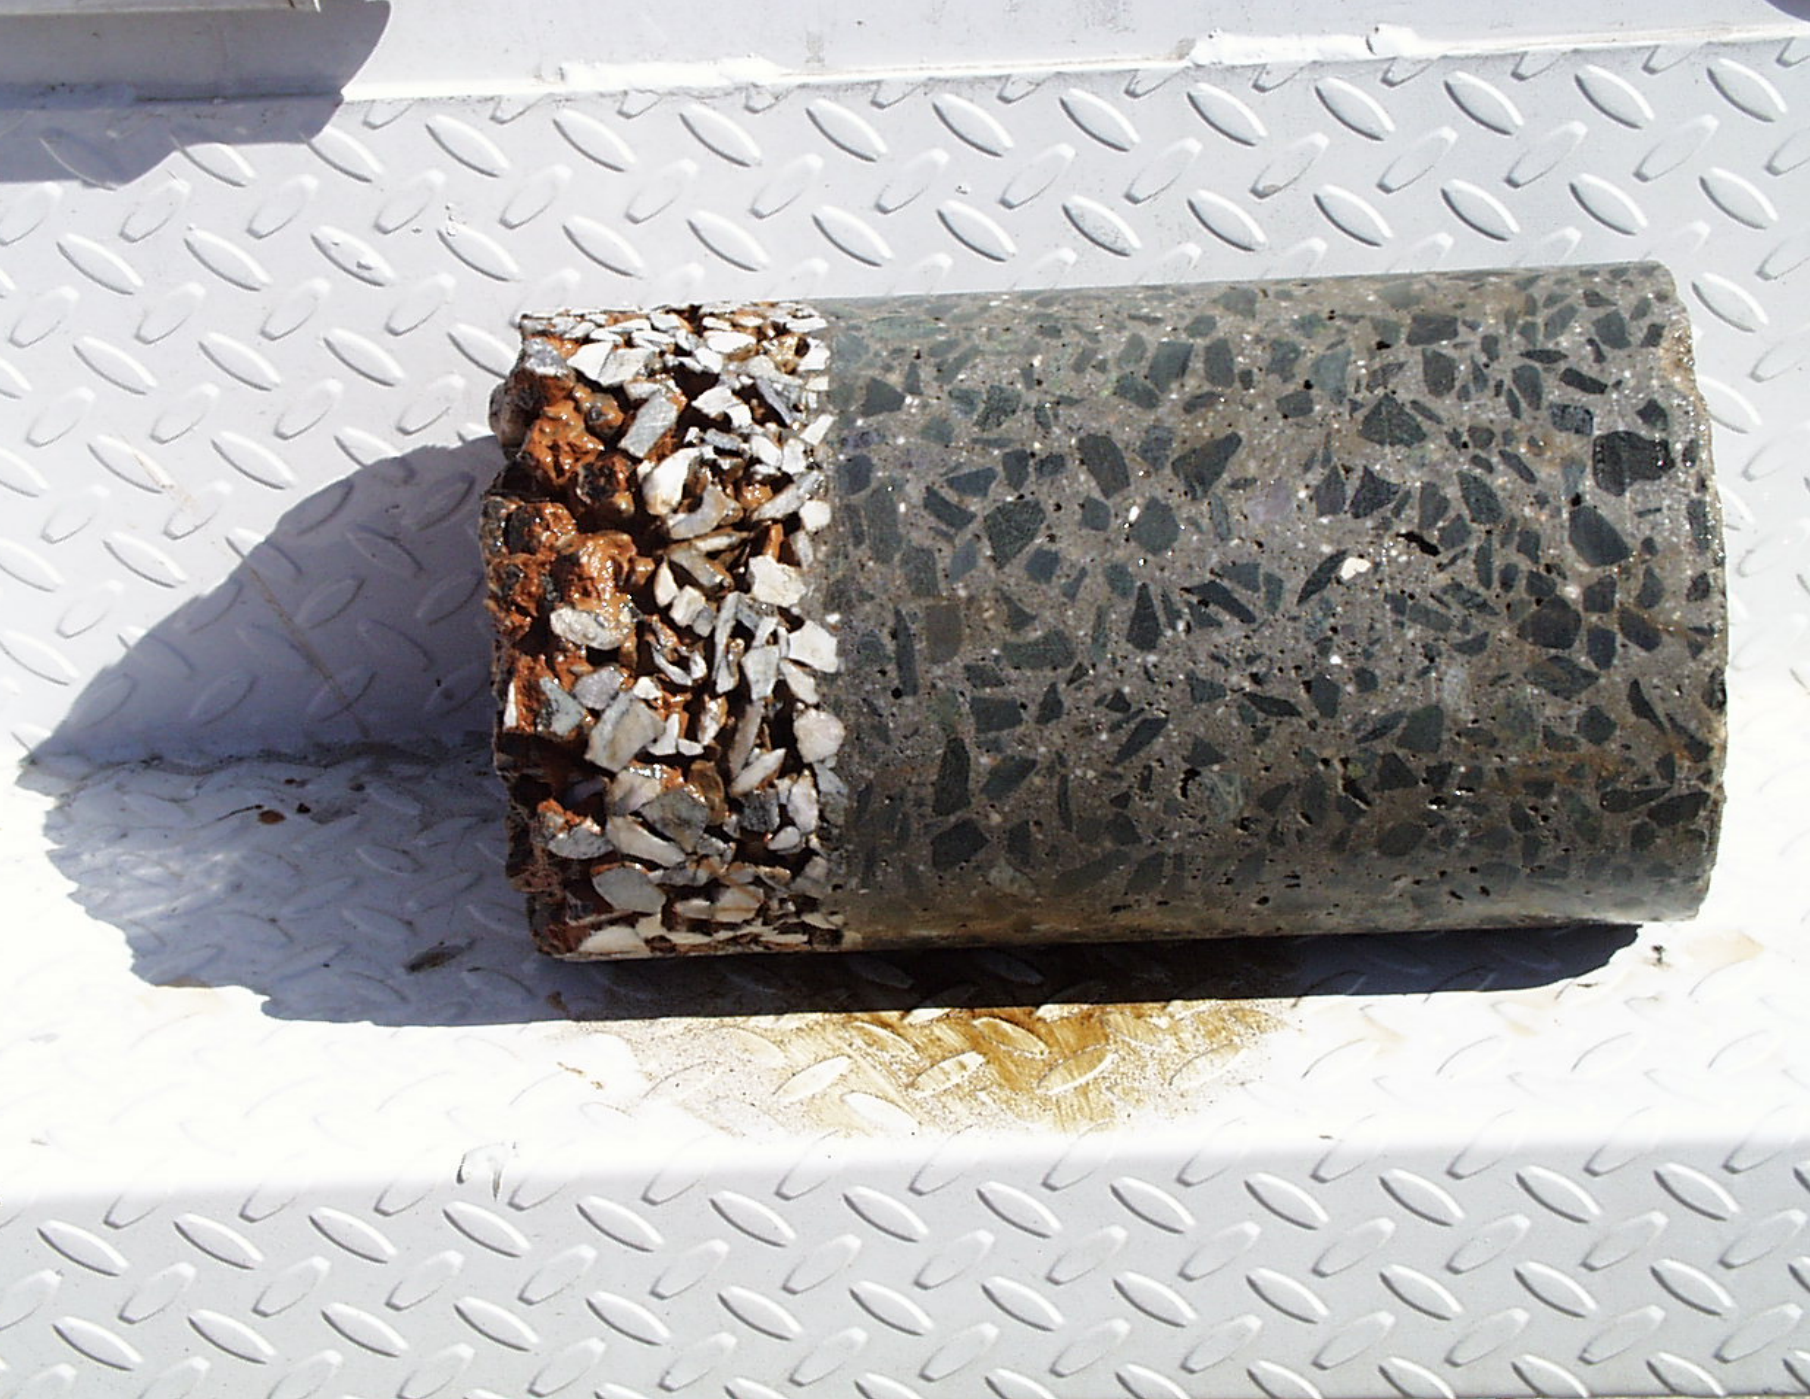
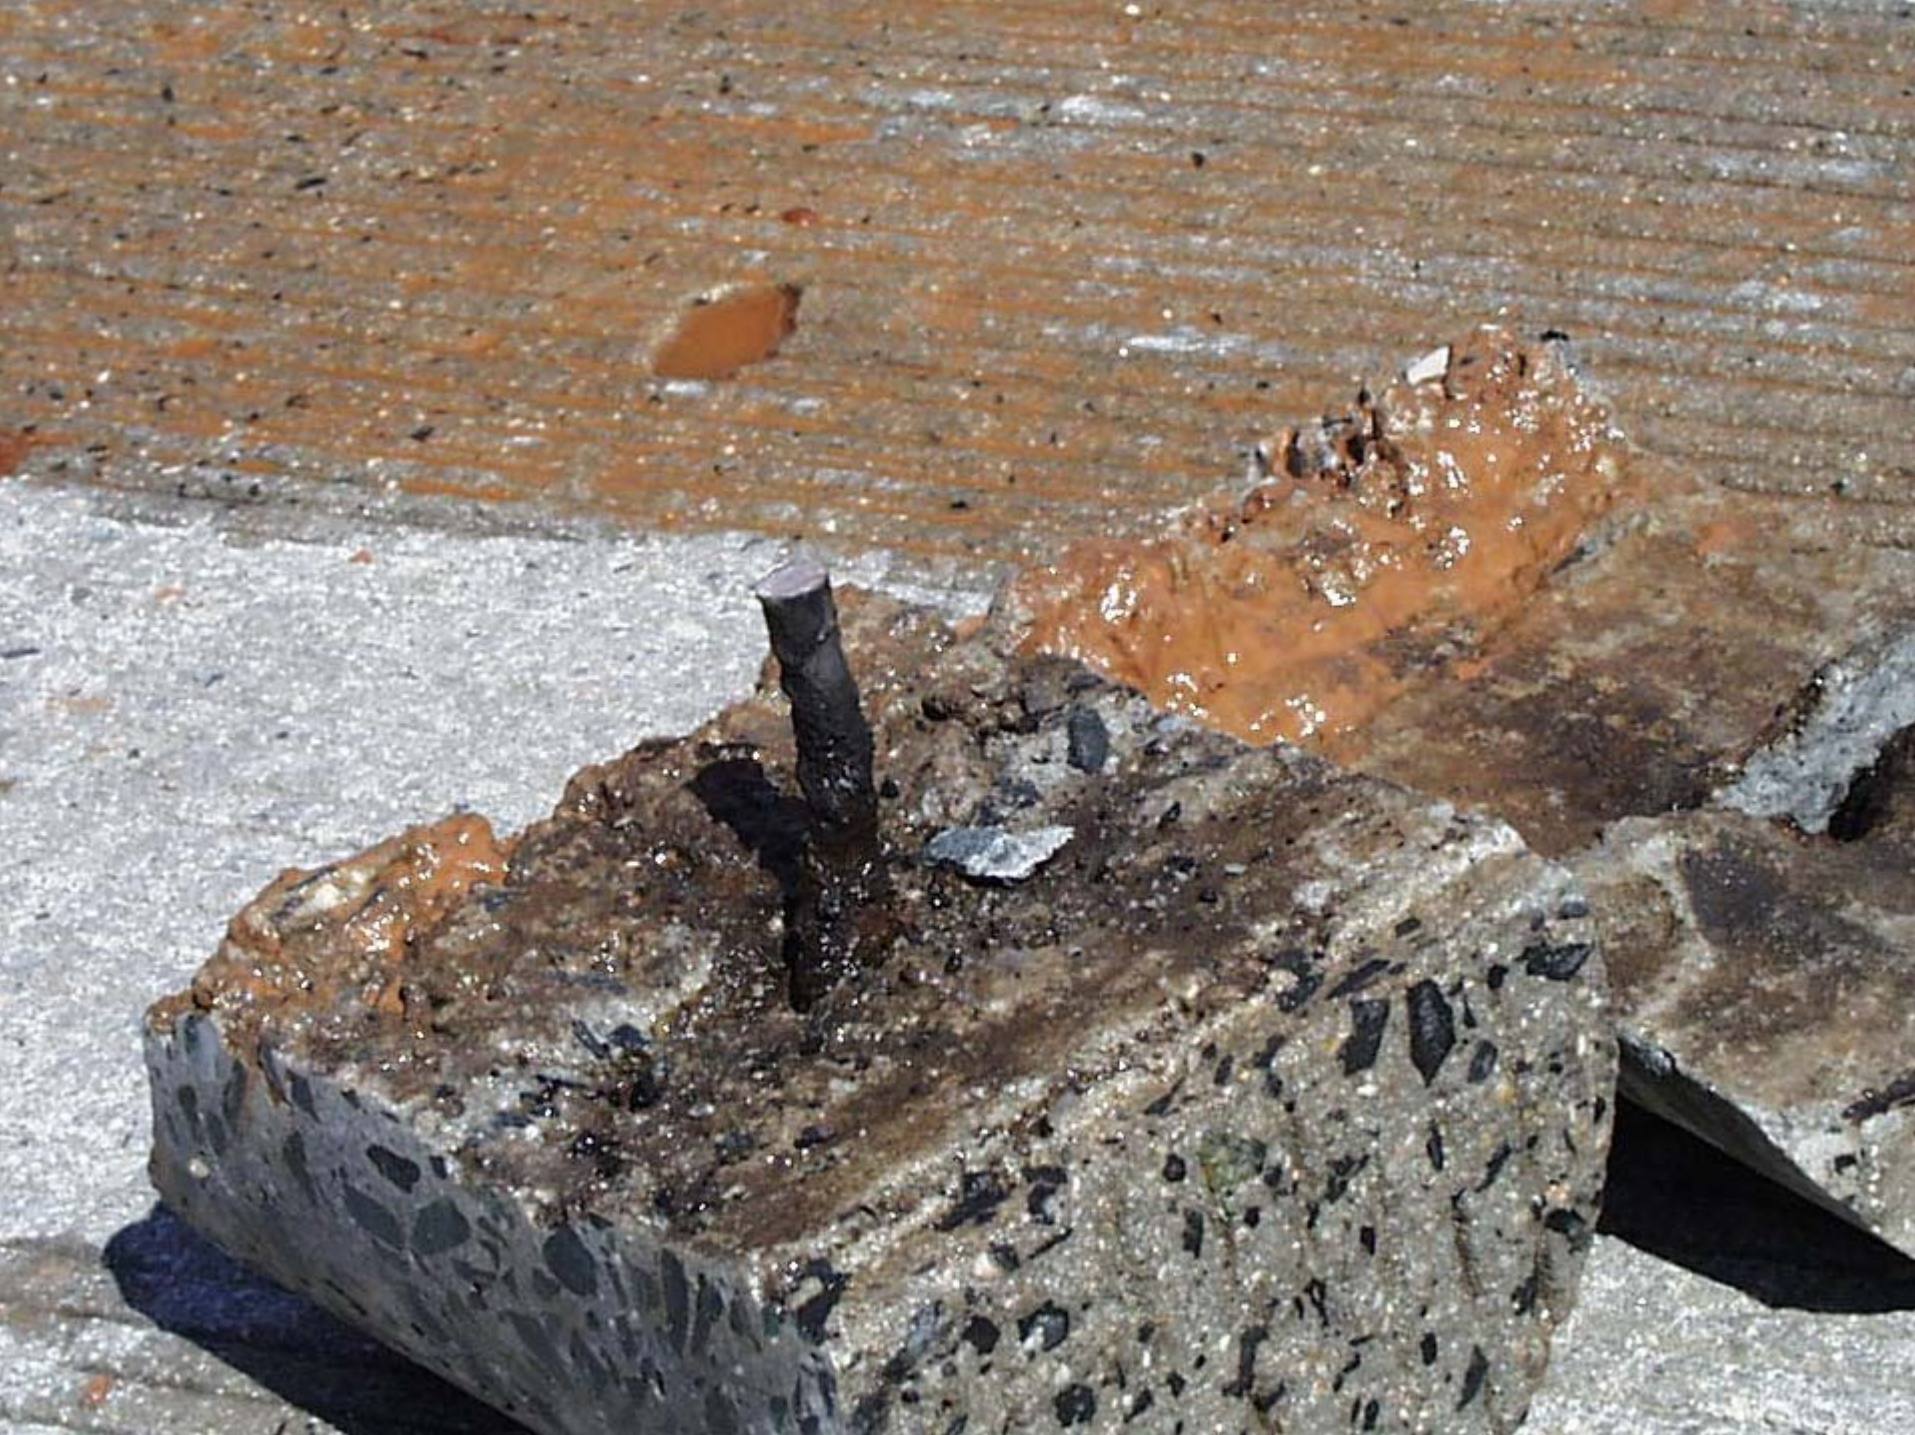
- Investigated Section – 0.25 mile
- Field Cores
  - Concrete Compressive Strength (6000 psi)
  - Drainage Layer
    - Clogged in distressed area
    - Clear in undamaged area
  - Soil Cement (700 psi)
  - Subgrade – A-4 and A-5 with a soaked CBR 3.0%

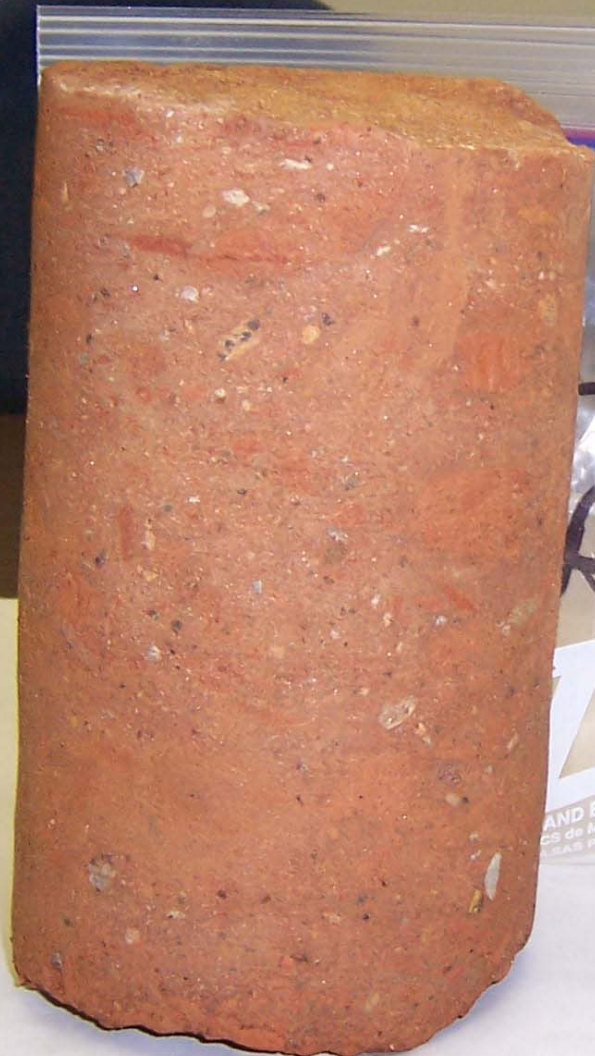
Hole #2  
Approximate Exposure  
Ziploc®  
Soil Cement

Partially Eroded Soil  
Cement Core

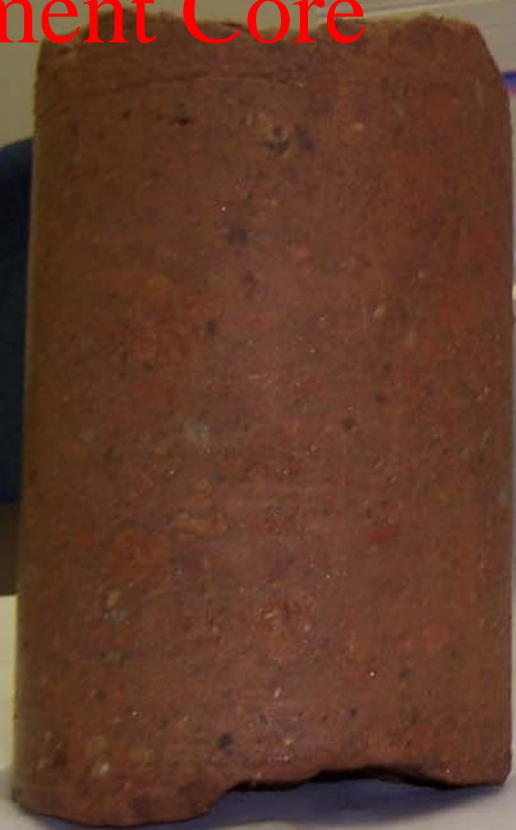
APP. BY-PASS  
E.B.L. TRAVEL  
LANE  
Hole #3
