# 2006 Southeastern States Pavement Management And Design Conference

# Jointed Plain Concrete Pavement, Case study

Mohamed Elfino, PhD, PE  
VDOT/ Materials Division

Shabbir Hossain, PhD, PE  
Virginia Transportation Research Council

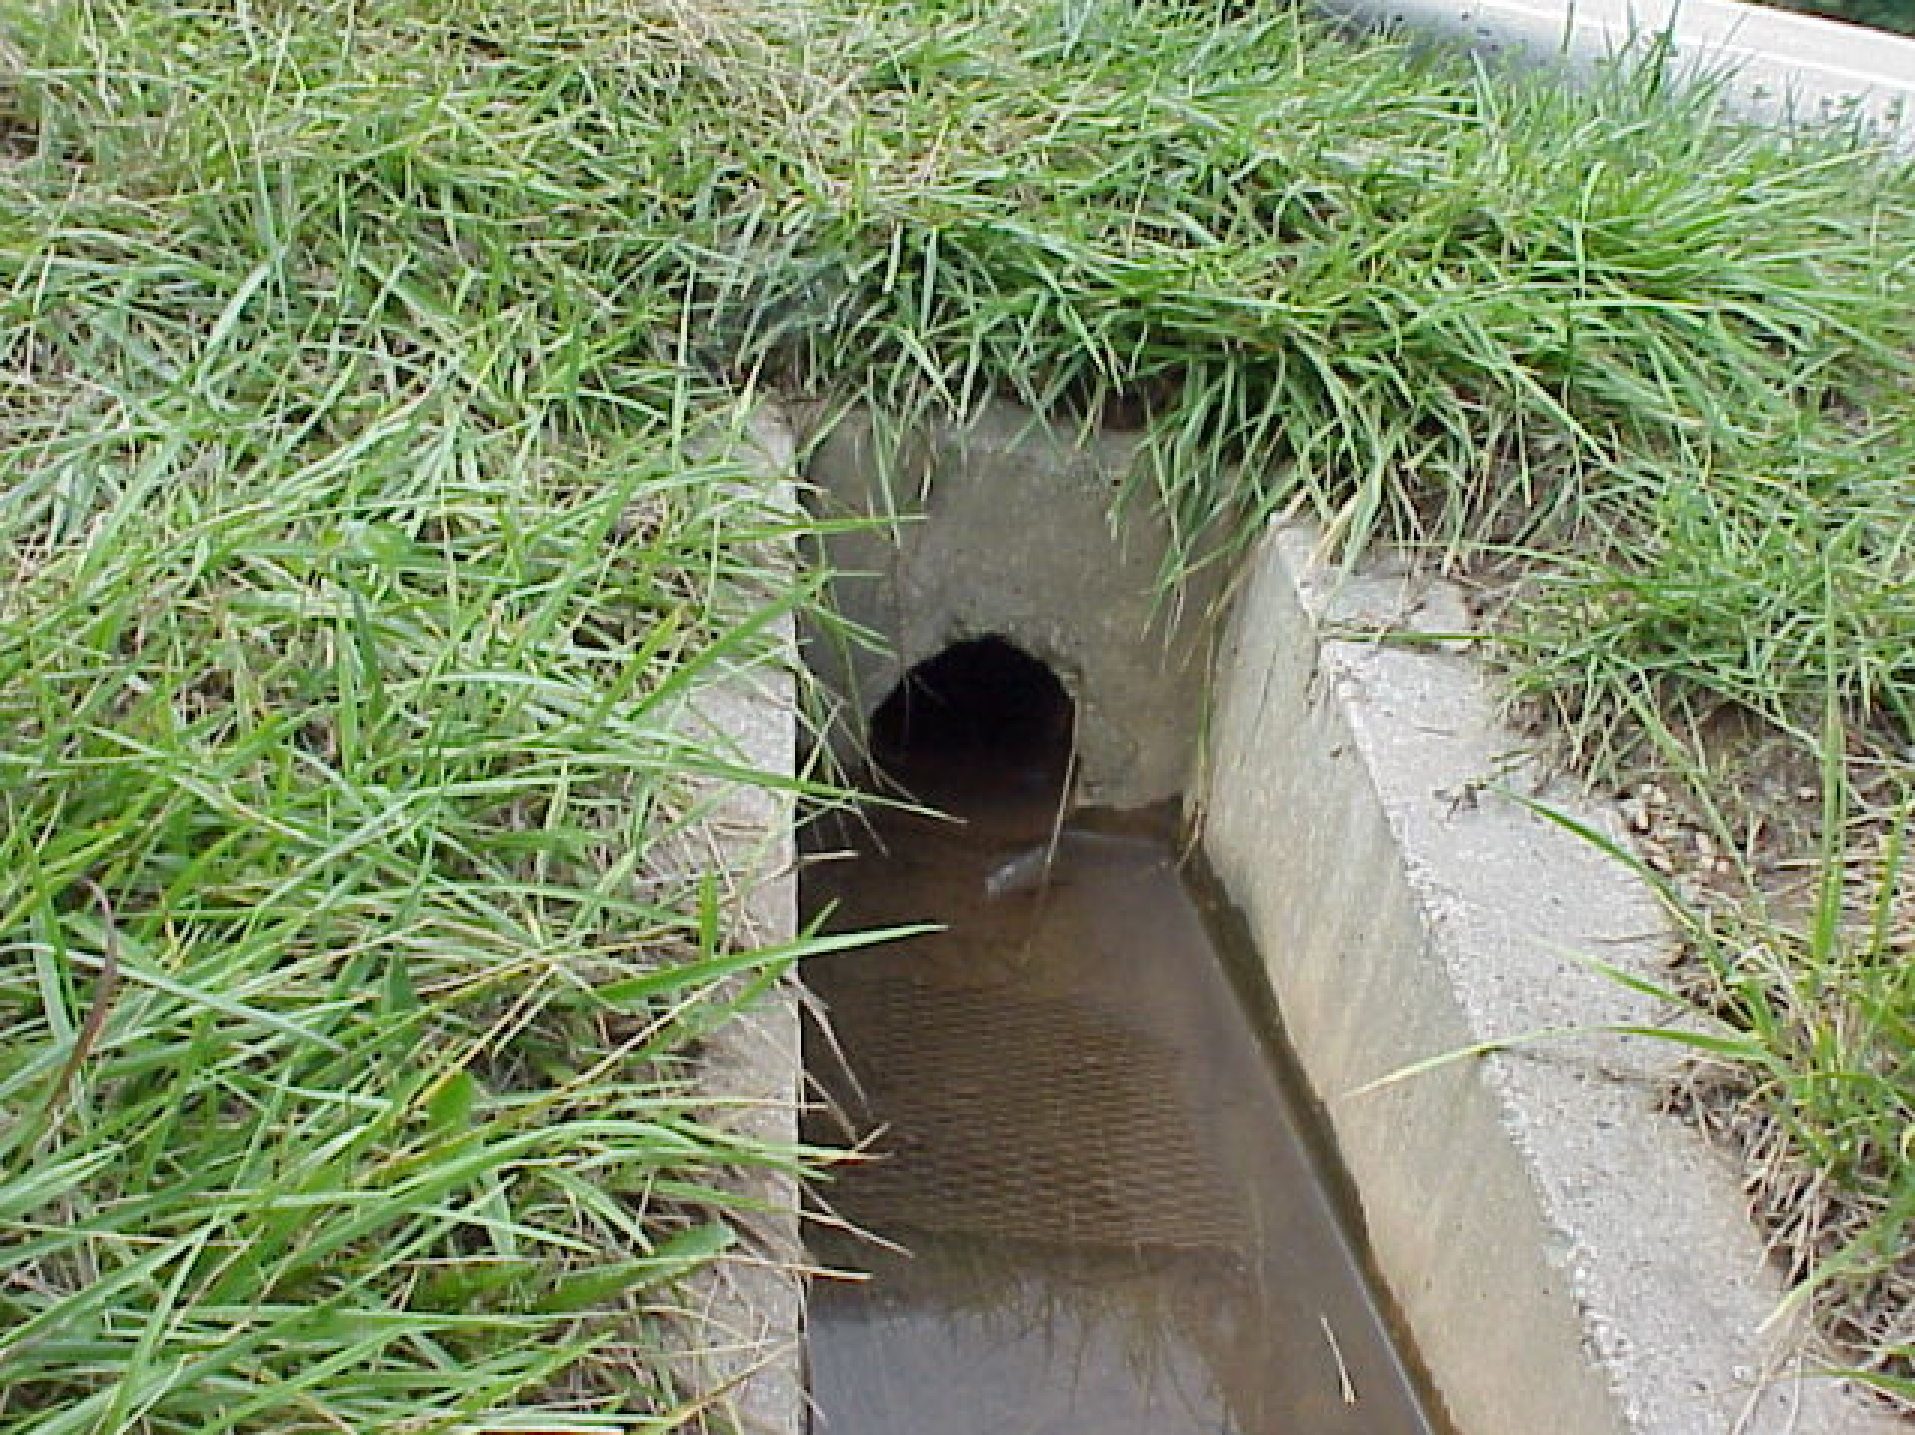
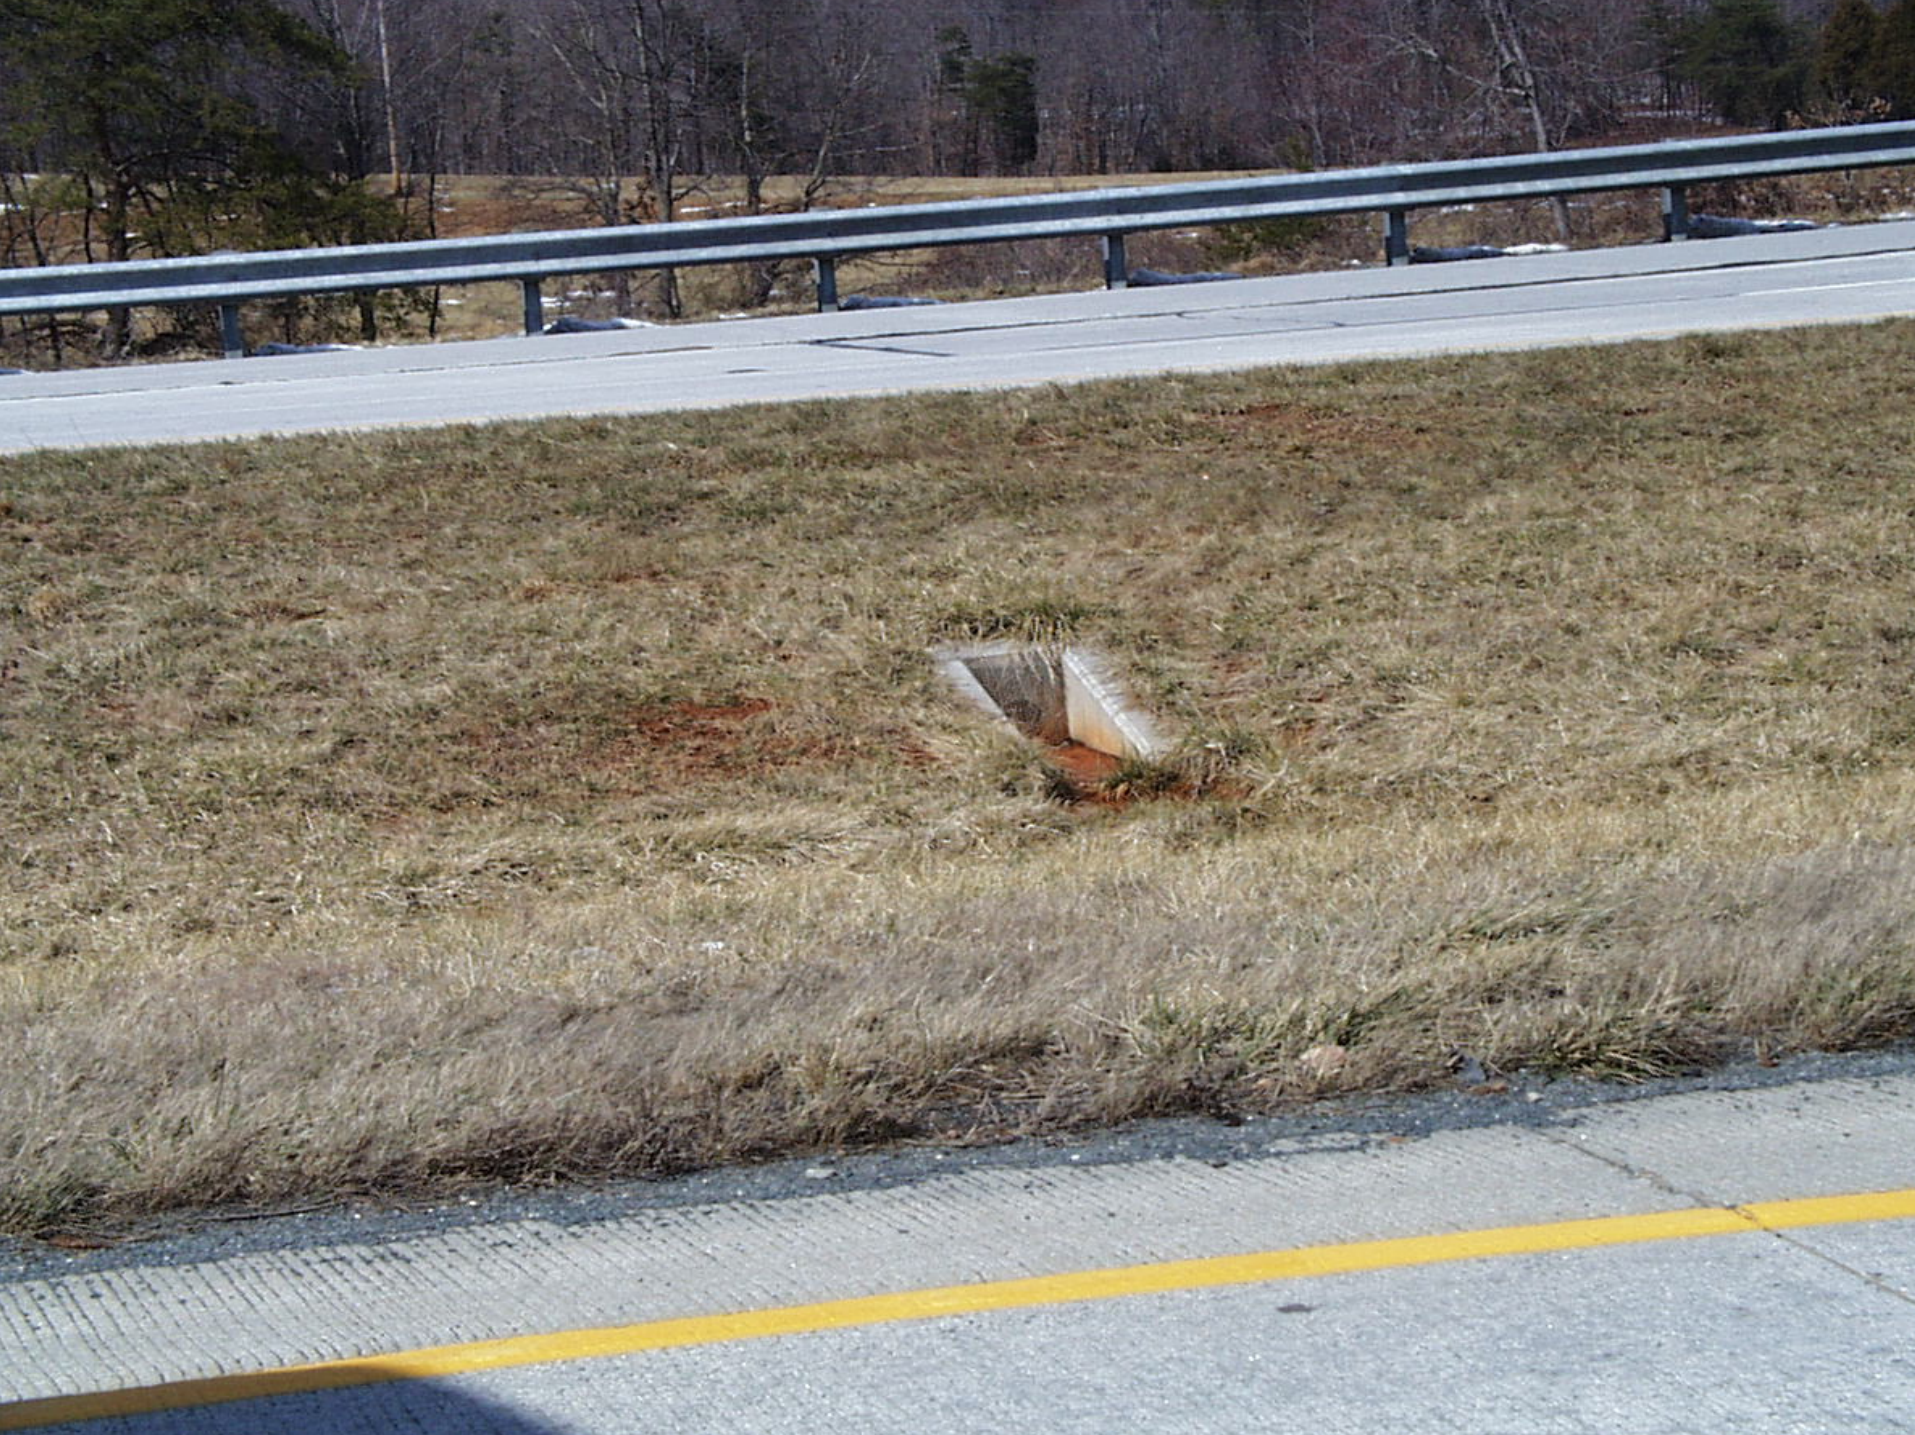
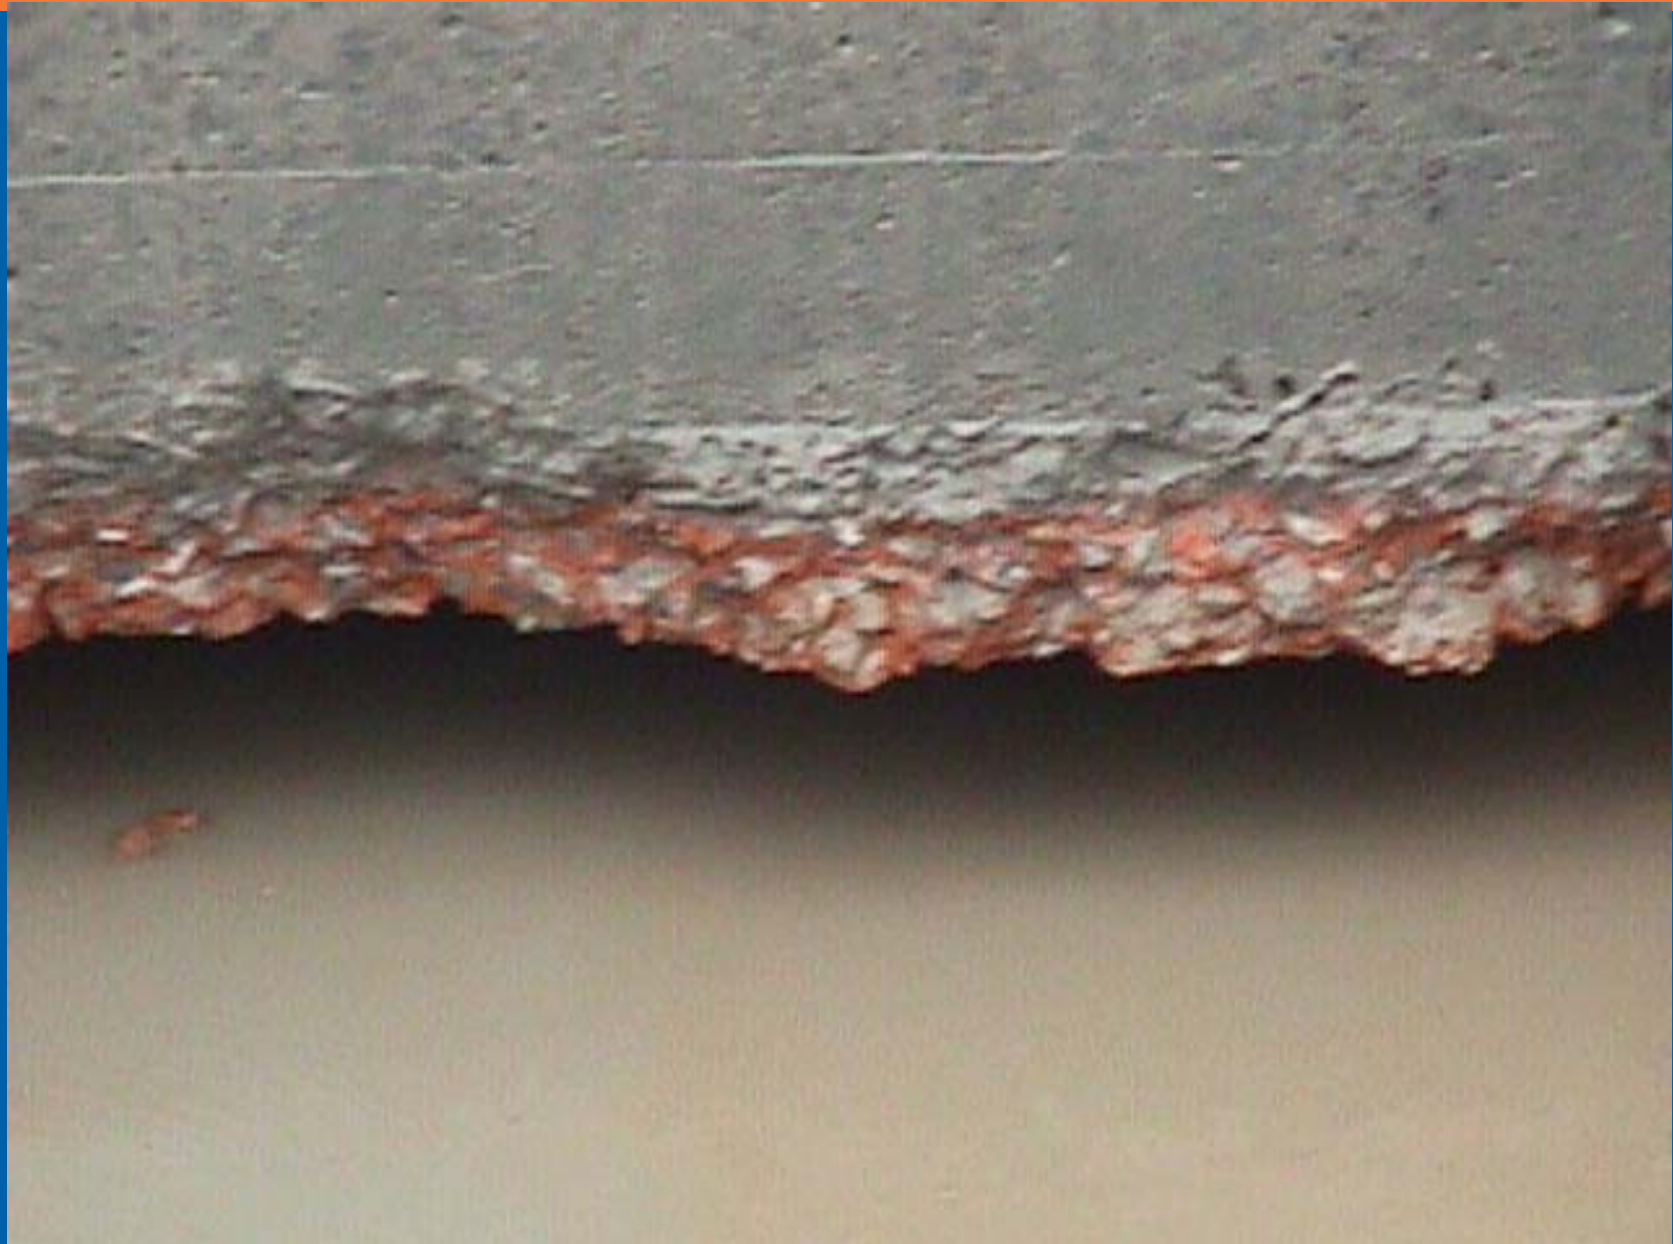
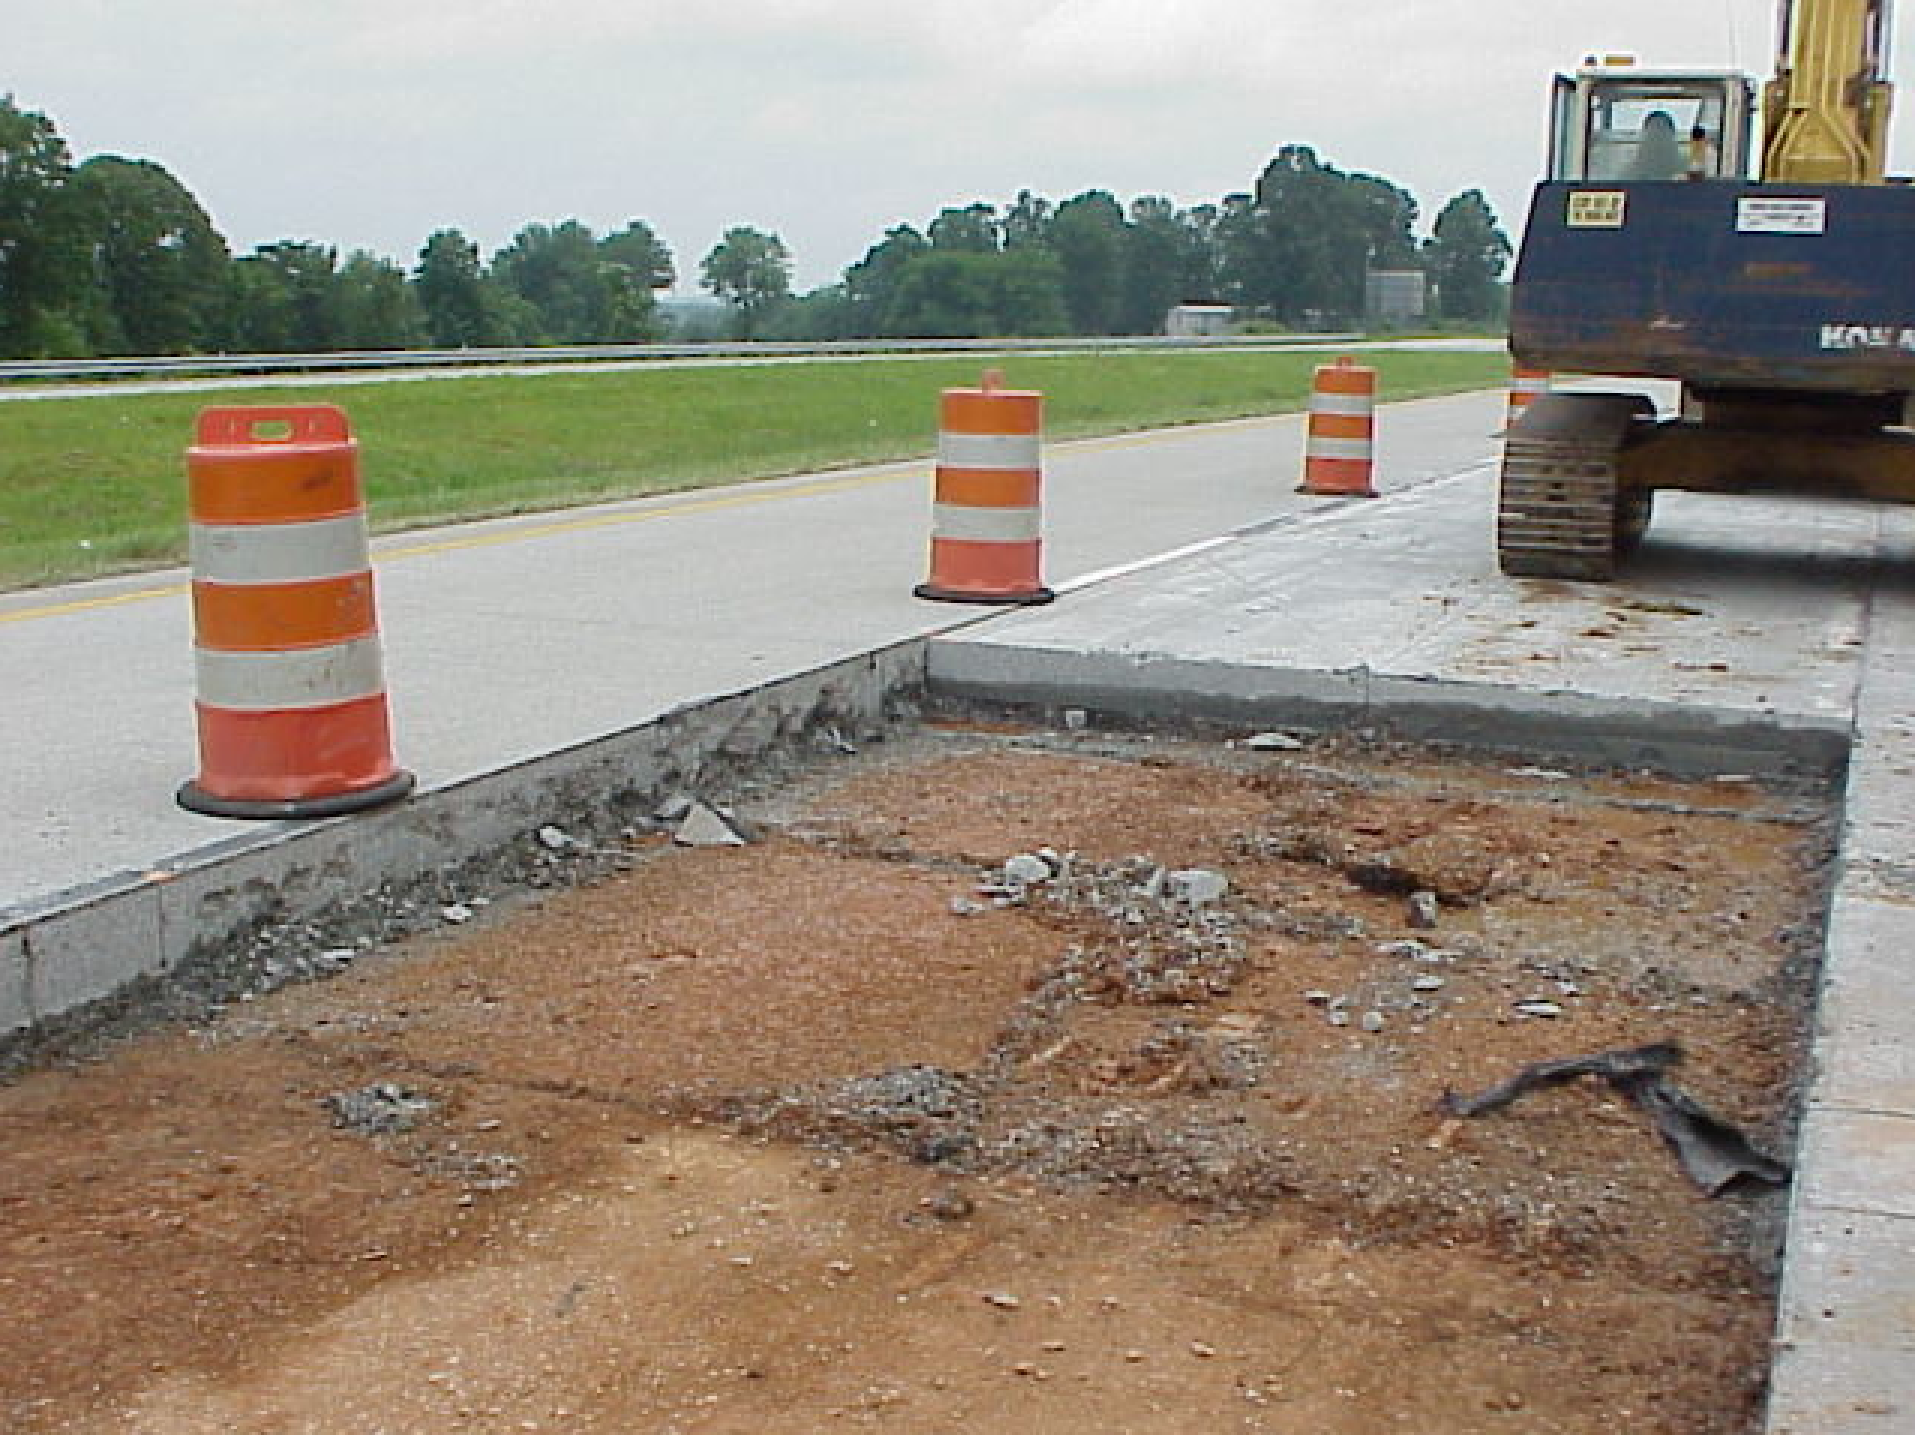
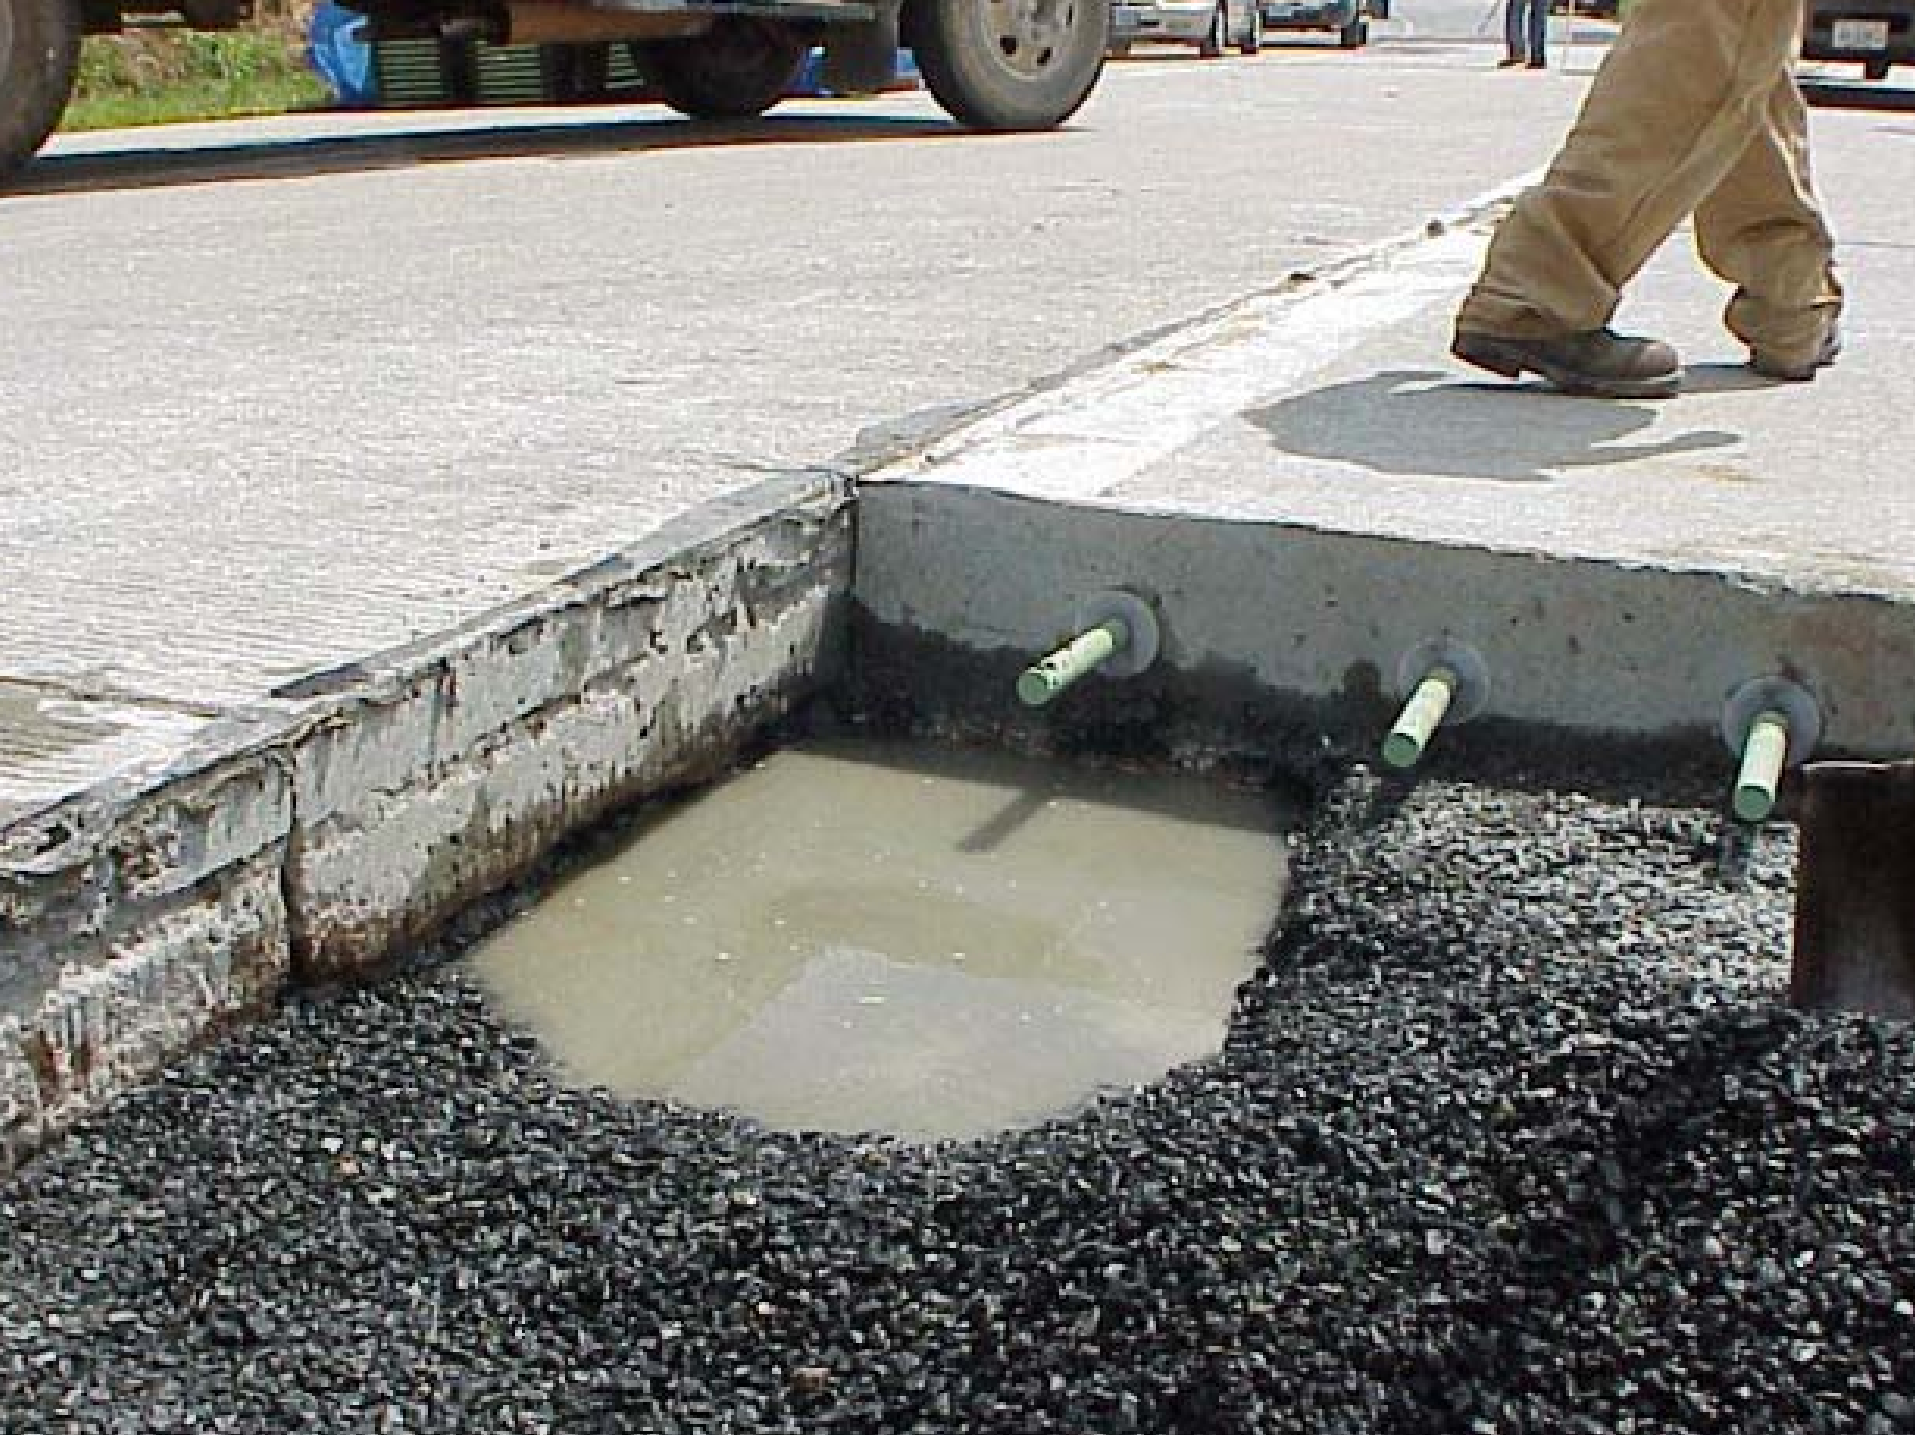
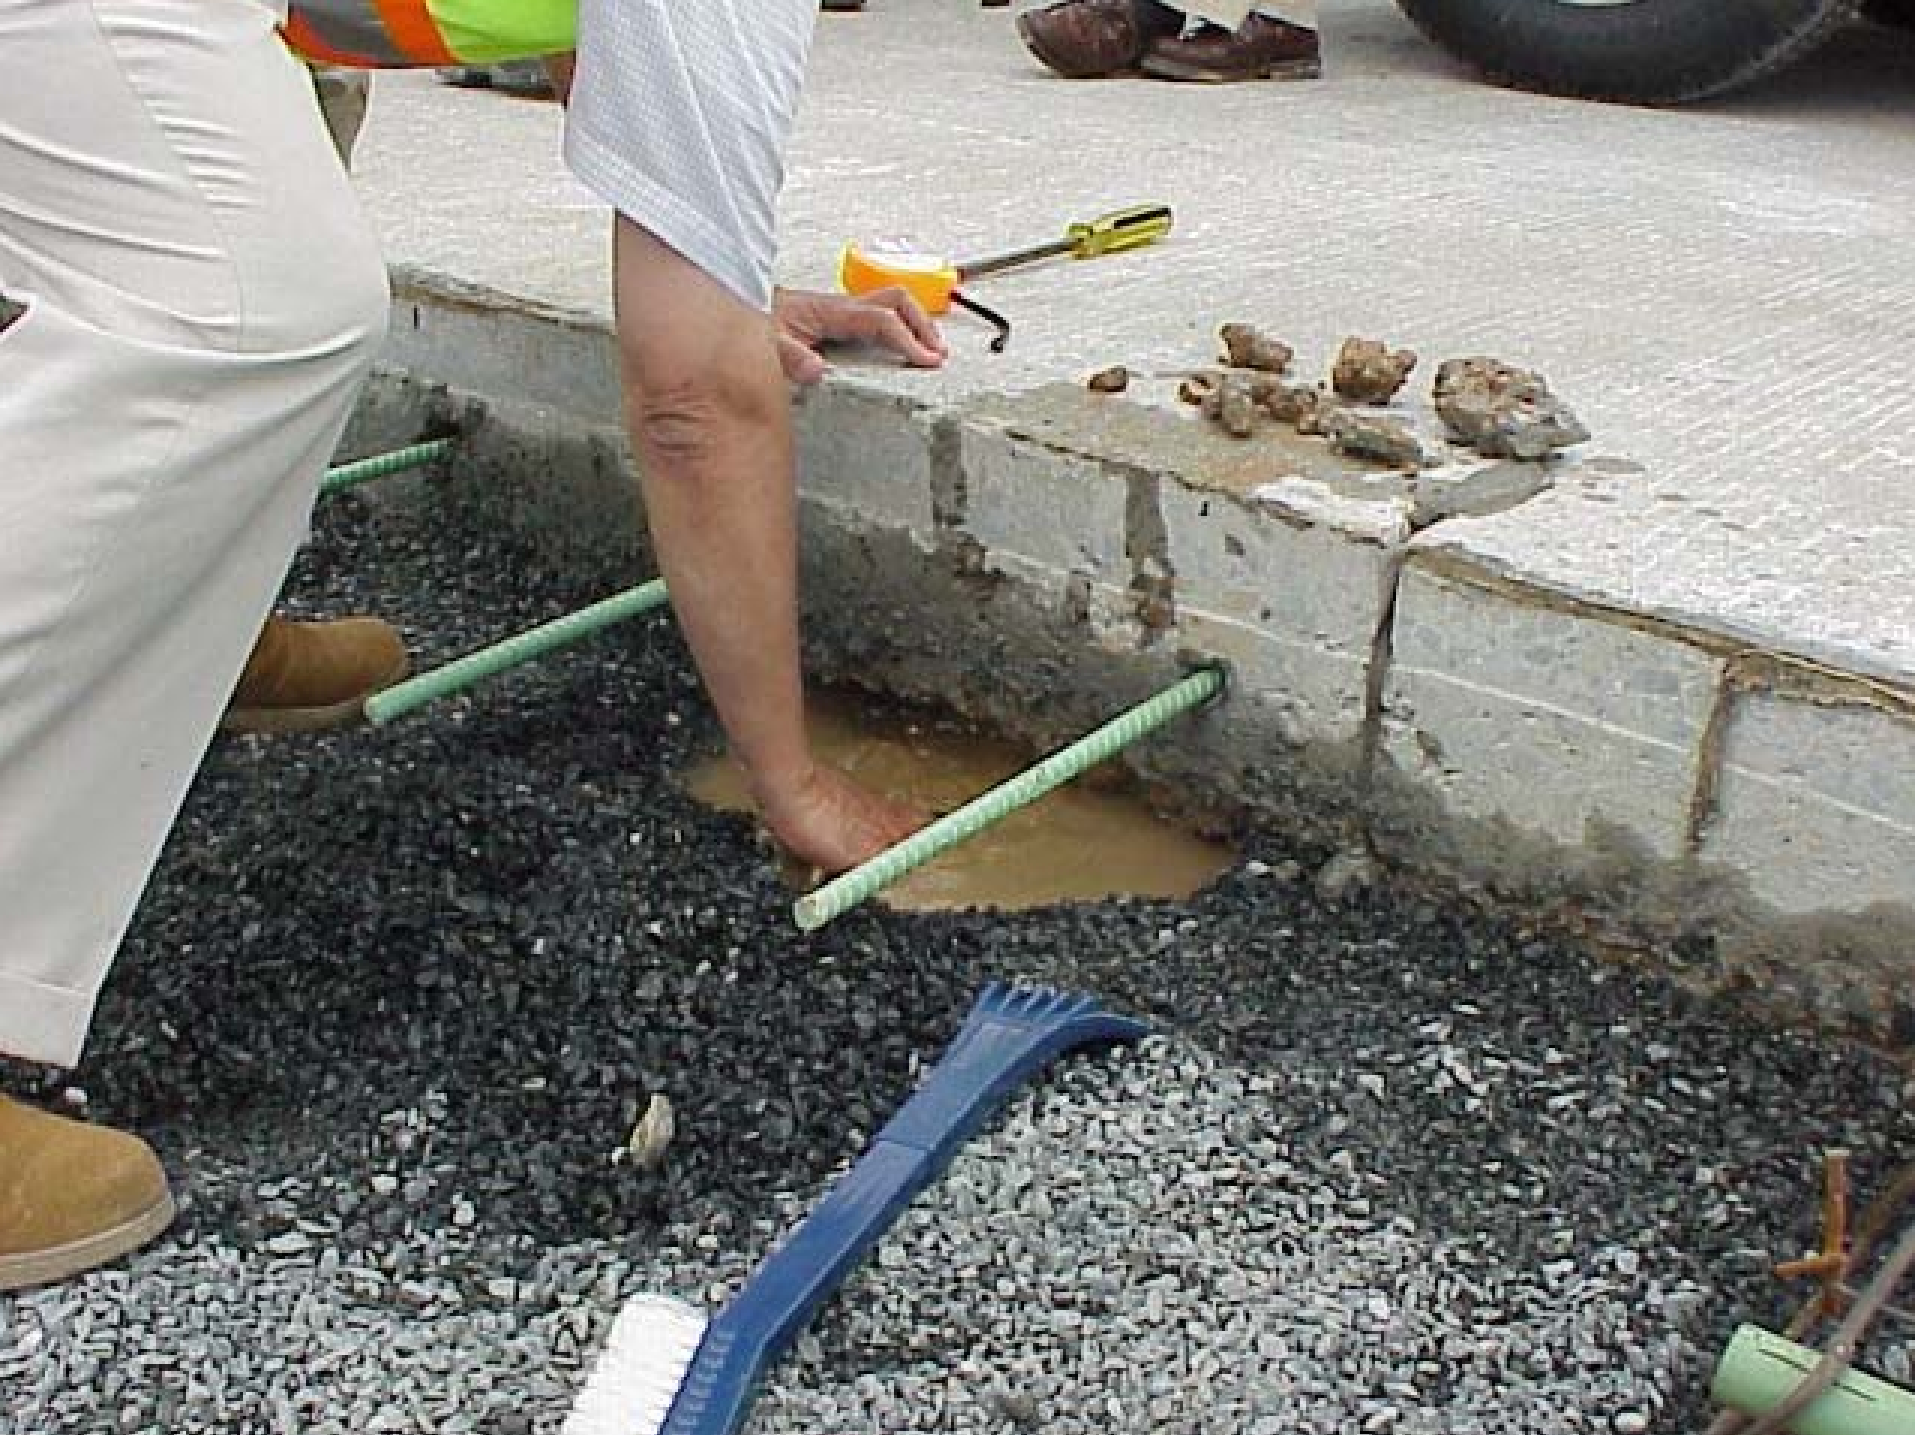
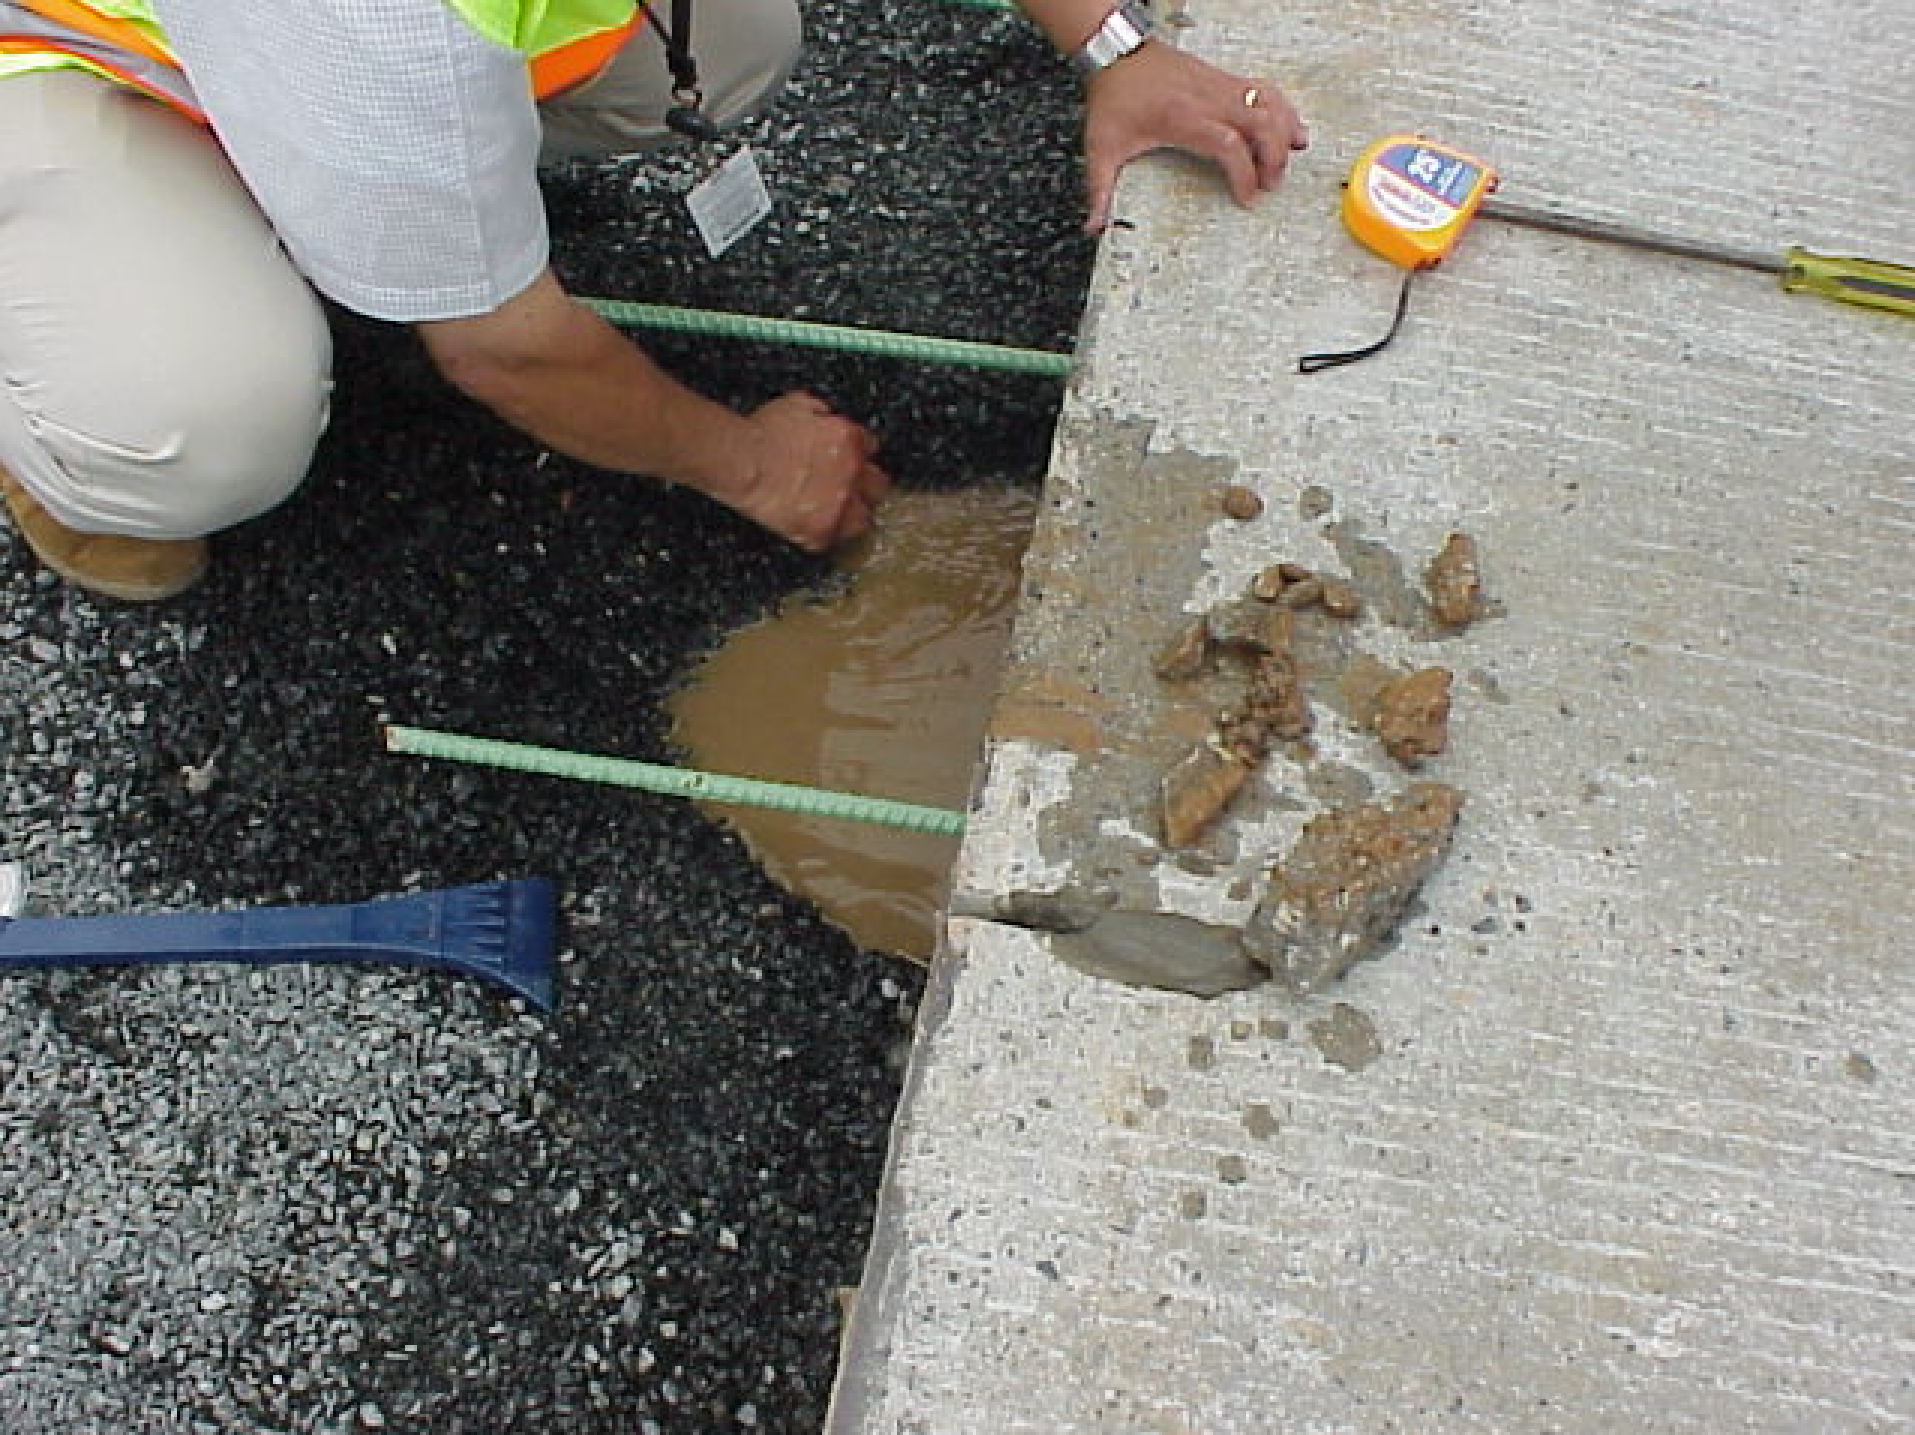
- Video inspection of Pavement Edgedrain
- All outlets are clear
- All the longitudinal pipes are clear
