# NCAT TEST TRACK UPDATE

# 2003 MIXED EXPERIMENT

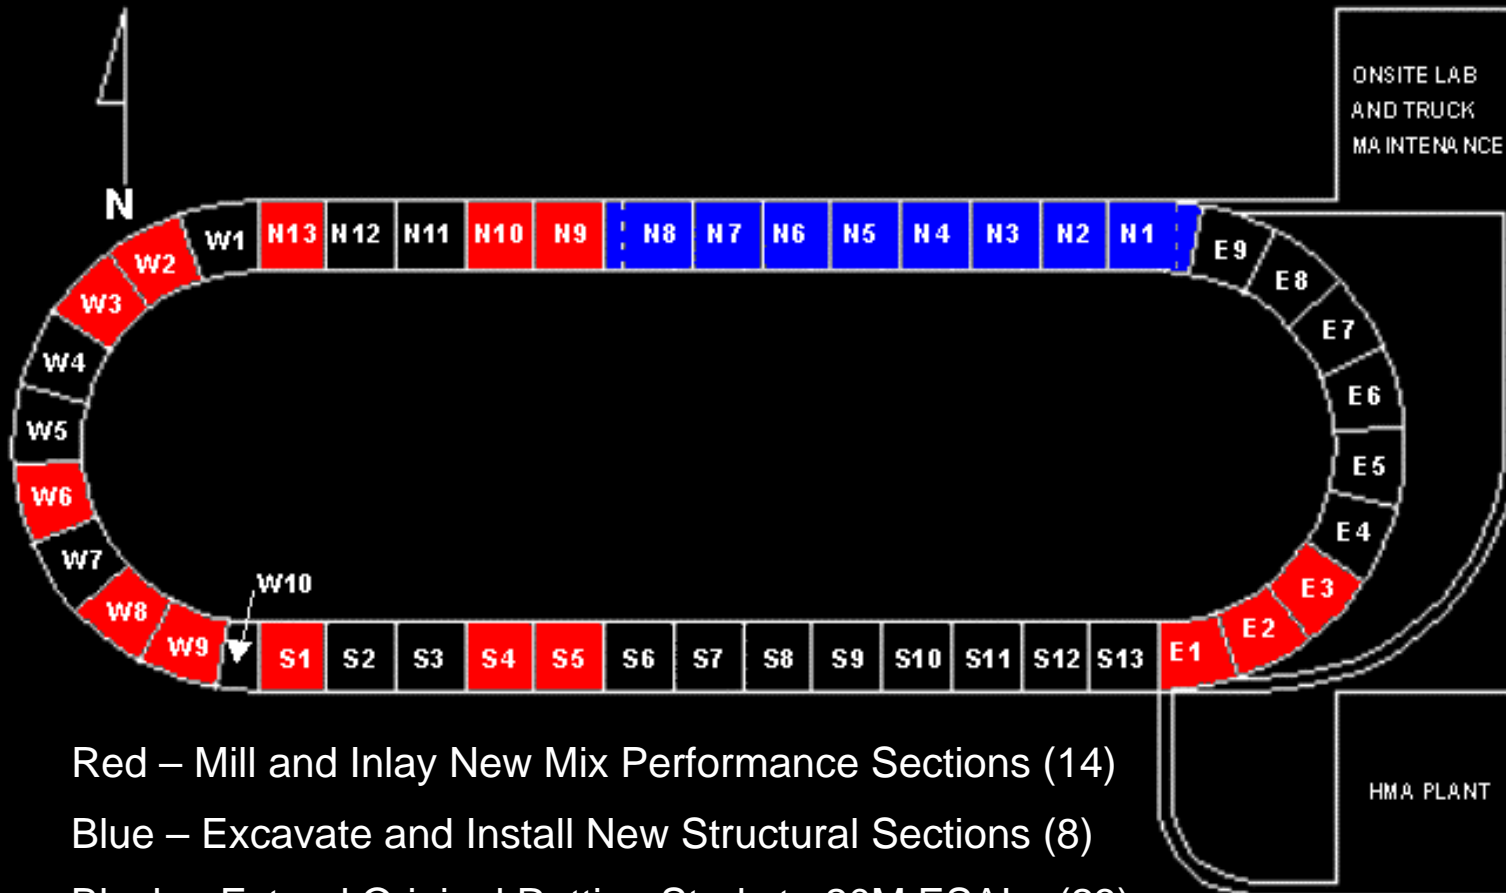
- Red – Mill and Inlay New Mix Performance Sections (14)
- Blue – Excavate and Install New Structural Sections (8)
- Black – Extend Original Rutting Study to 20M ESALs (23)

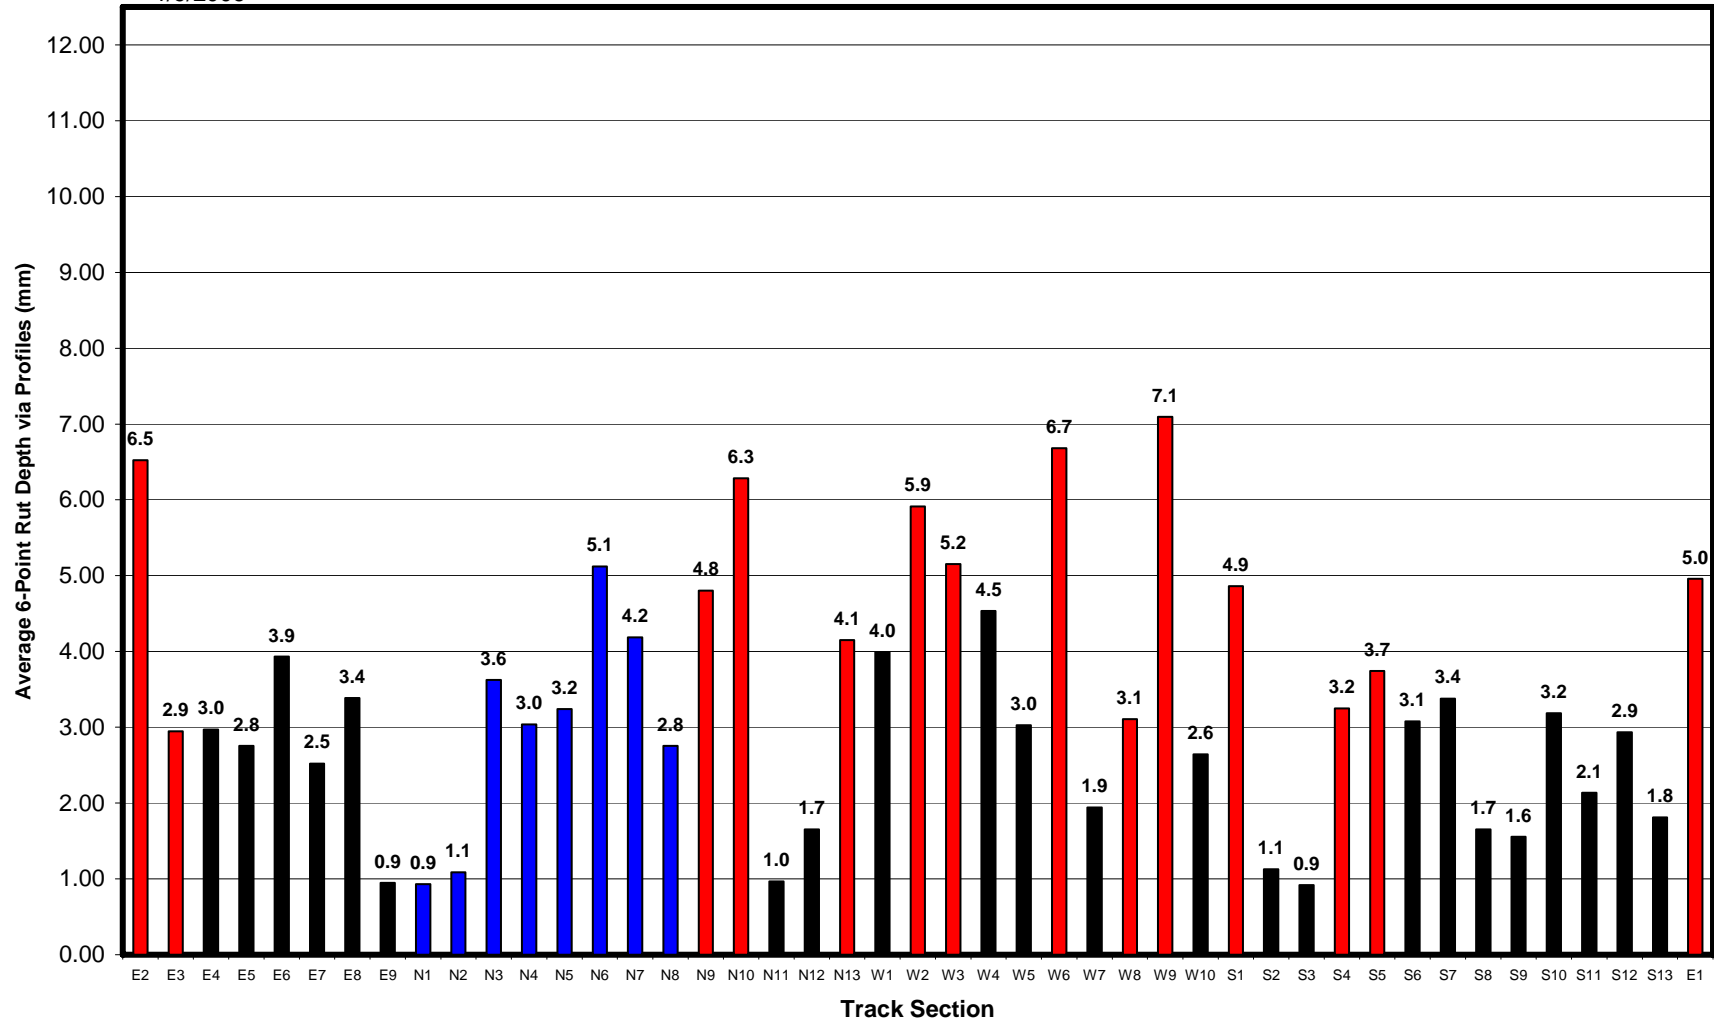
# RUTTING PERFORMANCE

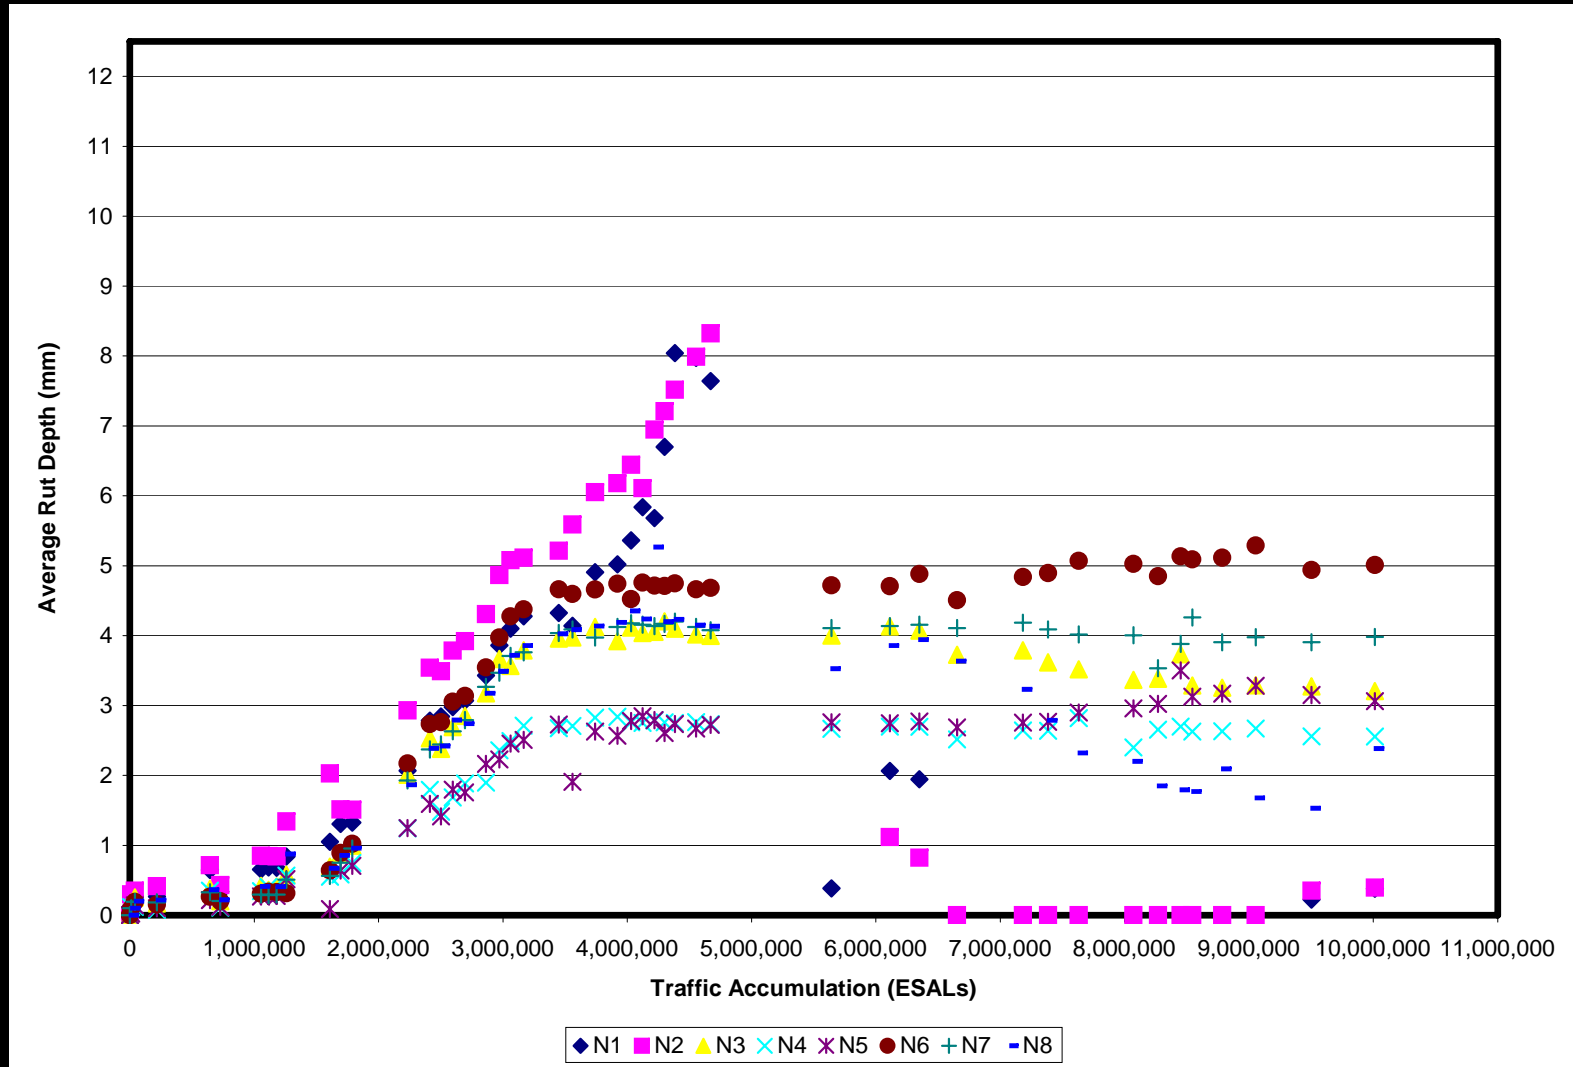
# STRUCTURAL STUDY RUTTING

- Both 5" Sections Failed (Slightly Later than Expected)
- Some Fatigue Cracking in 7" Sections (Much Later)
- No Cracking Observed in Either 9" Section

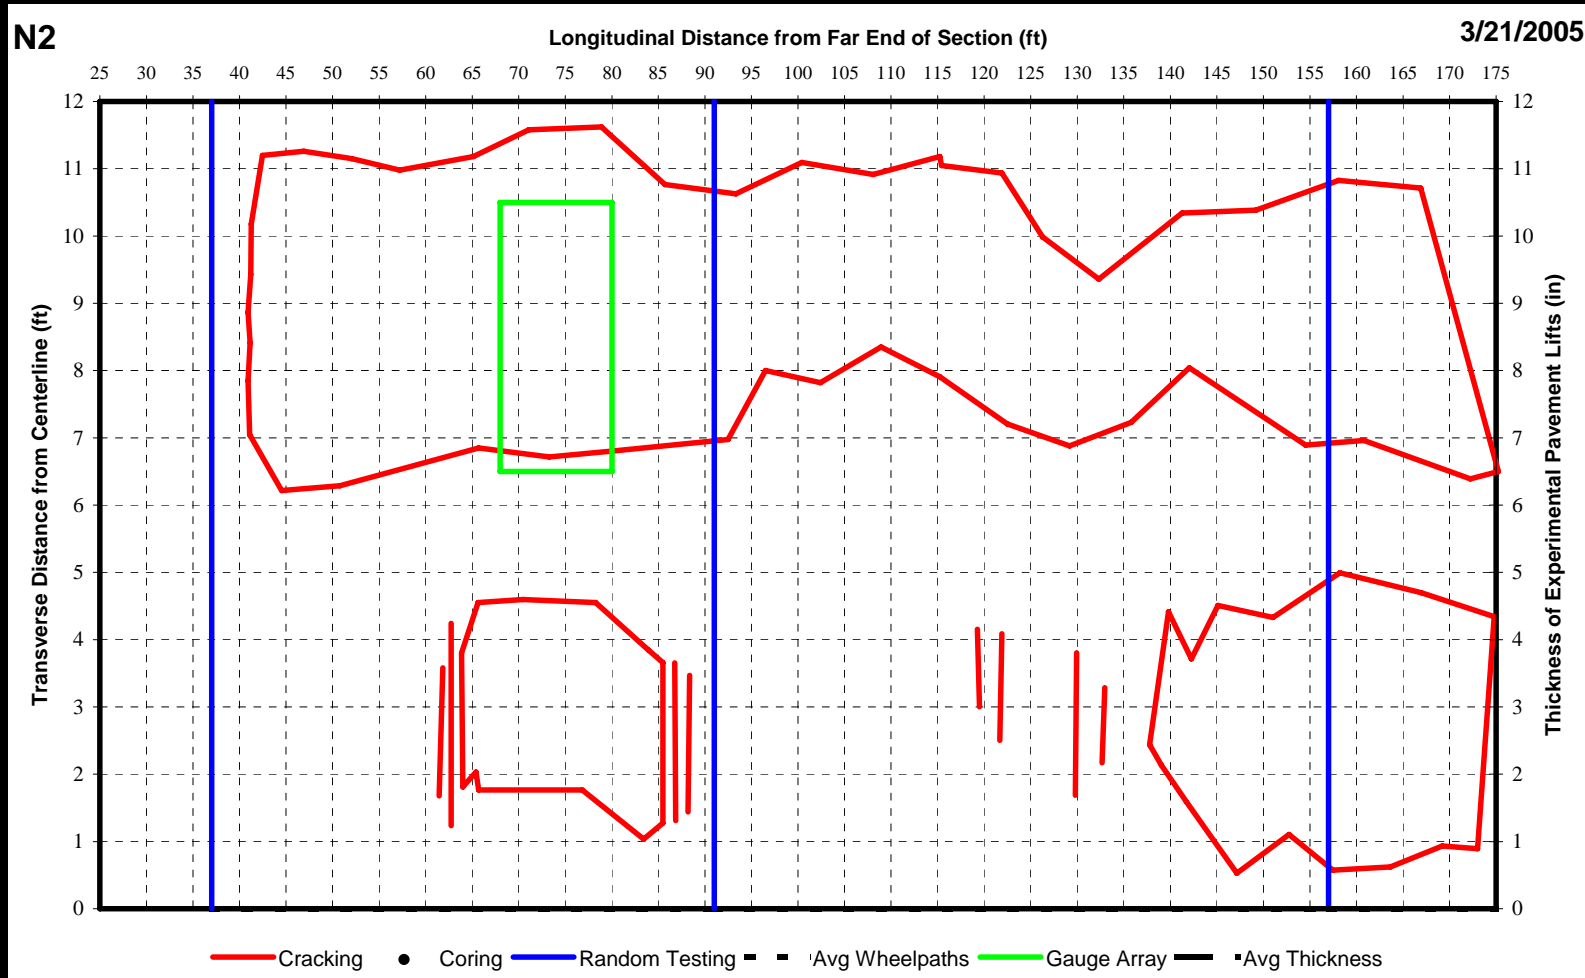
# SURFACE DISTRESS MAPPING

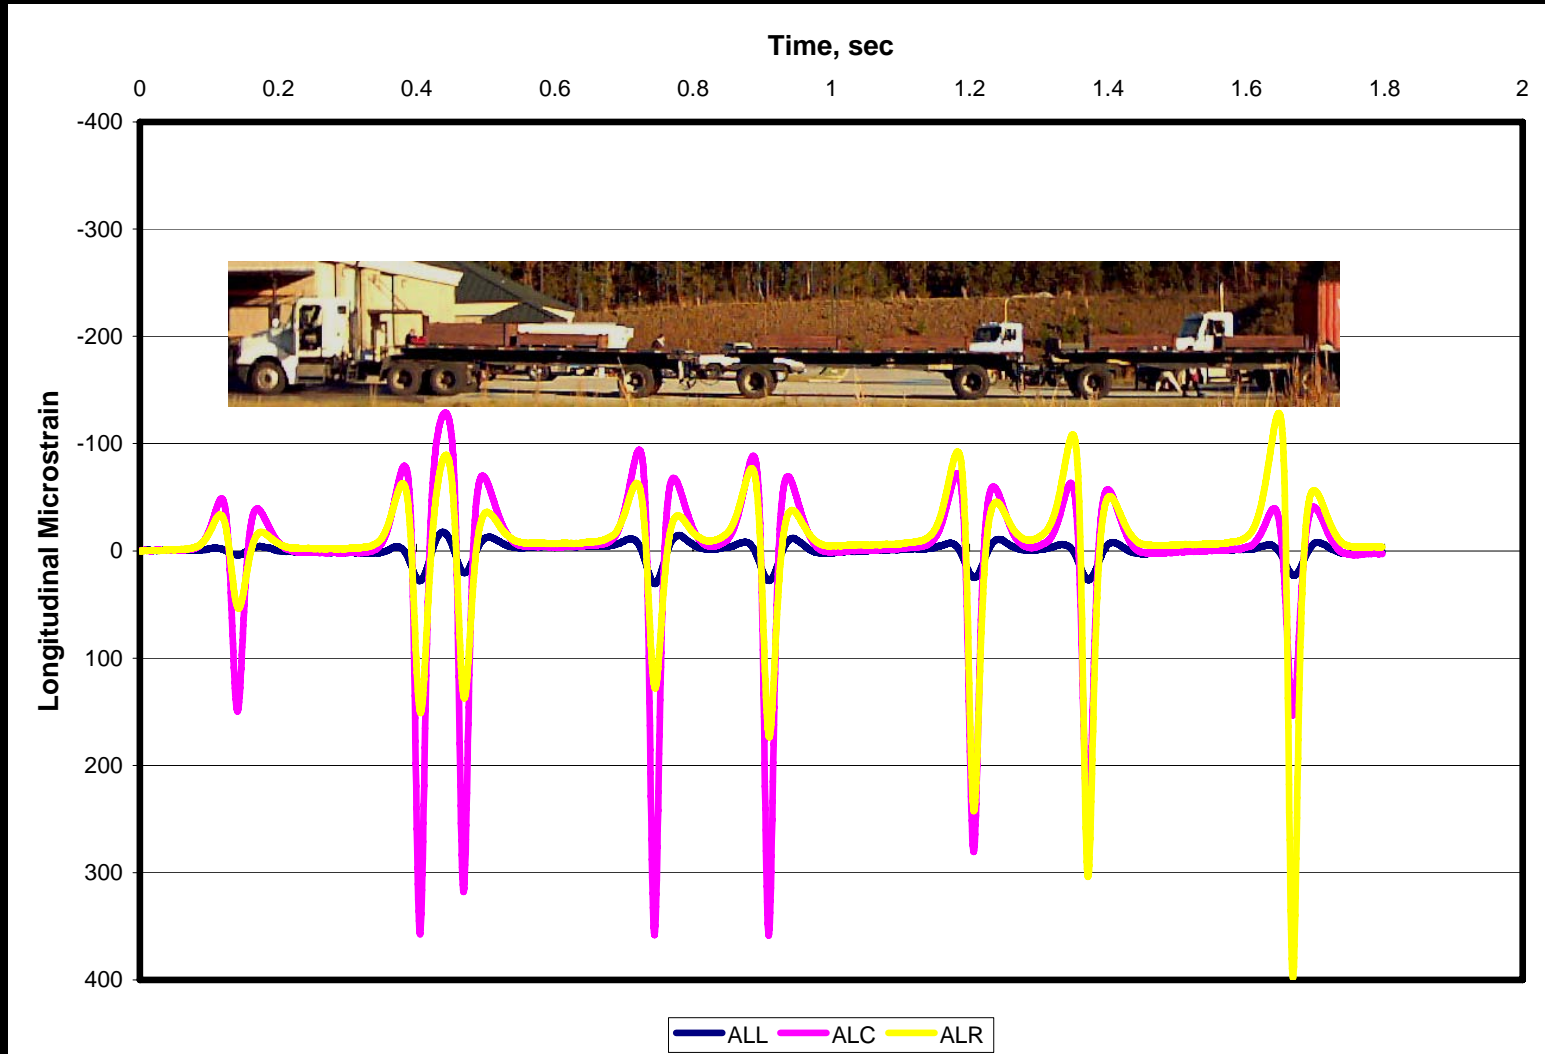
# MEASURED PAVEMENT RESPONSE

- Pavement Response **Measured** at Known Temperatures
- Mechanistic Pavement Analysis Approach **Validated**
- Pavement Response **Predicted** at All Temperatures
- Damage (Strains) **Accumulated** with Each Axle Pass
- Mechanistic-Empirical Pavement Design **Calibrated**

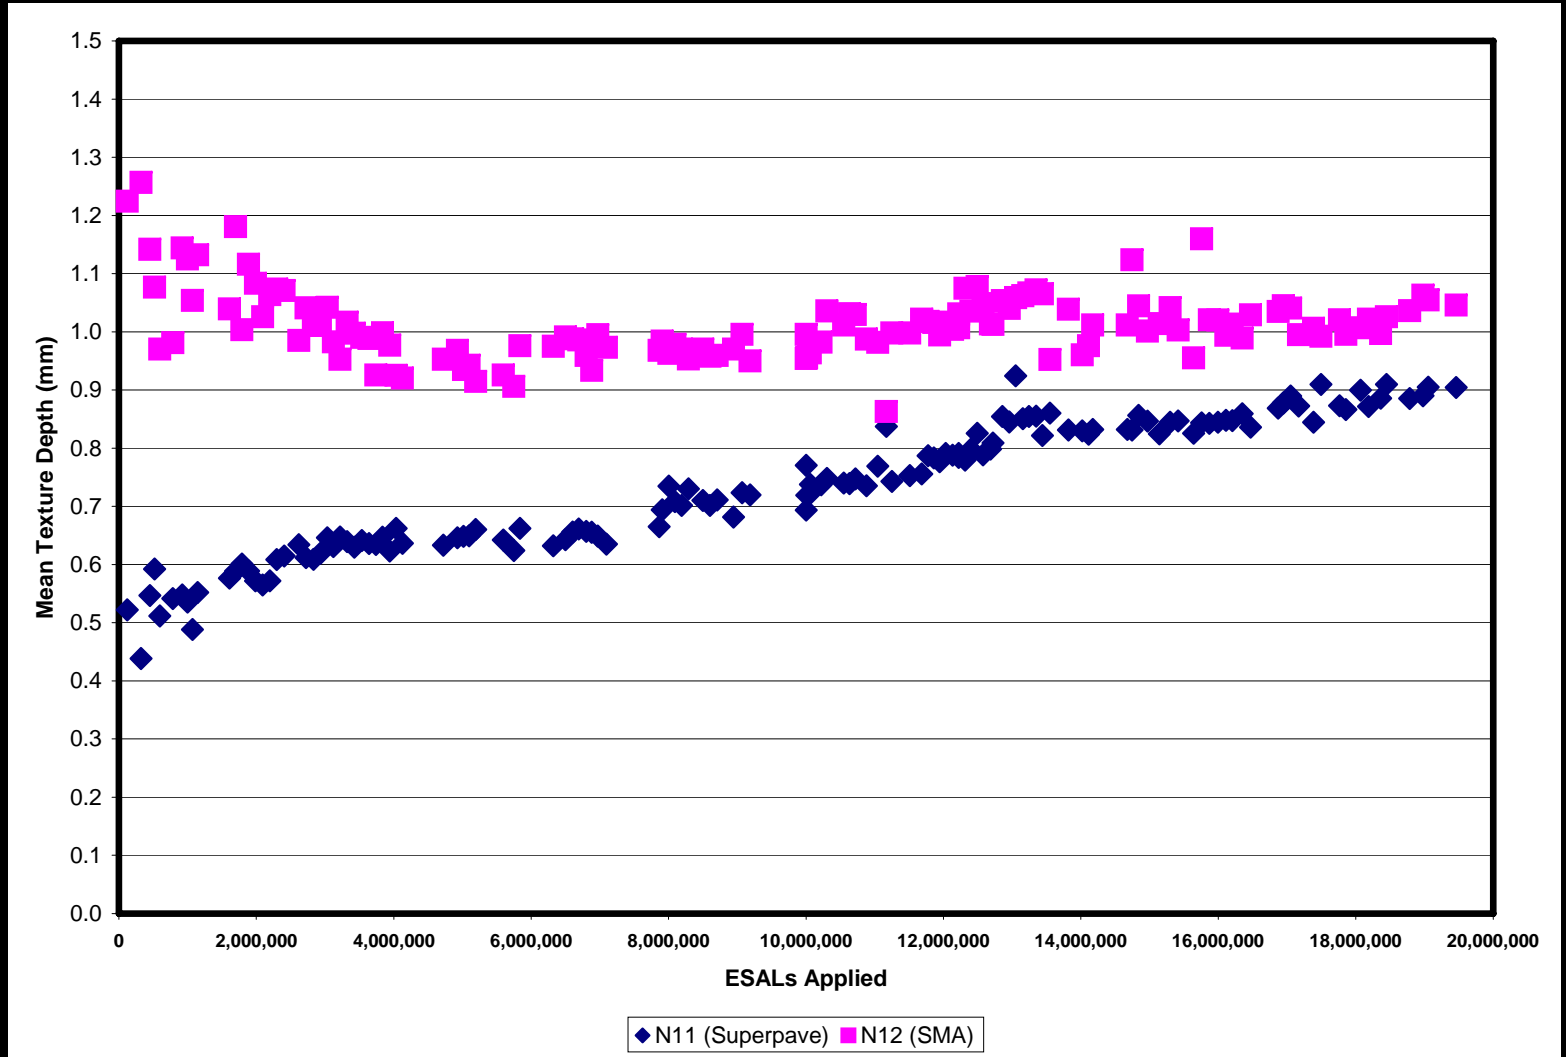
# Superpave vs SMA

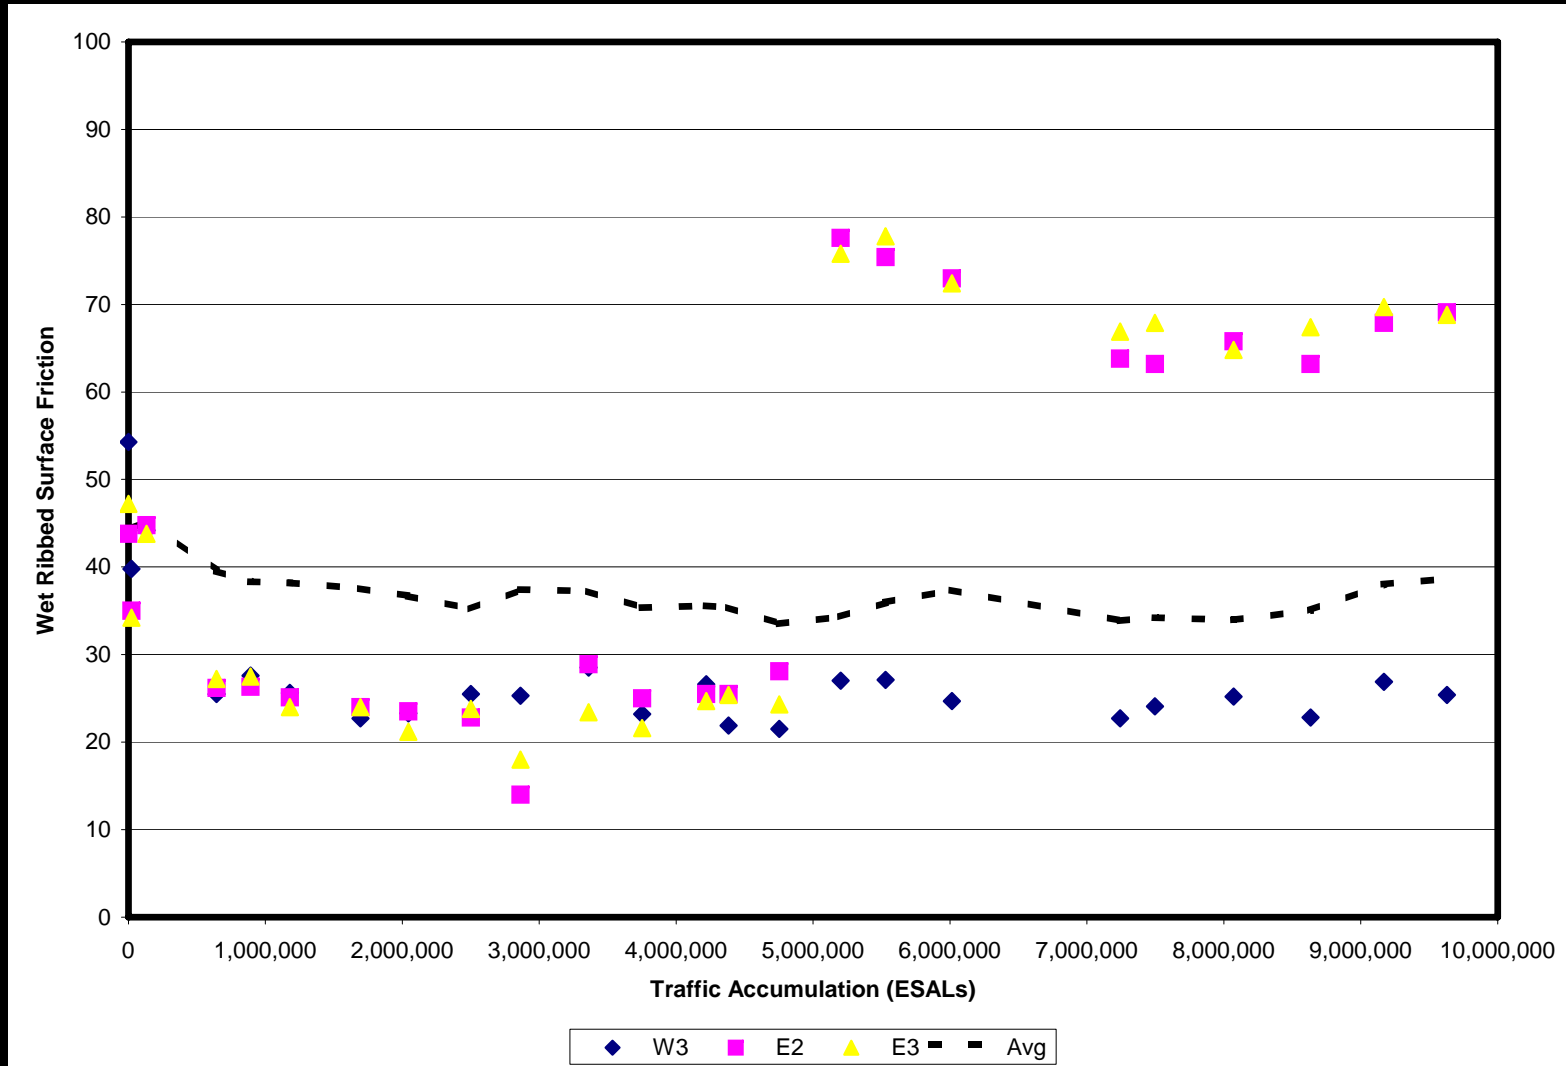
# FRICTION LOSS EXPERIMENTS

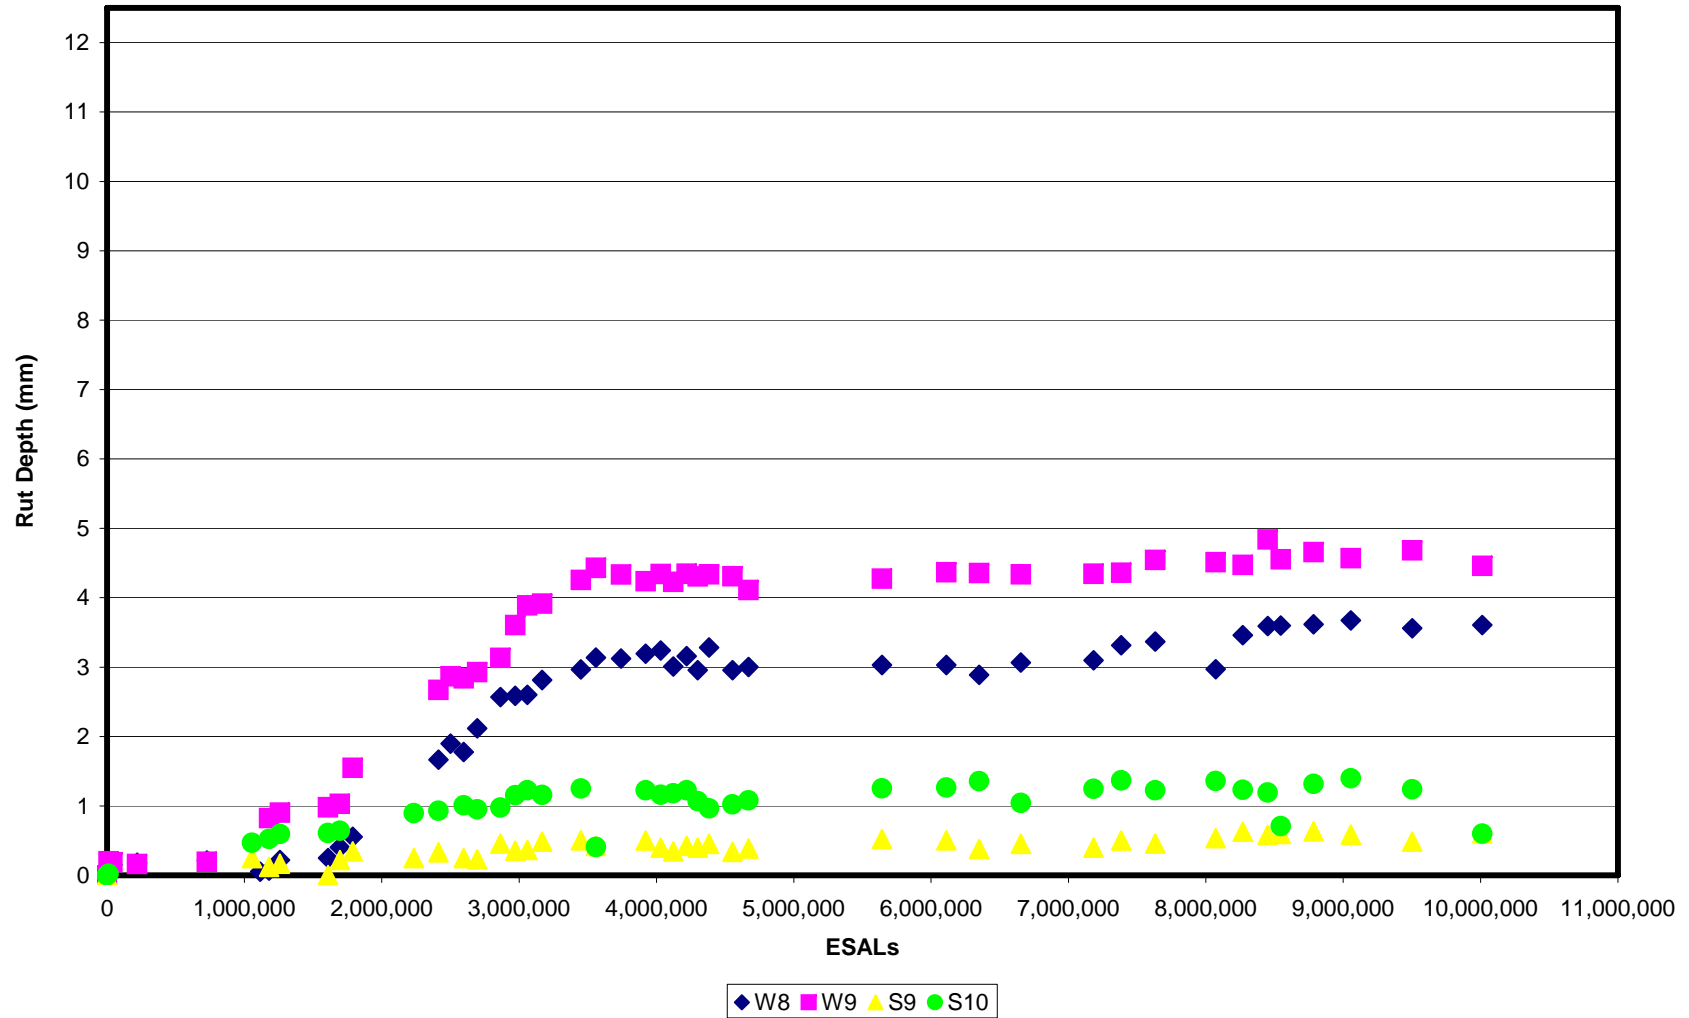
# 300K ESAL MIX COMPARISON

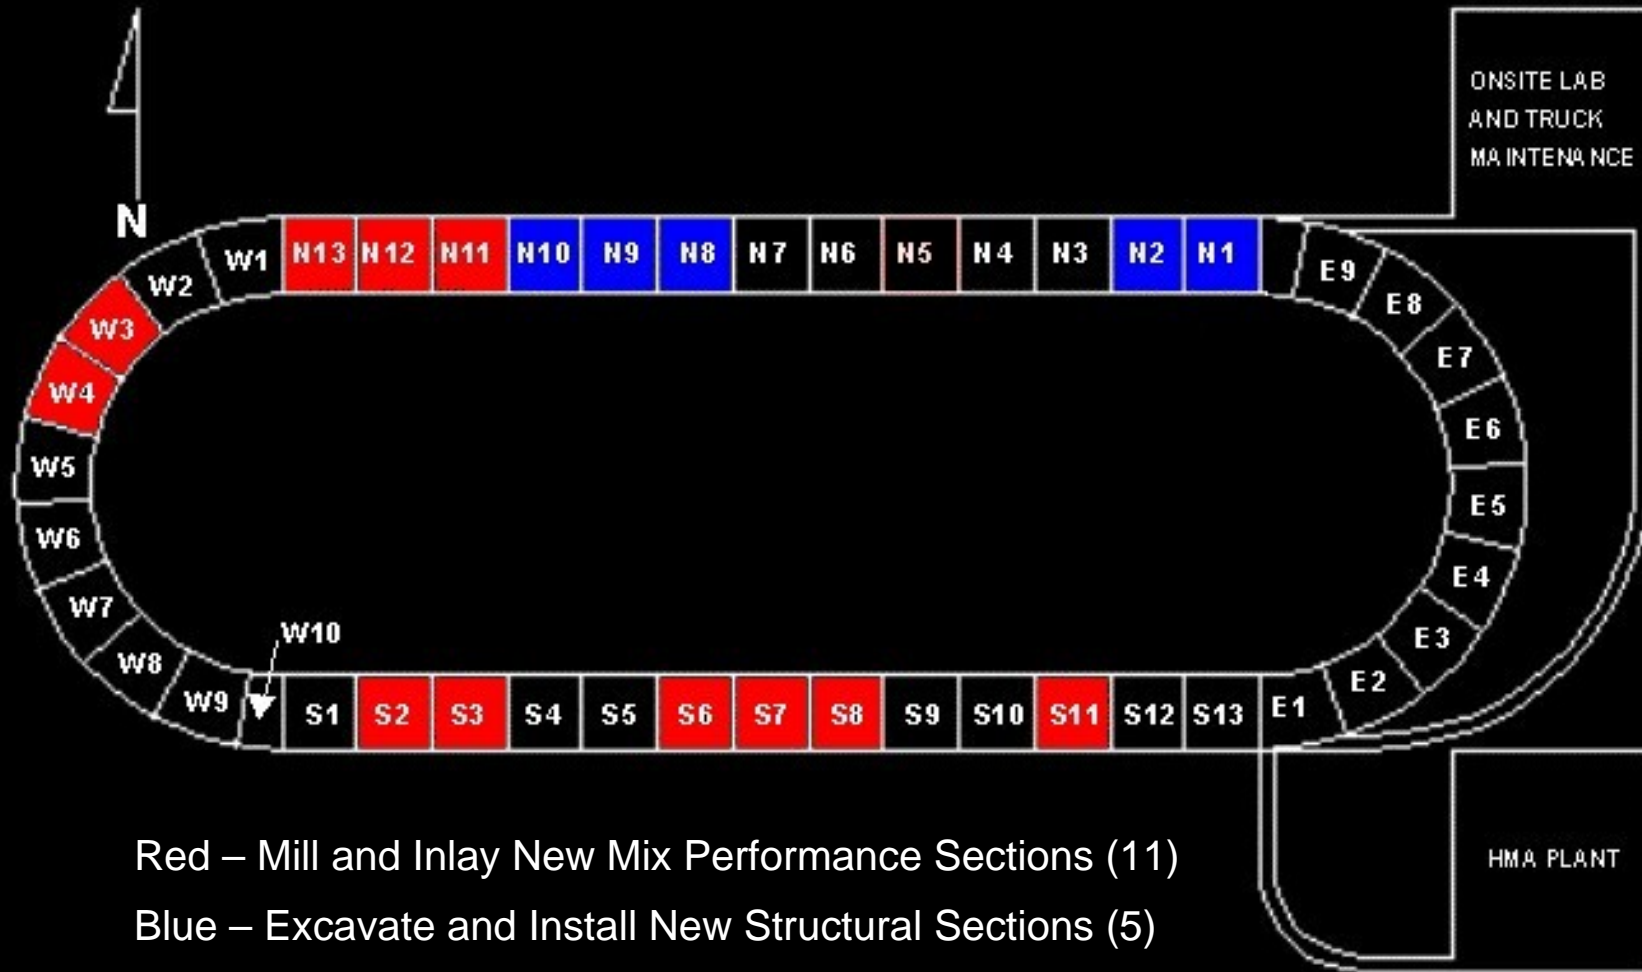
# REPLACEMENT SECTIONS

Red – Mill and Inlay New Mix Performance Sections (11)

Blue – Excavate and Install New Structural Sections (5)

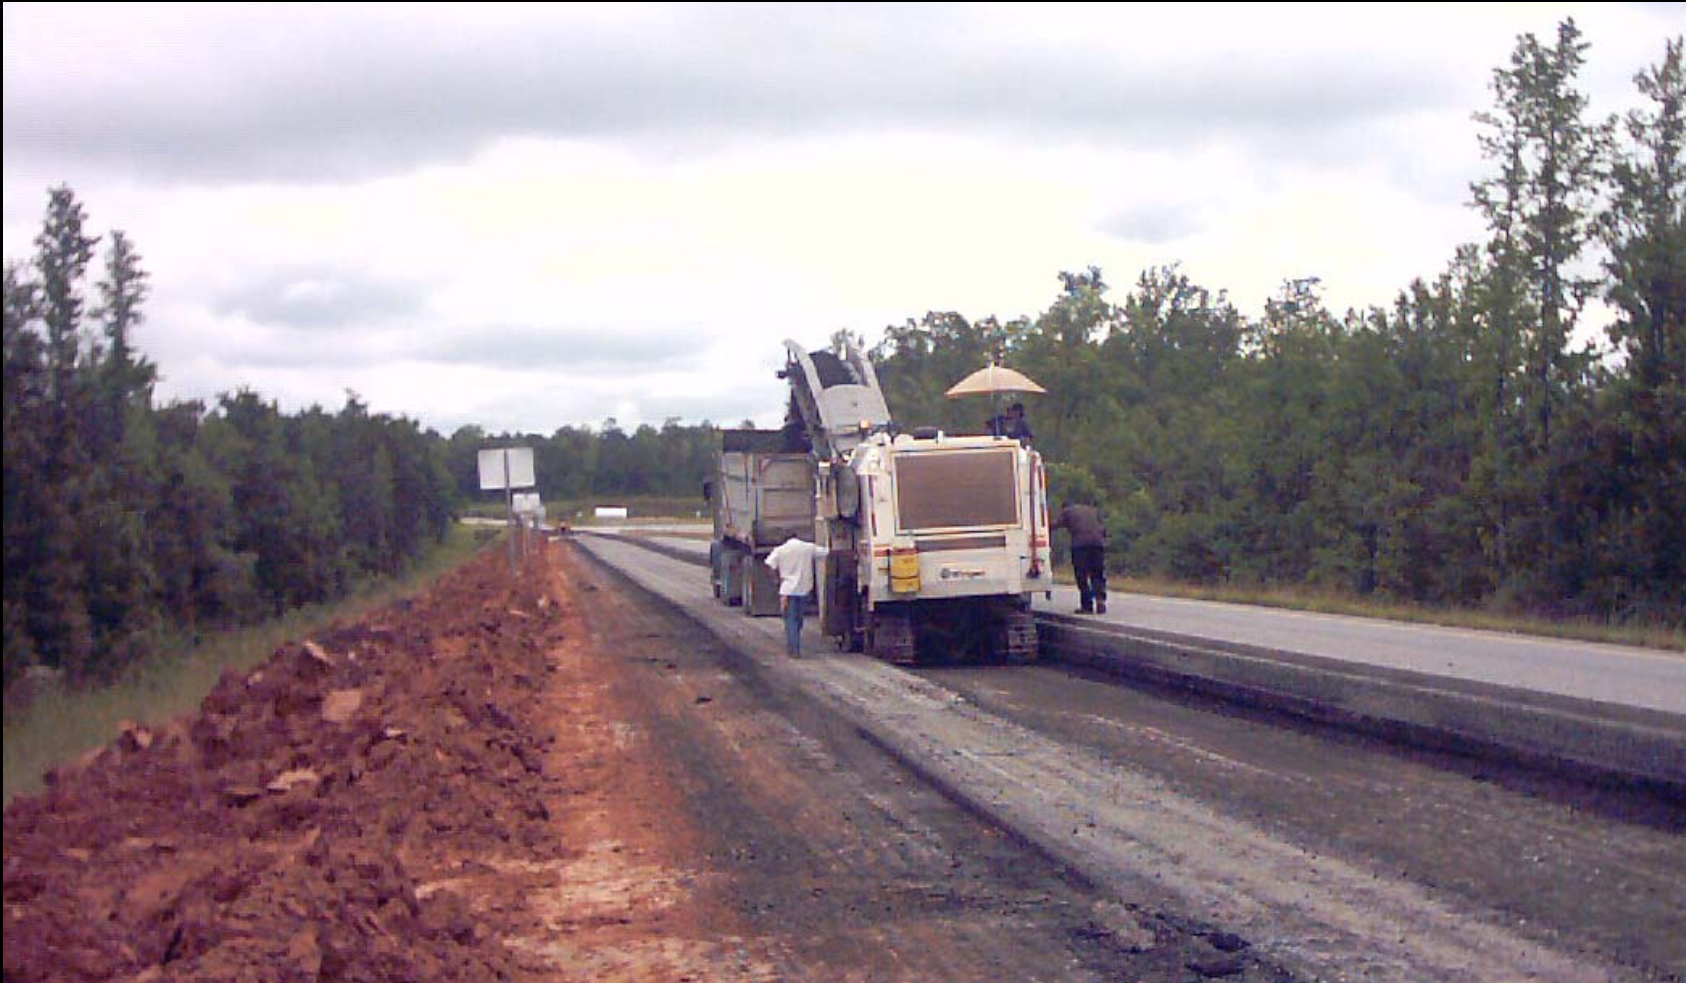
# STRUCTURAL MILLING
