Performance of Interstate Edge Drains in Arkansas

Gary M. Bennett, PE
Civil Engineer IV
Planning & Research Division
Research Section

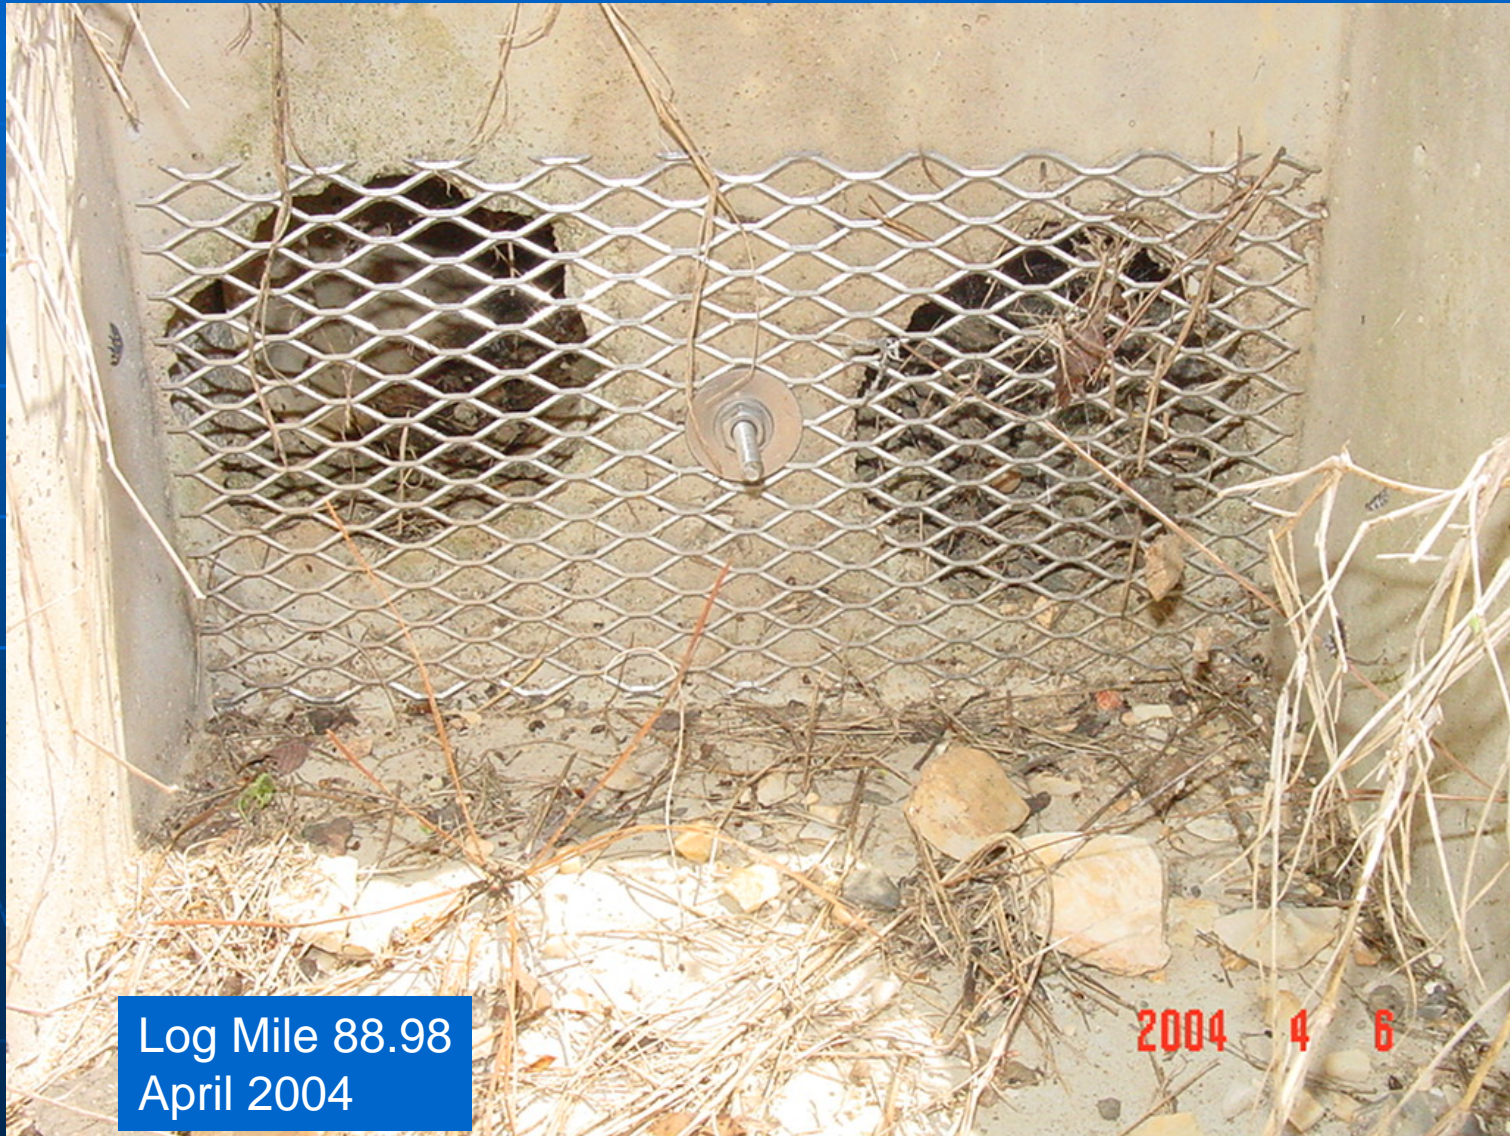
Drain Outlet Before Maintenance

Log Mile 88.98
April 2004

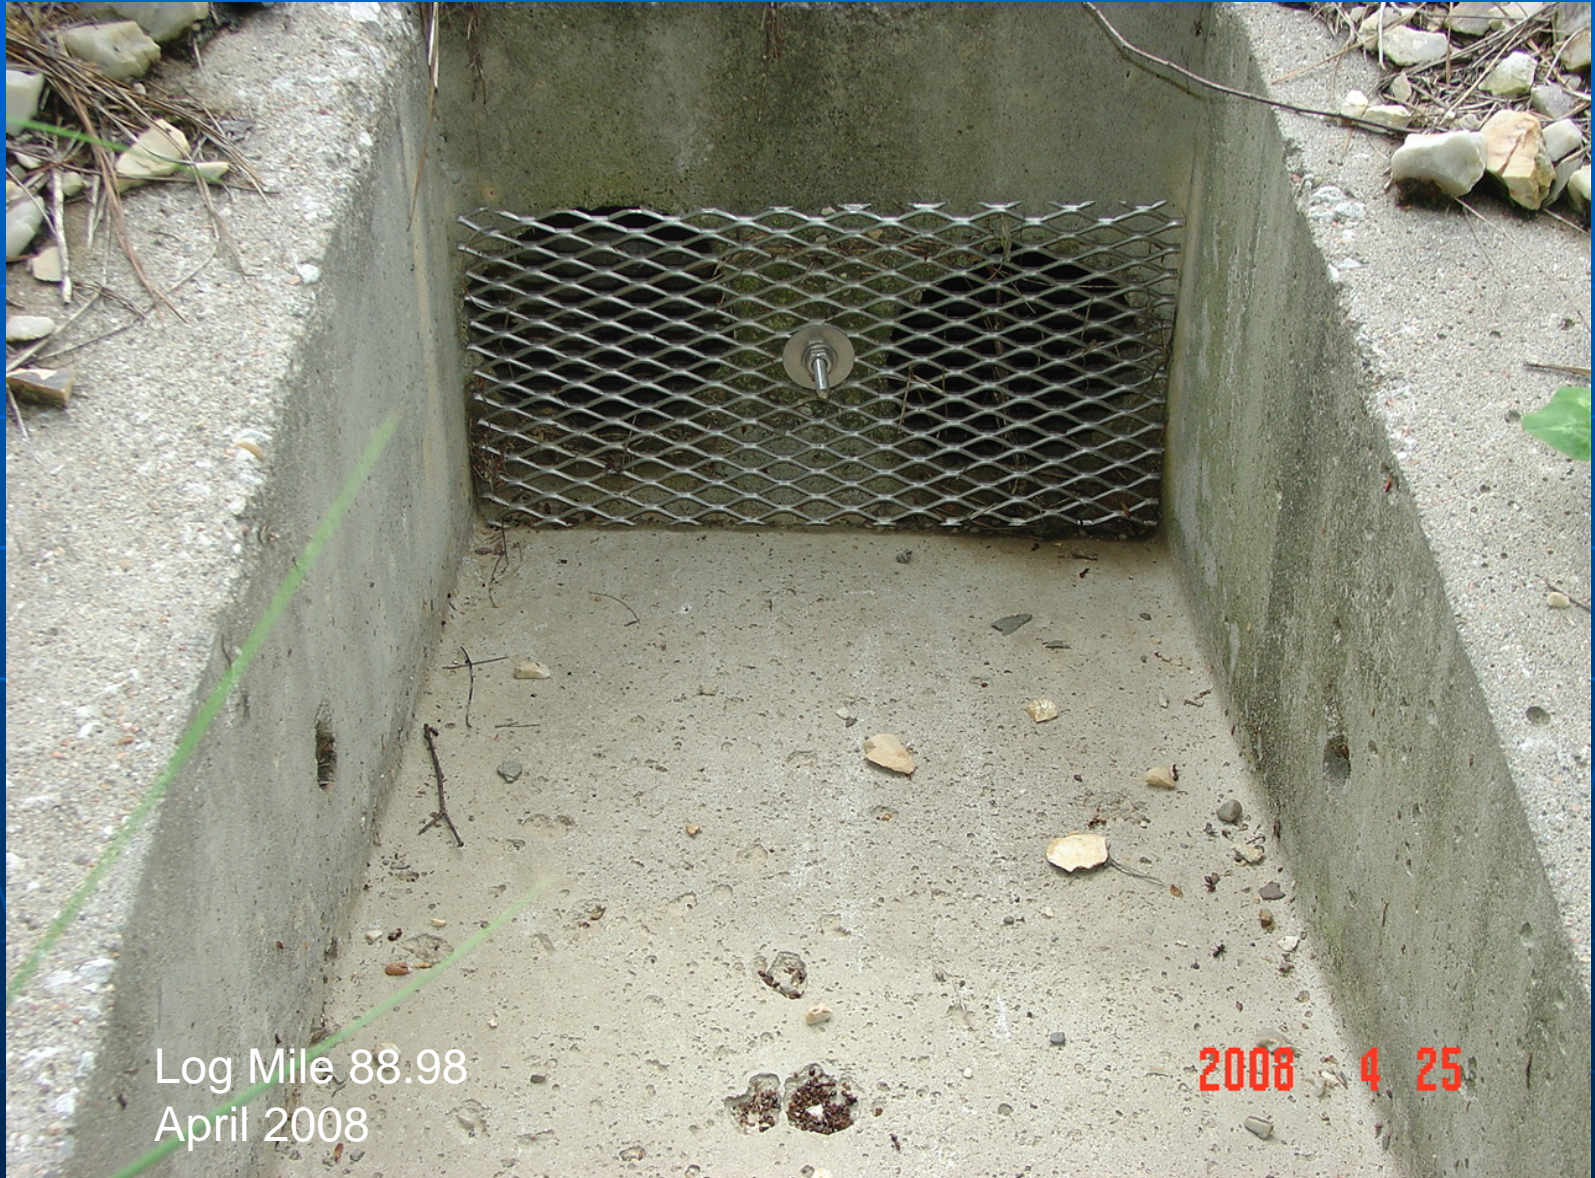
Maintained Drain Outlet

Log Mile 88.98
April 2008

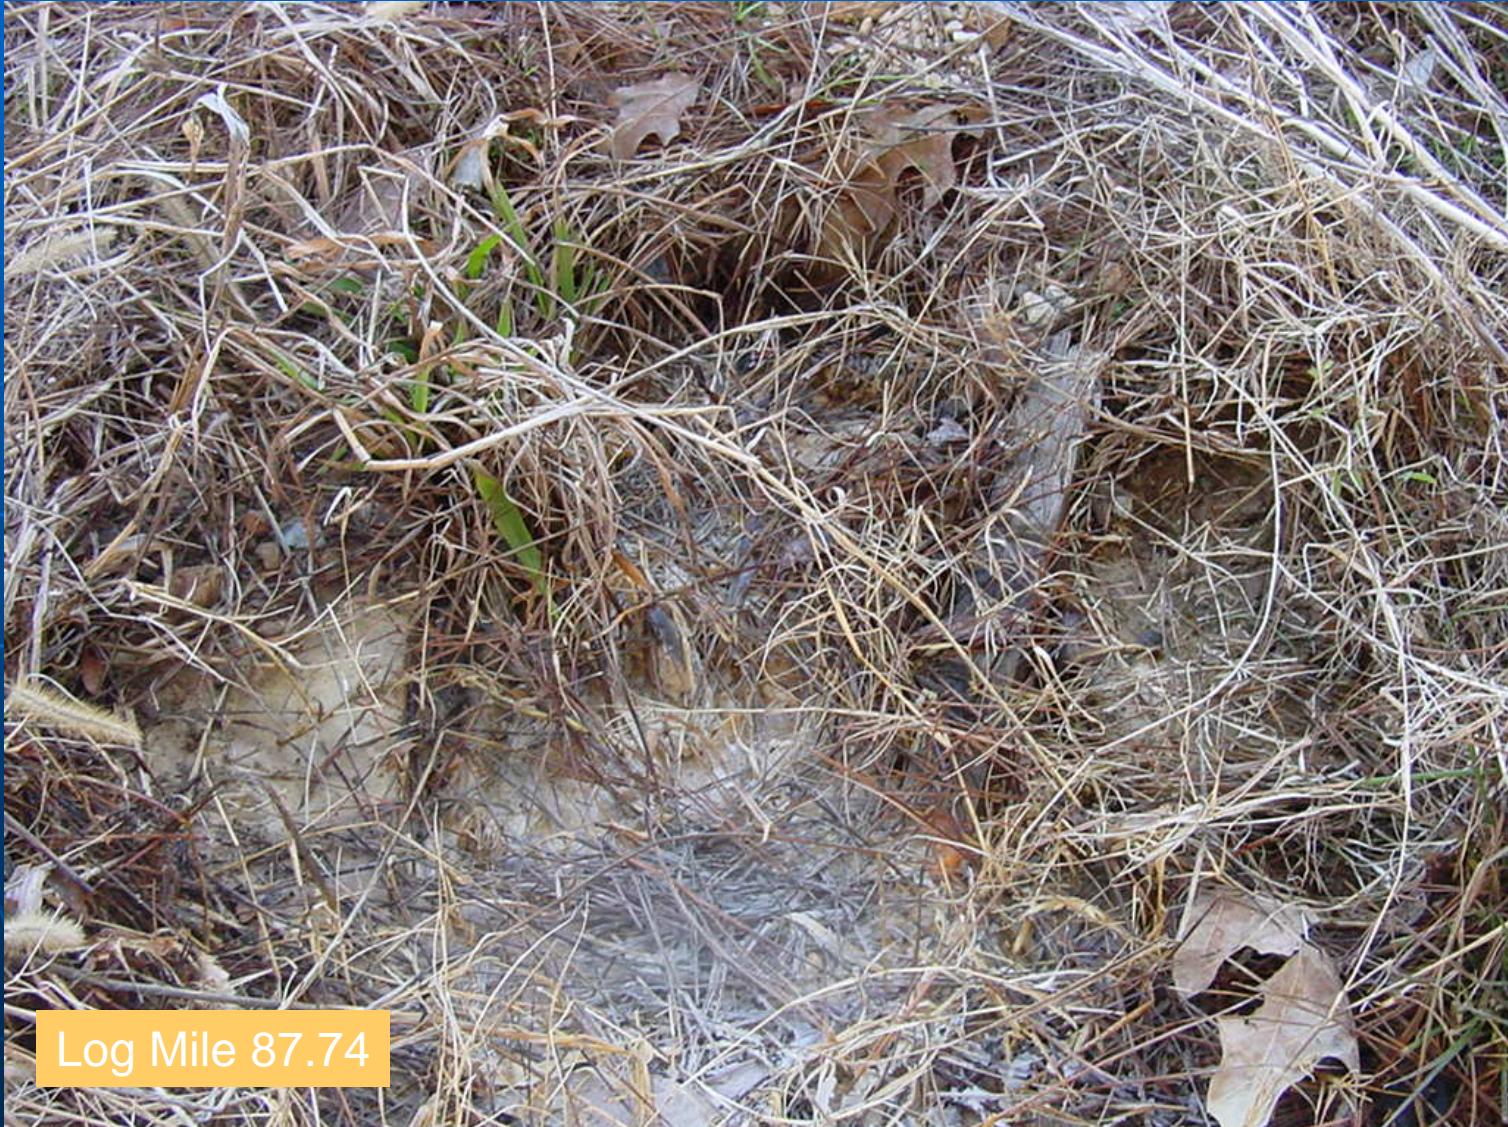
Drain Outlet Not Maintained

Log Mile 87.74

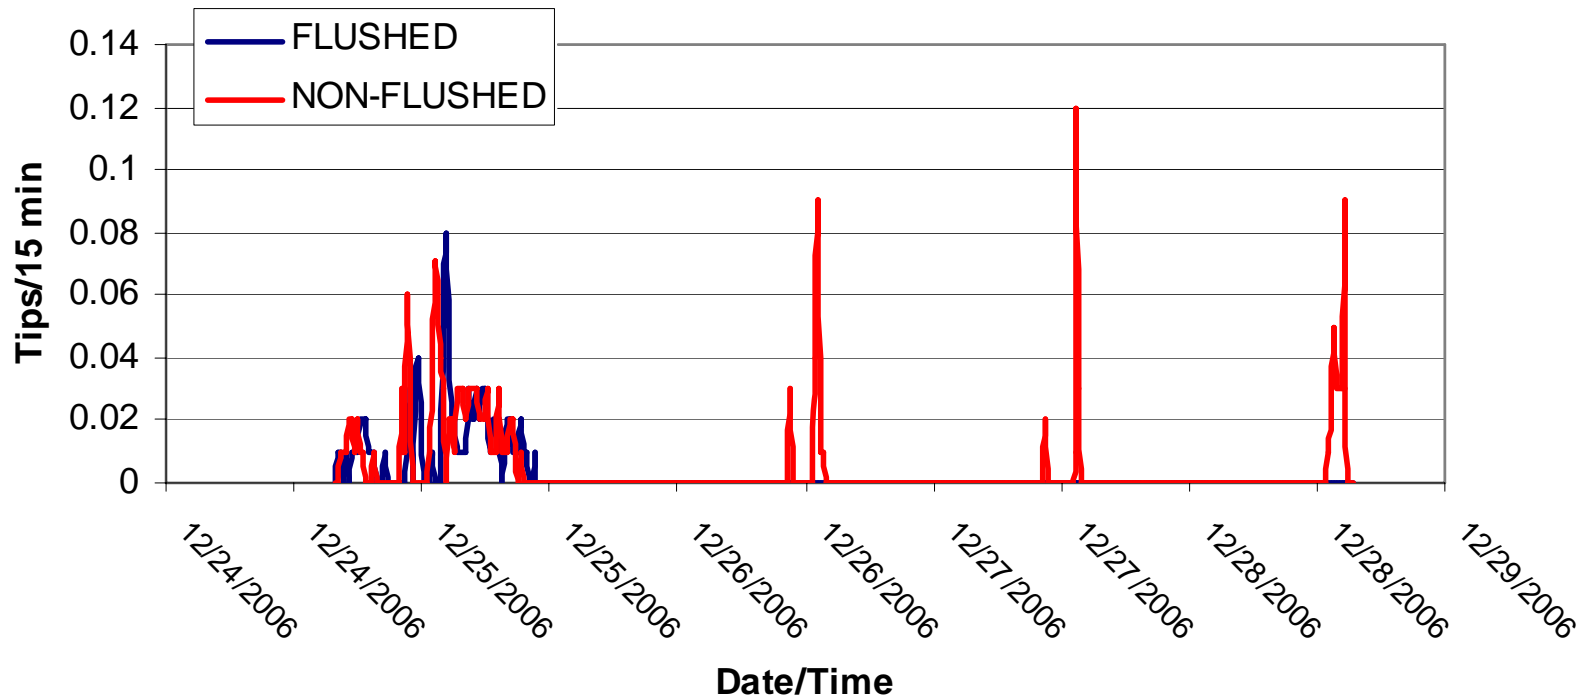
Rainfall Event

Rainfall Gauges for Flushed and Non-Flushed Sites
December 2006

- Rainfall and flow tipping bucket gauges
- Maintained and non-maintained section
- How does maintenance effect
 - Long term drain performance
 - Long term pavement performance

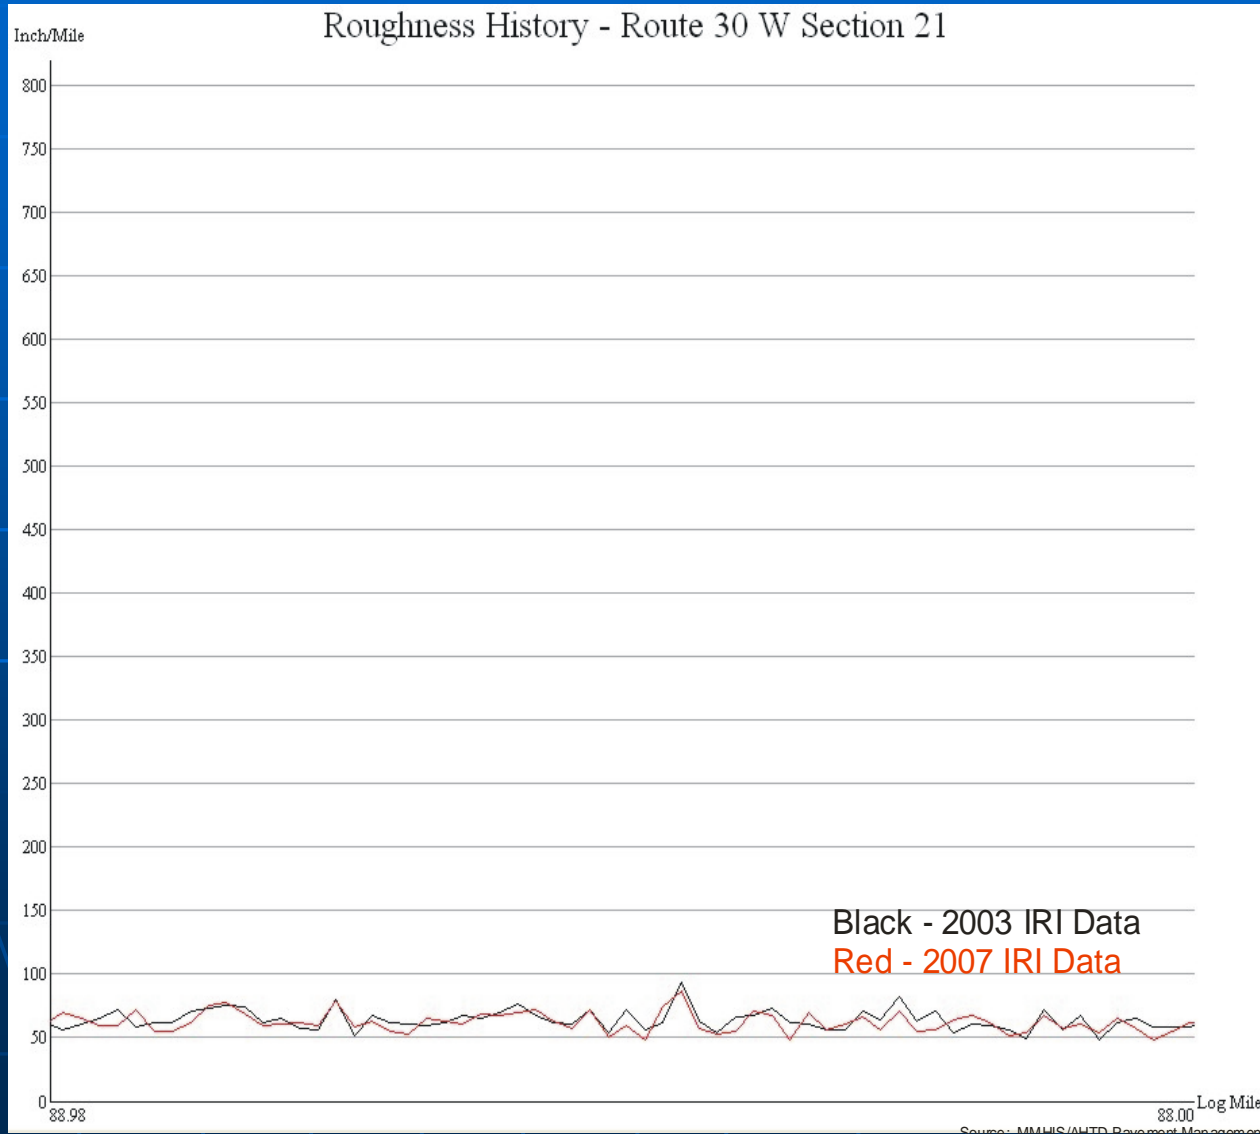
IRI for Flushed Section

<i>Flushed</i>			<i>Not Flushed</i>		
	<i>2003</i>	<i>2007</i>	<i>%Change</i>	<i>2003</i>	<i>2007</i>	<i>%Change</i>
IRI (in/mi)	57.6	61.07	6.0	62.9	63.7	1.3
Rutting (in)	0.15	0.2	33.3	0.15	0.2	33.3

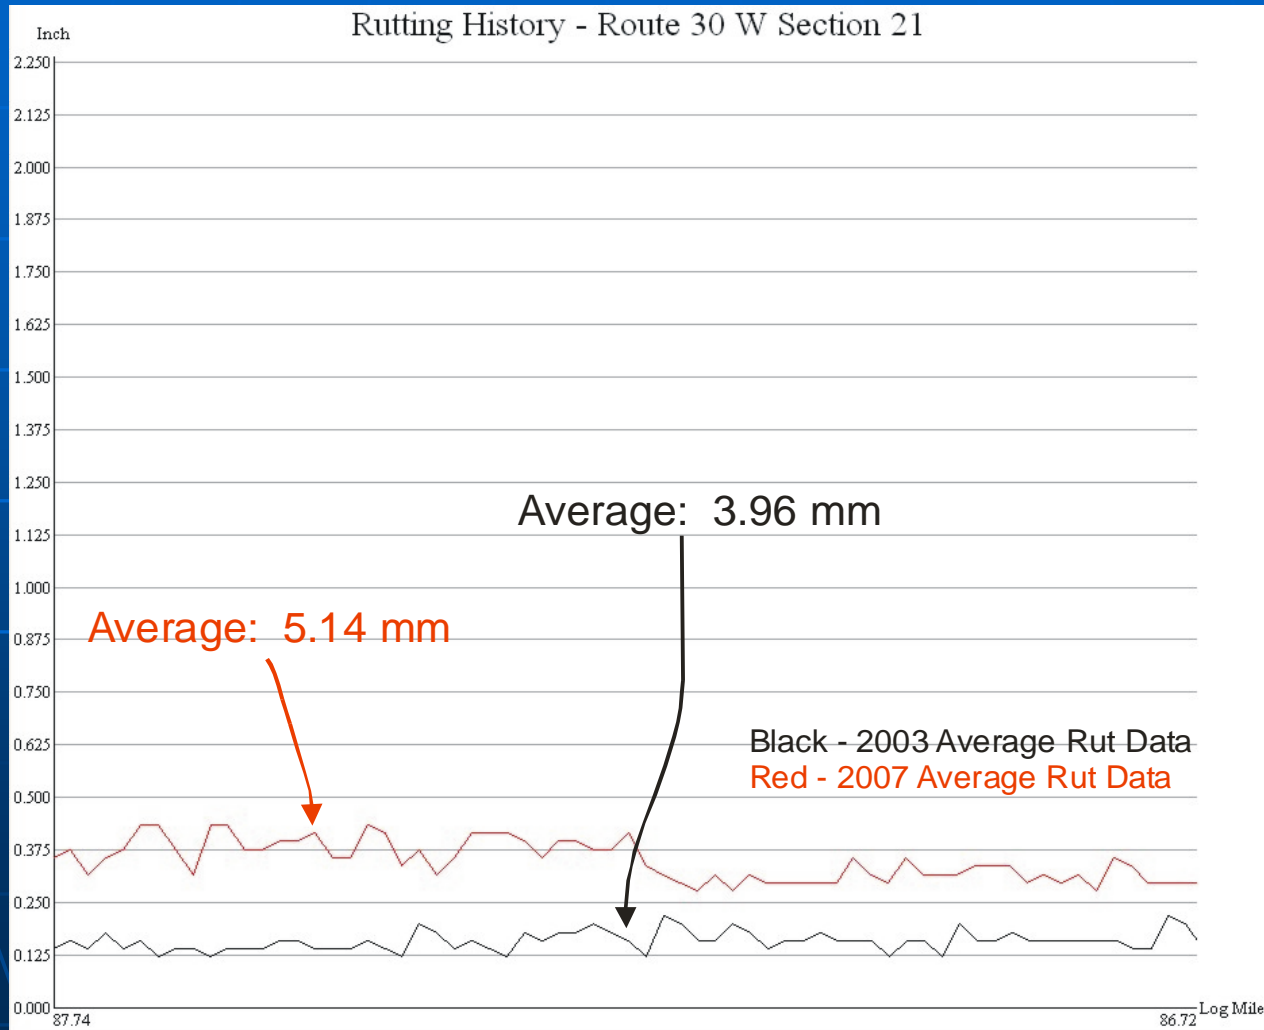
Rutting for Non-Flushed Section
