Bonded CRCP Overlay of a Distressed Jointed Concrete

Southeastern States Pavement Association 2018 Conference

October 25, 2018 Charleston, West Virginia

Moon Won, P.E. Texas Tech University

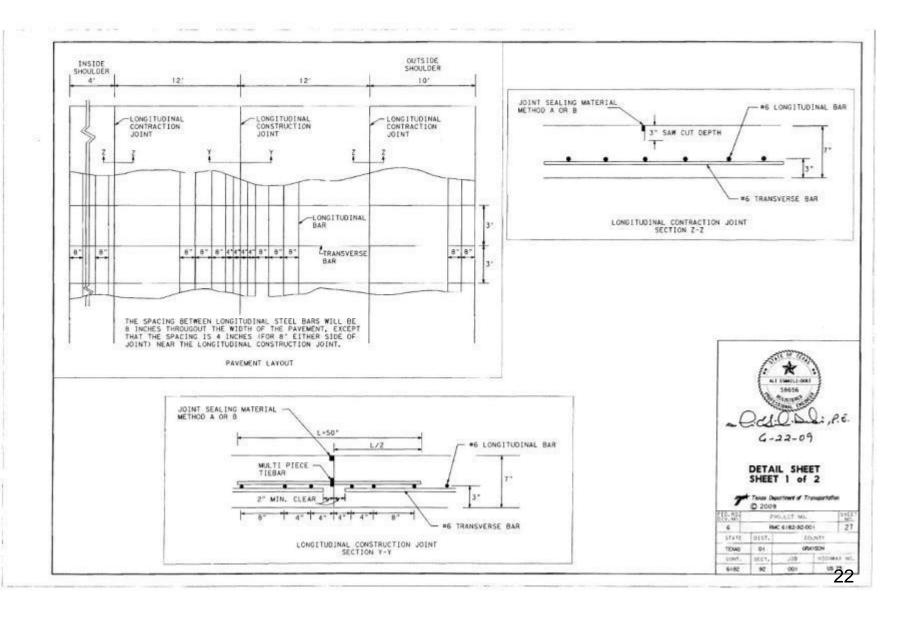
CRCP O/L Design Standard

- Design:
 - O/L slab thickness: 7-in
 - Longitudinal steel: 0.78 %
- Construction:
 - Concrete: Class P concrete
 - o Inside lane: May 21, 2010
 - Outside lane: June 21, 2010

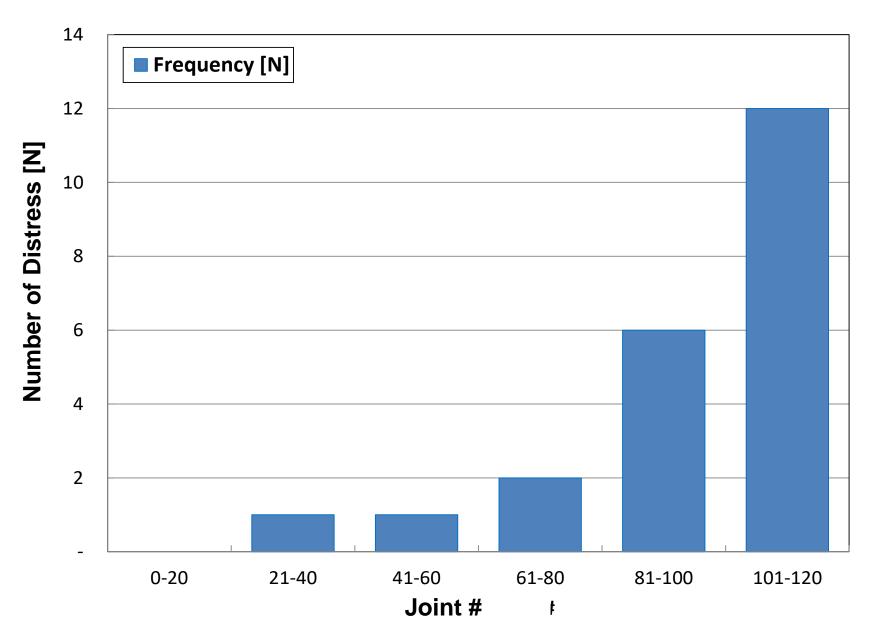
Distress in the Outside Lane

- Inside lane: perfect
- Outside lane: distresses at some joints
