**2005 Southeastern States
Pavement Management and Design Conference**

Pavement Forensics
Route 3, Lancaster County, Virginia

Mohamed Elfino, PhD, PE
Assistant State Materials Engineer

- **Project Number:0003-051-114, C501**
- **Location:WB Route 3, MP 16.10 – 19.10**
- **Lancaster County, Fredericksburg District**
- **White Stone - Kilmarnock**

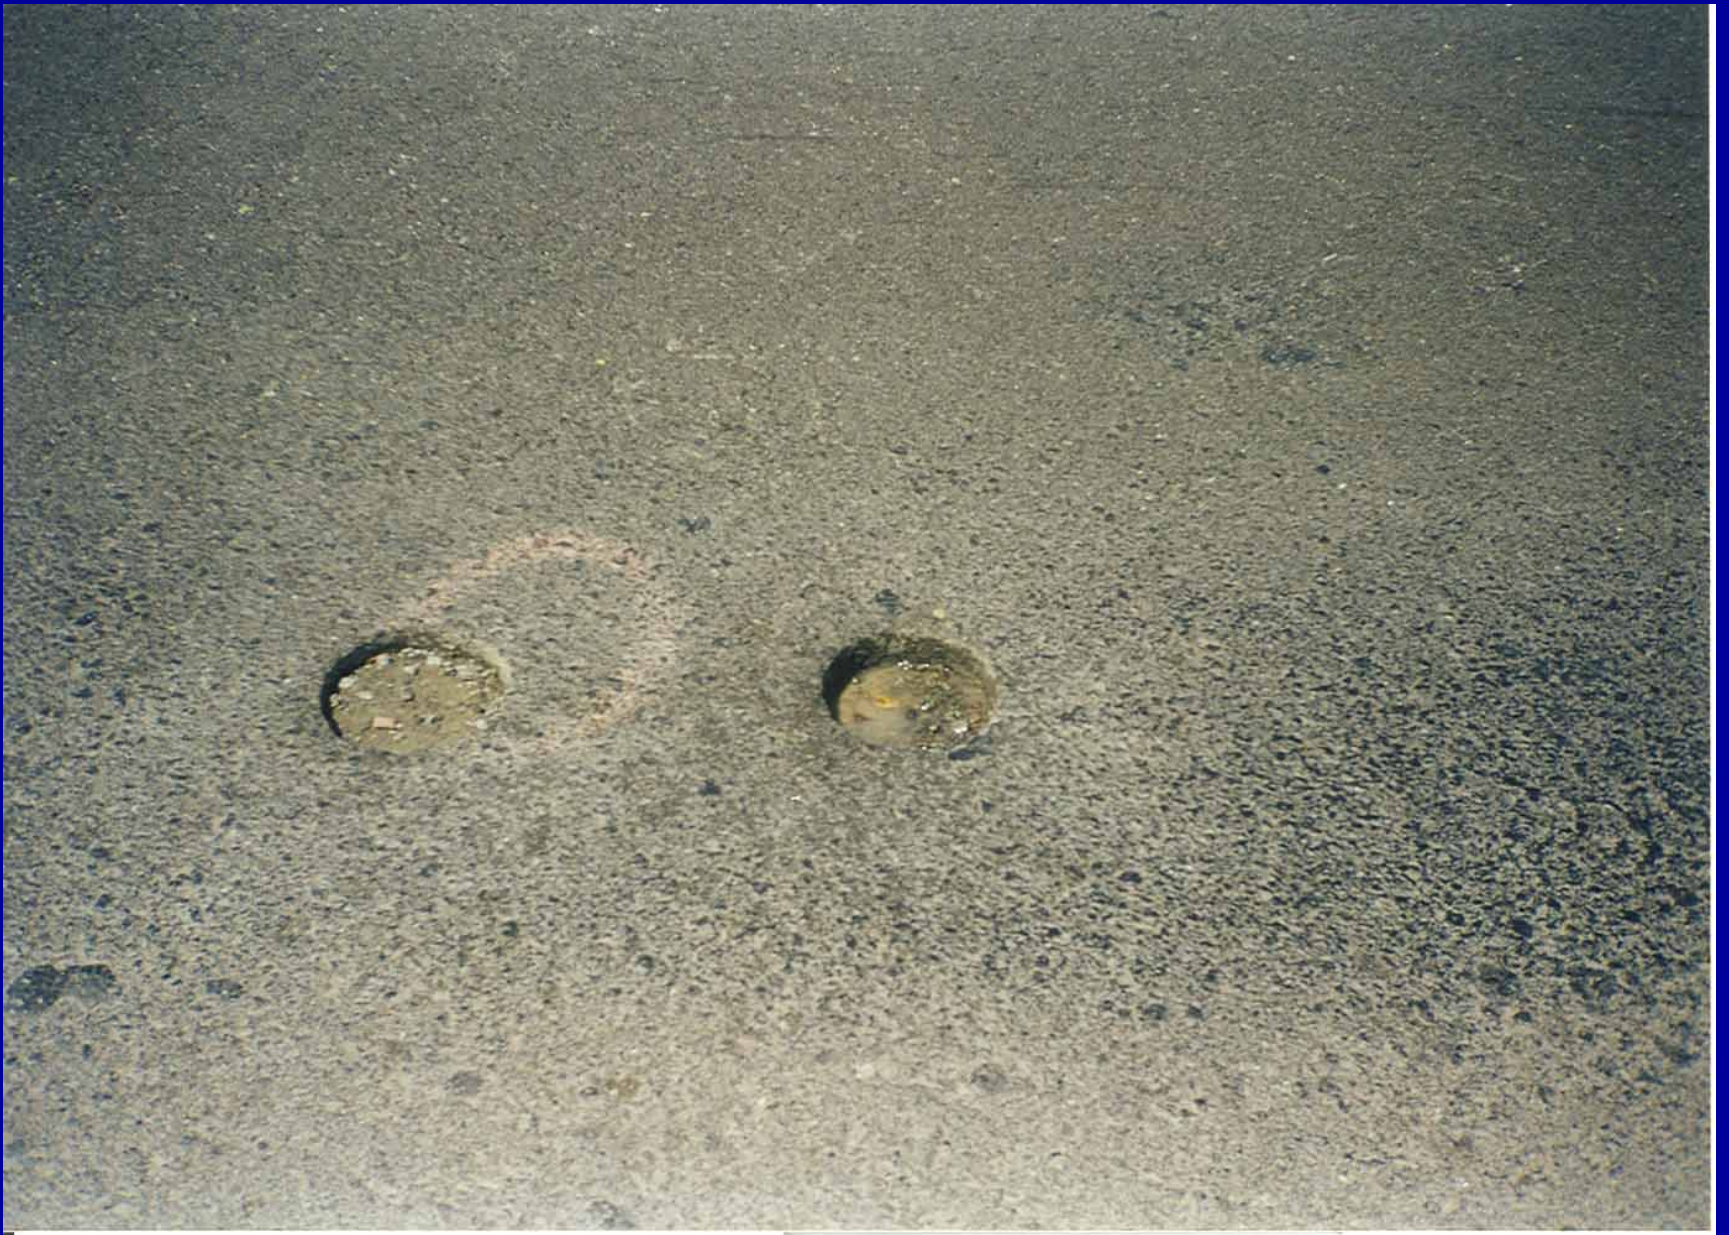
Rte. 3 Lancaster Co.
COMPOSITE STIFFNESS PROFILE
(Travel Lane)

- **The composite stiffness versus station was plotted for 1994, 1999, and 2000 using the FWD deflection data**
- **An average composite stiffness of 500 lbf/mil for all years were obtained, which entails that little to no improvement was made between 1994 ,1999, and 2000**

Average Stiffness	1994 -	558 lb/mil
	1999 -	528 lb/mil
	2000 -	439 lb/mil
