WisDOT Non-Cementitious Repair Materials Study

Prashant Ram
Applied Pavement Technology, Inc.

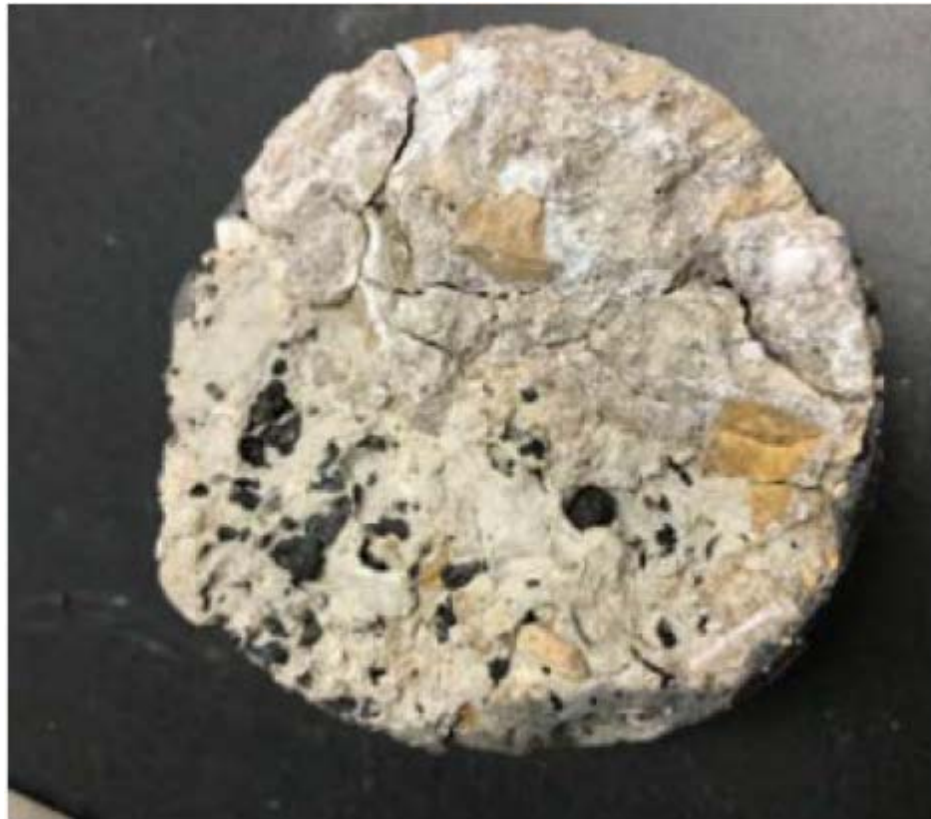
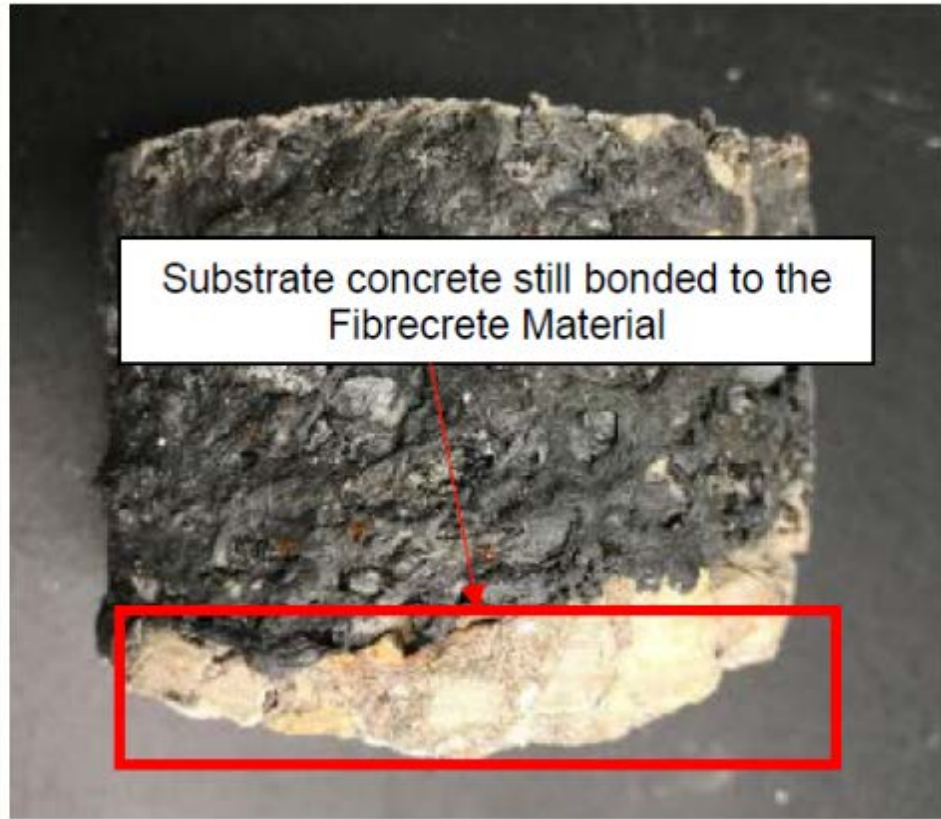
RM-1 Cores (1/2)

Considerable amount of substrate concrete material bonded to the bottom of the peeled-off Fibrecrete patch

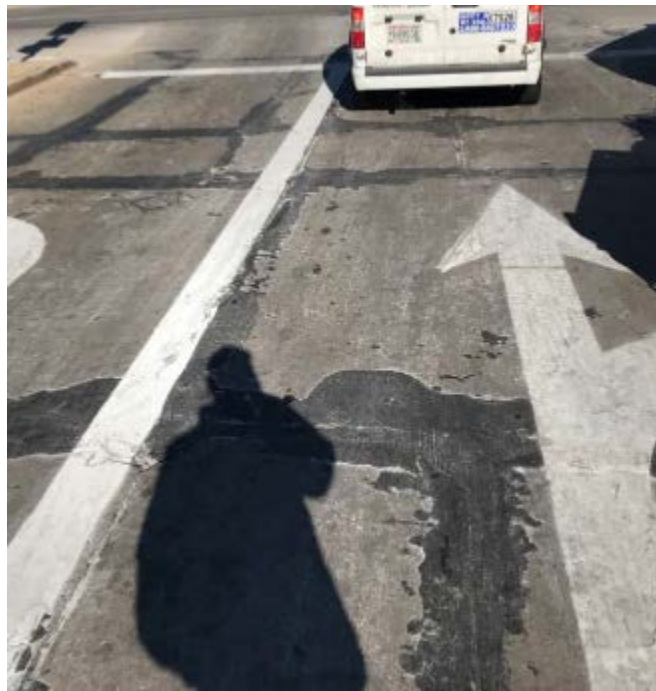
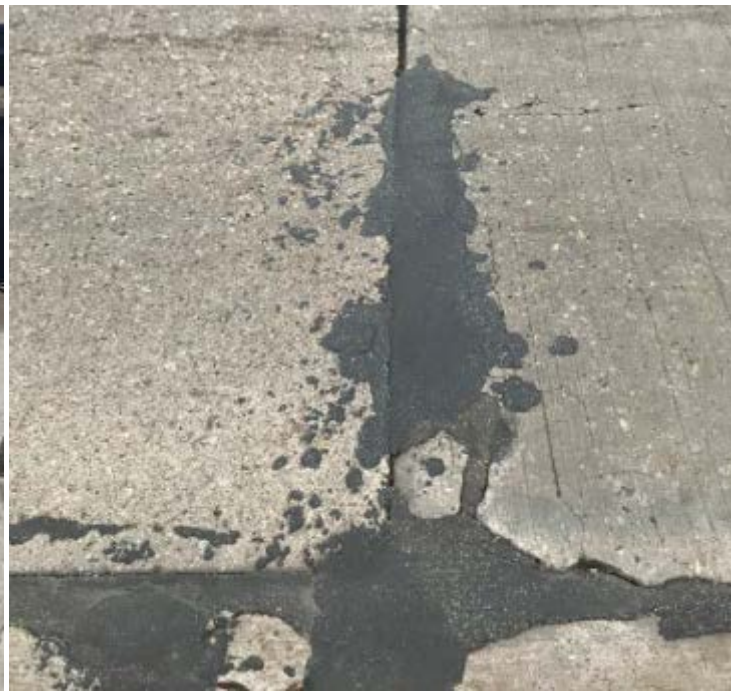
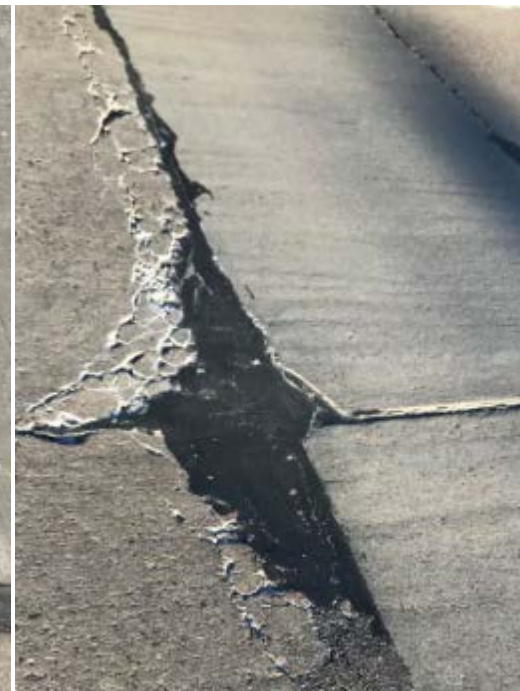
RM-3 Repairs

- Popular repair material for asphalt pavements
 - » Widely used in SE Region
- Limited use on PCC pavements
 - » Maintenance personnel noted good performance in joint and spall repairs
 - » Mostly used as stop-gap fix
