Cost-Effective Detection and Repair of Moisture Damage in Pavements

Introduction

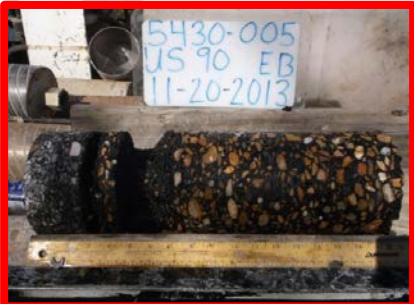
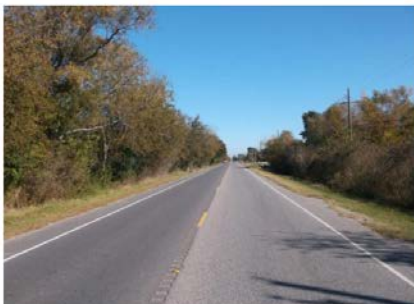
003-11-1 03.691 US0090_C.jpg

003-11-1 03.691 US0090_V.jpg

Comments	Deterioration of Layer Materials?
Stripping from 3.0 to 7.0 inches	<input checked="" type="checkbox"/>

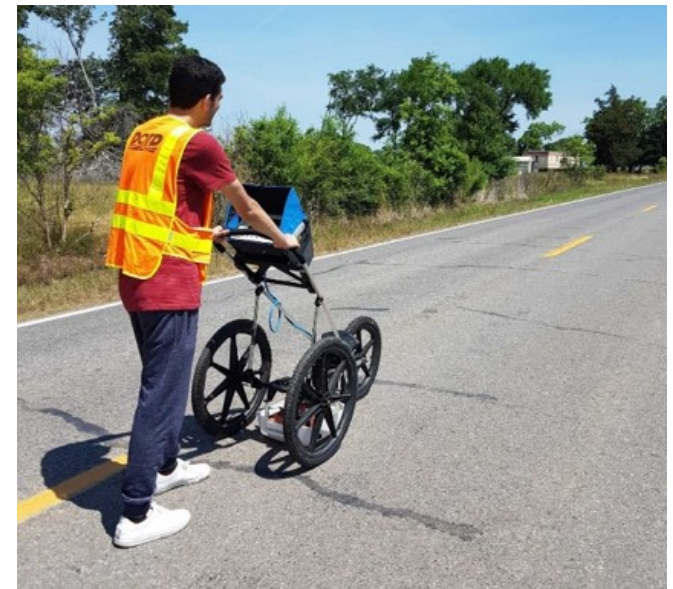
Ground Penetrating Radar (GPR)

- Non-destructive and continuous tool
 - transmits short pulses of electromagnetic waves into ground
 - reflections from the material boundaries and subsurface anomalies are identified from the reflected signal.
- Noninvasive, continuous, and high-speed evaluation
- Capabilities:
 - Pavement layer thickness estimation
 - detection of subsurface moisture
 - density variations and voids
 - underground utility locations...

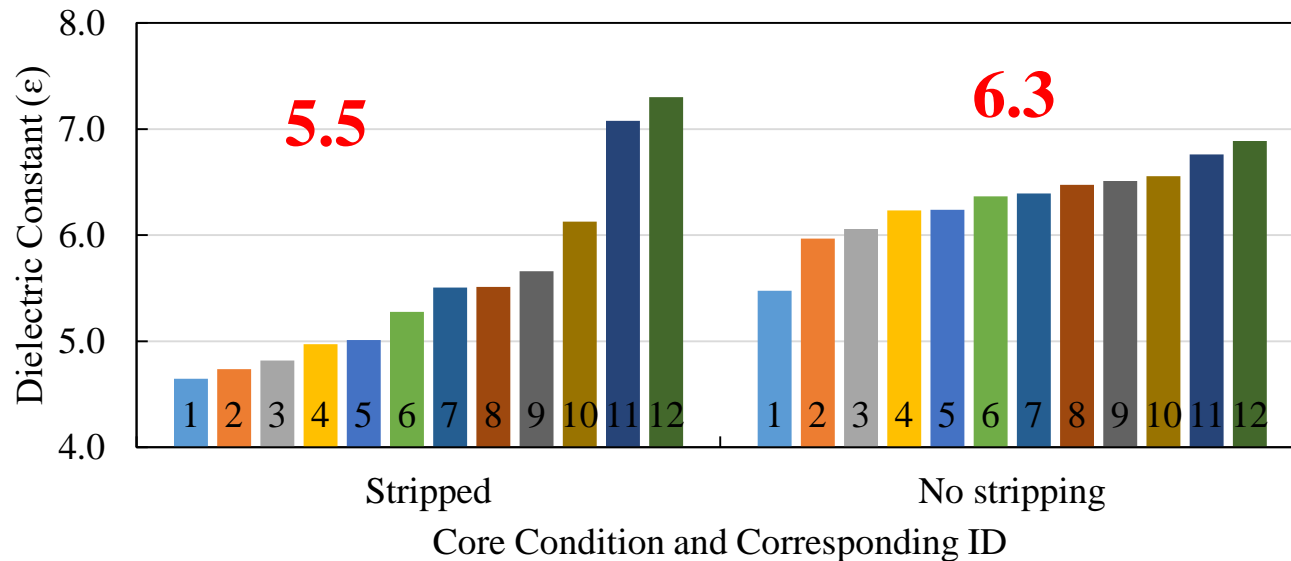
- Surface dielectric constants were calculated for 12 stripped and 12 non-stripped cores in Louisiana **during dry season**

- Stripped sections exhibited **lower** dielectric values due to stripping induced voids

- Stripping was found to be associated with lower dielectric values of the HMA layers.
- Intermediate large negative peaks between the regular positive peaks in GPR traces indicated moisture damage.
- UI profile:
 - Varied around unity for homogenous sections.
 - Fluctuated greatly for non-homogeneous sections.

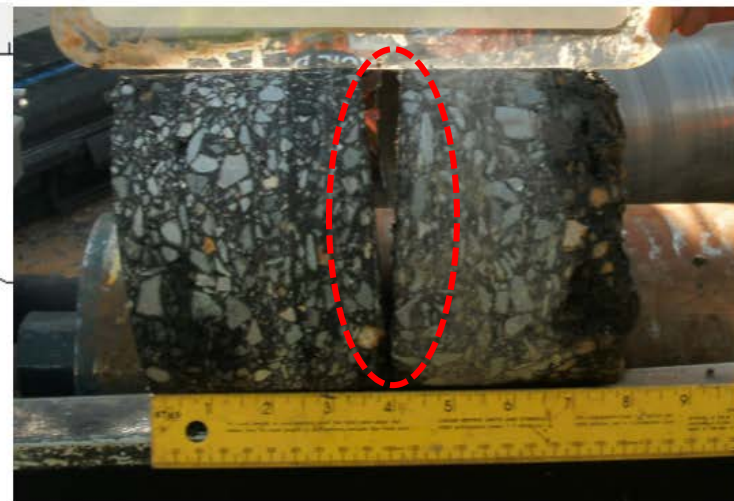
- Careful visual inspection of the traces was used in identifying the stripped locations.

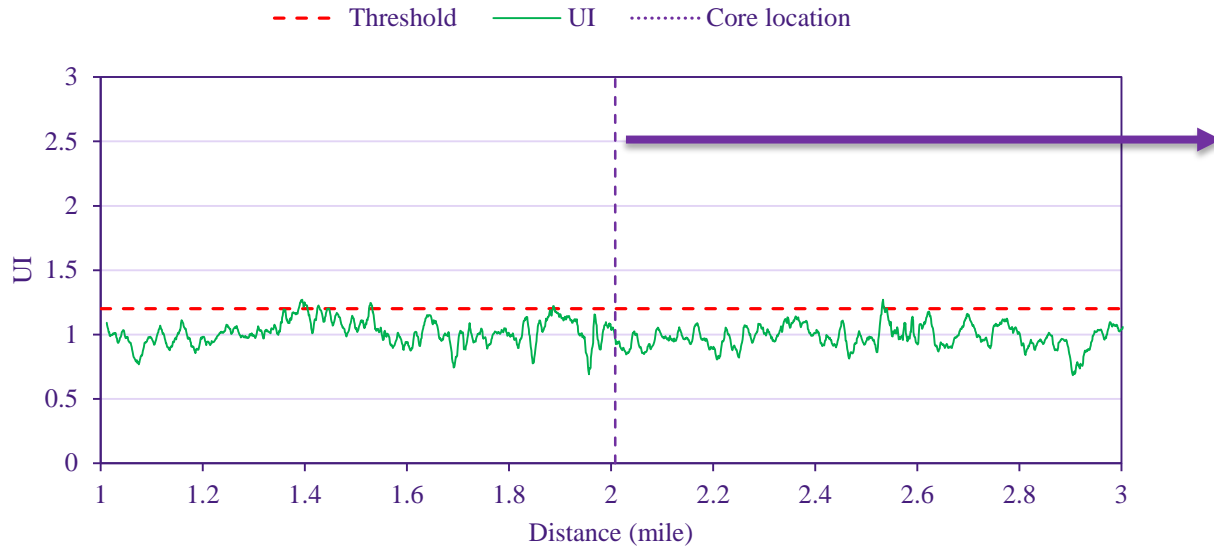
(088-03)

Core Depth	UI threshold
3 to 7 in.	1.2
7 to 17 in.	1.4

UI Profile

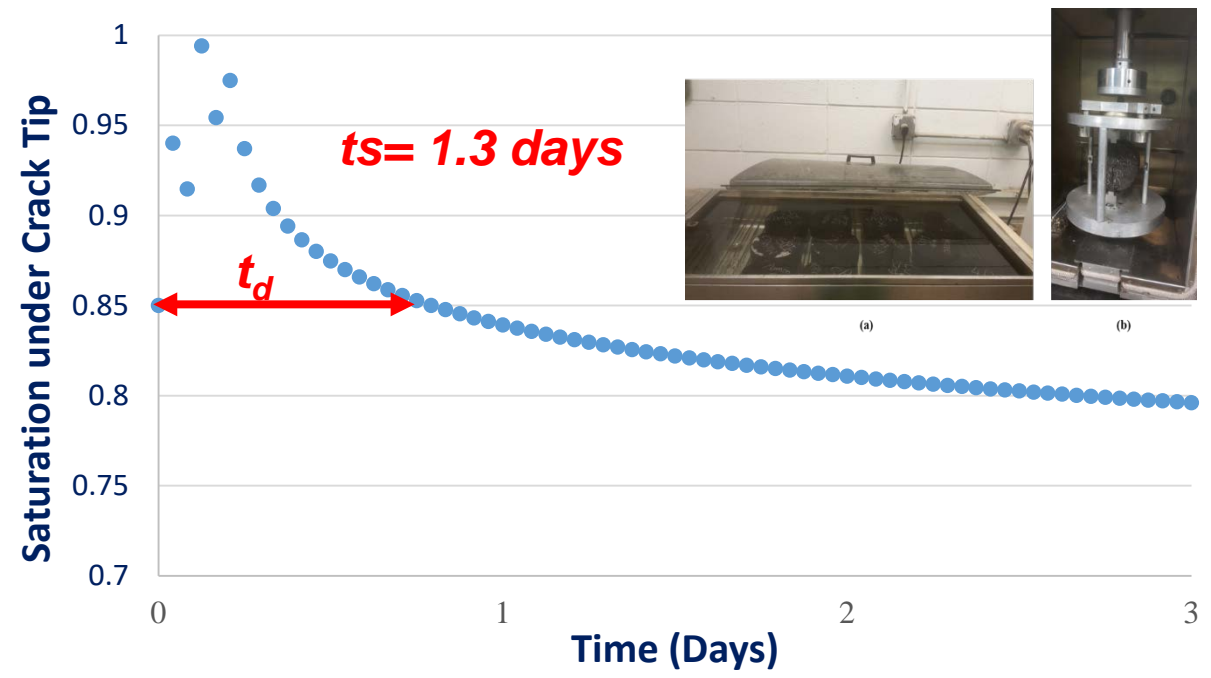
Hourly Transient Analysis (72 hours)

- GWT
- Relative humidity
- Air temperature
- Rain intensity
- Hydraulic conductivity

➤ Output

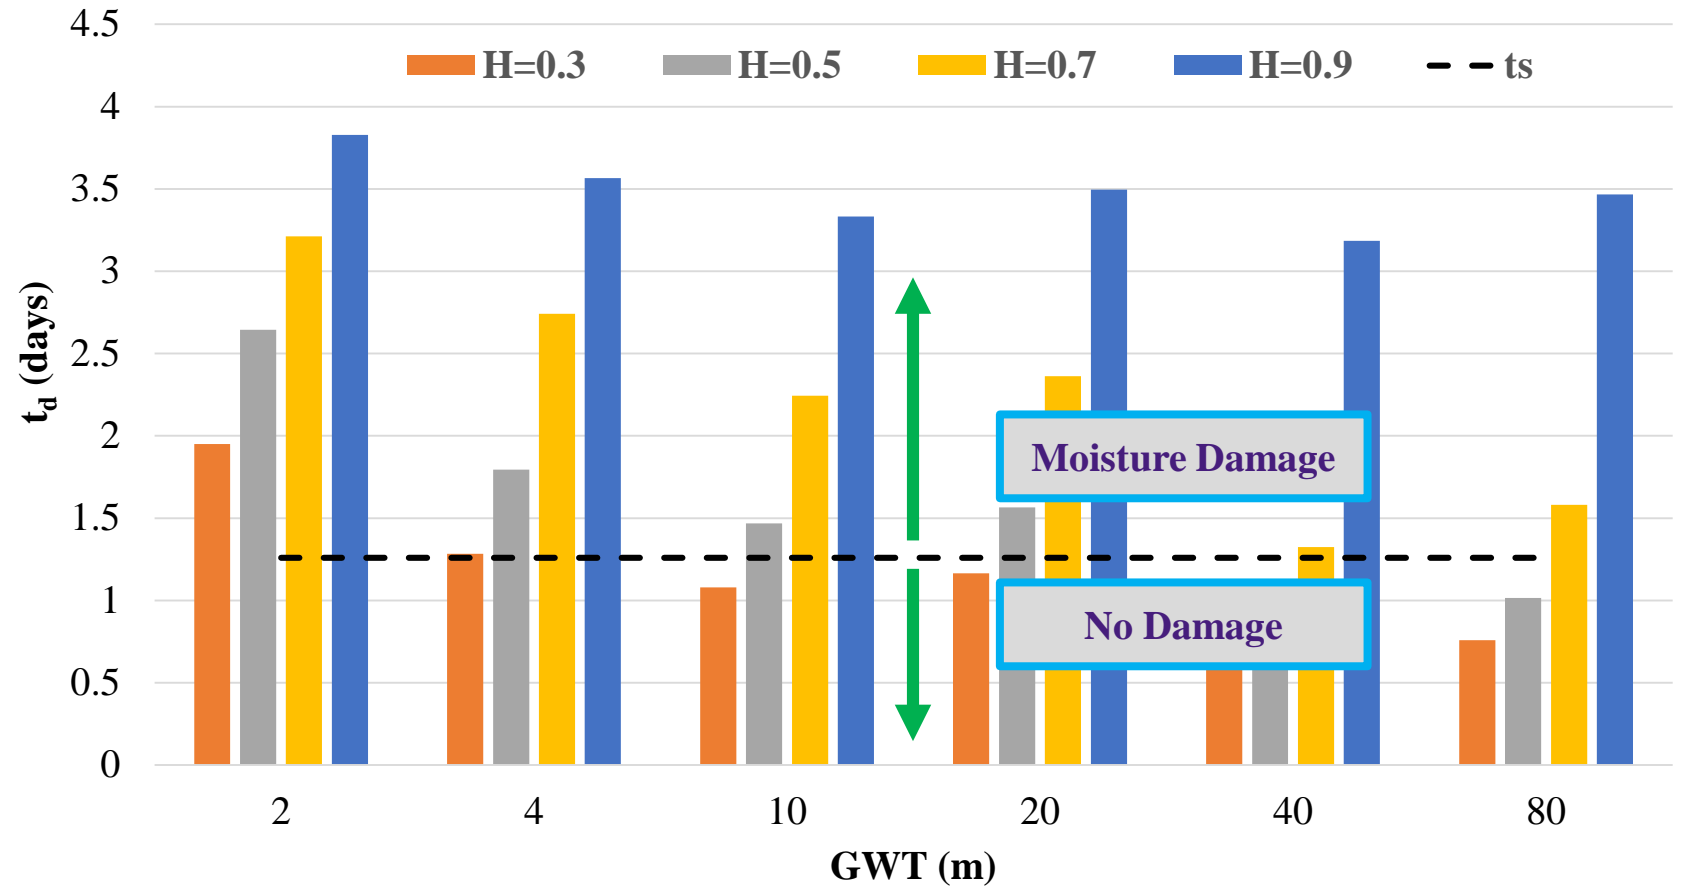
Results

$$K \leq 2 \times 10^{-6} \text{ m/s}$$

- Regions with relatively low air relative humidity and deep GWT are not expected to experience stripping due to accelerated drainage by evaporation.
- All previous techniques accompanied by core drilling will result in a highly accurate evaluation of moisture damage in AC pavements.

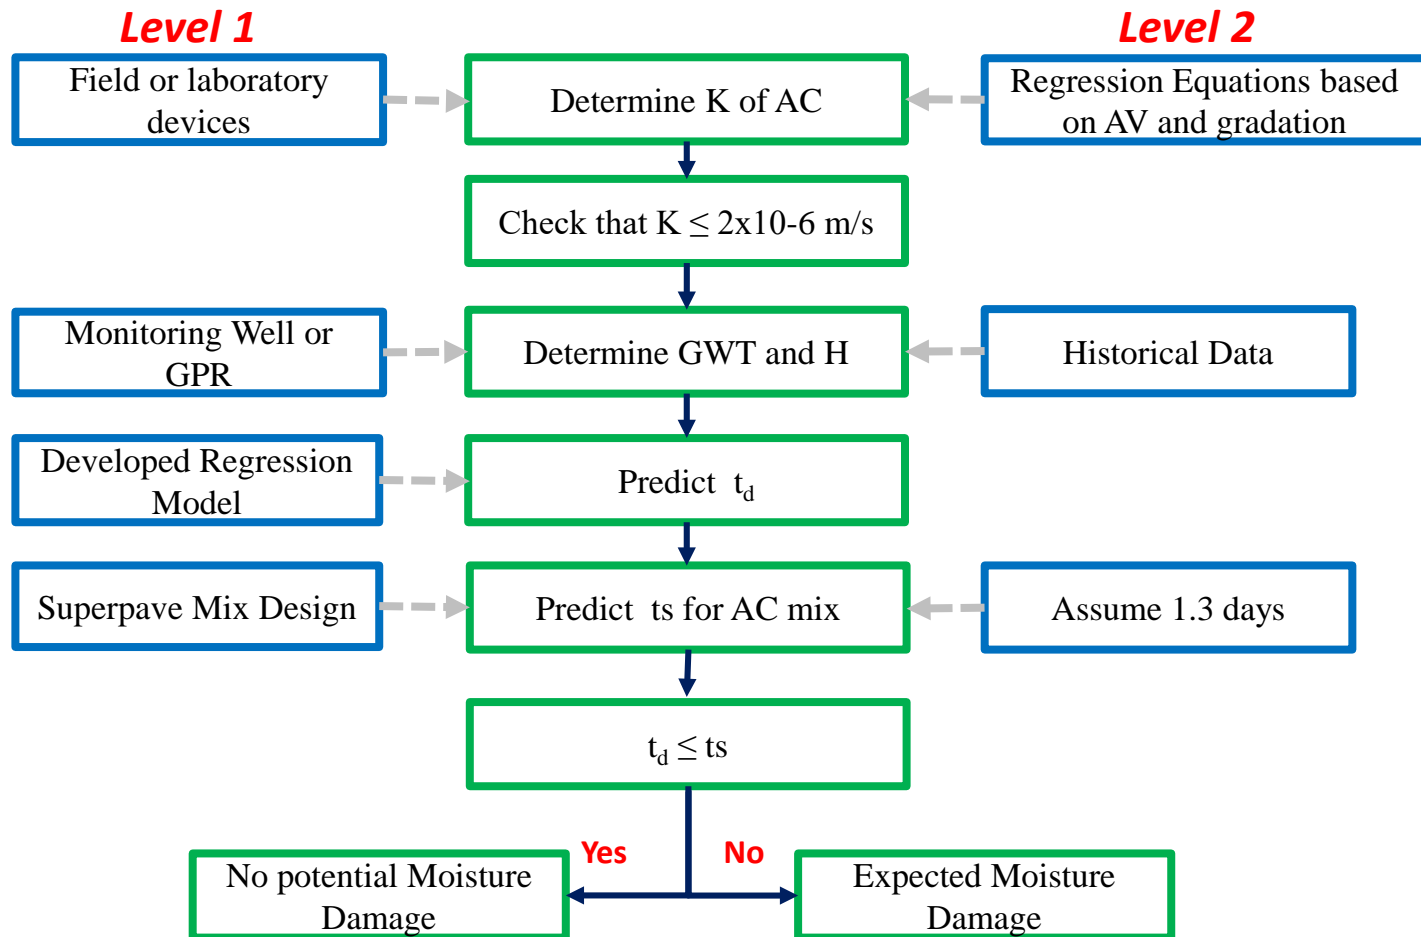
$$t_d = 1.7621 - 0.0491 GWT + 0.00044 GWT^2 + 3.2473 RH^3$$

R² = 84 %

Detection of Moisture Damage using Regression Model
